AVIATION OCCURRENCE REPORT

RUNWAY OVERRUN

RELIANT AIRLINES INC.
DASSAULT/SUD FAN JET FALCON N212R
PETERBOROUGH AIRPORT, ONTARIO
18 FEBRUARY 1998

REPORT NUMBER A98O0034

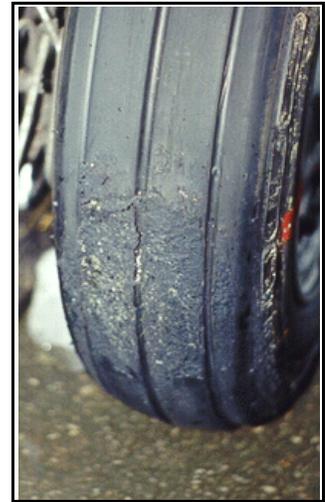
All four tires on the dual-wheeled aircraft main landing gear had an area of reverted rubber present (see Figure 1), indicative of hydroplaning. When hydroplaning occurs, the tires of the aircraft are completely separated from the actual runway surface and will continue to hydroplane until a reduction in speed permits the tire to regain contact with the runway surface. During total dynamic hydroplaning, the tire lifts off the runway and rides on the wedge of the water, causing such a complete loss of tire friction that wheel spin-up will not occur. On wet runways, where there is not enough water to cause dynamic hydroplaning, viscous hydroplaning can occur. This term describes the normal slipperiness or lubricating action of water. Viscous hydroplaning does not reduce the friction to such a low level that wheel spin-up will not occur. On the other hand, reverted rubber hydroplaning can occur when a locked tire is skidded along a very slippery water- or slush-contaminated runway, at any speed above about 20 knots, where the heat generated by friction produces steam and begins to revert the rubber, on a portion of the tire, back to its uncured state. The increase in stopping distance as a result of hydroplaning is impossible to predict accurately, but it has been estimated to increase by as much as 700 per cent. Performance graphs for the aircraft indicate that a landing distance of 4 400 feet was required for the aircraft at the calculated landing weight of 22 198 pounds. Landing distance was calculated for a bare, dry runway condition.

1. Precipitation changed from light rain to snow and rain at or near the time at which the flight crew commenced their approach to the airport.
2. The runway surface was contaminated with a thin layer of slush at the time the aircraft landed.
3. The aircraft main landing gear tires hydroplaned on landing roll, reducing the aircraft braking action.
4. The aircraft main landing gear wheels locked in a skid when braking was applied with the brake anti-skid system deactivated.
5. The drag chute, when deployed , did not remain attached to the aircraft.
6. The aircraft overran the end of the runway.

The aircraft hydroplaned and overran the runway, probably as a result of the anti-skid brake system being selected off and maximum brakes being applied. It was not determined whether having the anti-skid system selected would have prevented the overrun, but the distance to a full stop would have been reduced.
