AVIATION INVESTIGATION REPORT

A02O0349

AIRCRAFT DIFFICULT TO CONTROL

de HAVILLAND DHC8-311, C-FACF

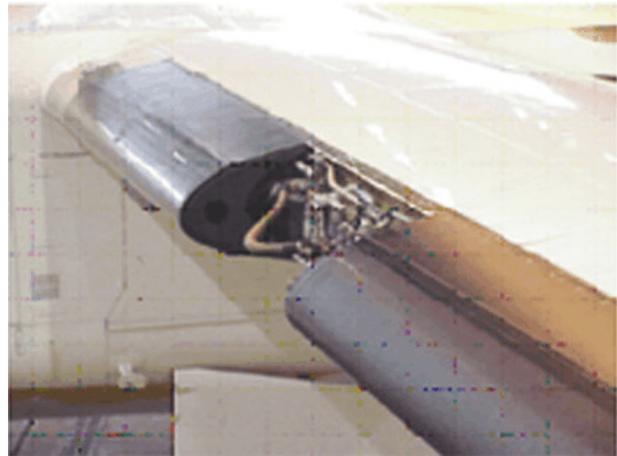
The de Havilland DHC8 (registration C-FACF, serial number 259) was being operated by Jazz Air Inc. as Flight JZA7956 from Toronto, Ontario, to Windsor Locks, Connecticut (KBDL), U.S.A. The aircraft departed from Runway 06L at Toronto/Lester B. Pearson International Airport (LBPIA), Ontario, at 1950 eastern standard time on the scheduled night instrument flight rules flight. During the take-off run, a three-foot piece of the wing leading edge (with the de-ice boot attached) separated from the left wing. The flight crew noticed a vibration on the flight controls during the initial climb after take-off and elected to return to Toronto/LBPIA. Air traffic control received a report of debris on Runway 06L, and the DHC8 aircraft leading-edge piece was retrieved. The aircraft landed without further incident on Runway 06L, with emergency response vehicles on standby. When the leading-edge section was examined, it was determined that the 14 screws that secure the leading-edge section to the bottom of the wing were missing.

Photo 1. Missing number 4, left, leading-edge panel

Jazz Air Inc. added a general maintenance procedure (GMP) to Section 1 of its *Maintenance Procedures Manual*, requiring an independent visual inspection of the leading-edge installation. GMP number 14 states:

Jazz Air Inc. has added a line maintenance procedure (LMP) to Section 2 of its *Maintenance Procedures Manual*, specifying the procedure to be followed for passing information from the departing maintenance crew to the incoming maintenance crew. LMP number 10 states:

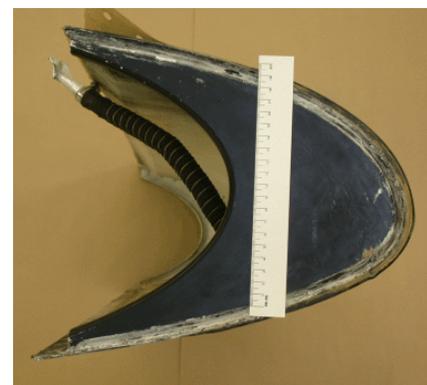
Photo 2. Cross-section of the left leading edge

The number 4 leading-edge panel is approximately 38 inches long, D shaped, with 11 inches between the top and bottom rows of screws. The leading-edge panel is painted black and has a black pneumatic de-ice boot across the leading edge. It is secured to the wing structure by 14 brass-coloured, countersunk screws on the top, and another 14 on the bottom. Although there is some paint in the countersunk recess of the leading edge, most of the screw holes have a significant amount of bare aluminium showing. All of the screws securing all of the leading-edge sections are unpainted.

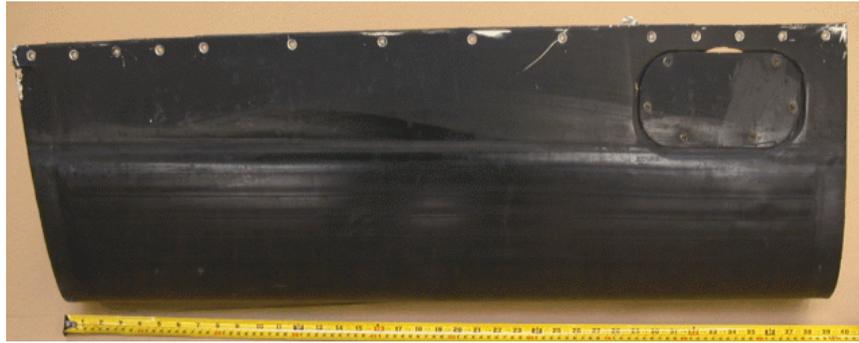
Photo 3. Left leading-edge section

The unpainted, brass-coloured screws that hold the leading-edge sections in place are highly contrasted by the black paint and pneumatic boot on the leading edges. All of the leading-edge screw holes are countersunk, and there is little paint remaining on the shoulders of these countersunk holes. The contrast provided by the bare aluminum of the leading-edge structure is similar to that of an unpainted screw. Thus, unless someone, an AME or pilot, is looking specifically for the screws, it would not be obvious that the screws had not been installed.
