AVIATION INVESTIGATION REPORT

A04A0110

RUNWAY EXCURSION

BOEING 727 C-GMSX

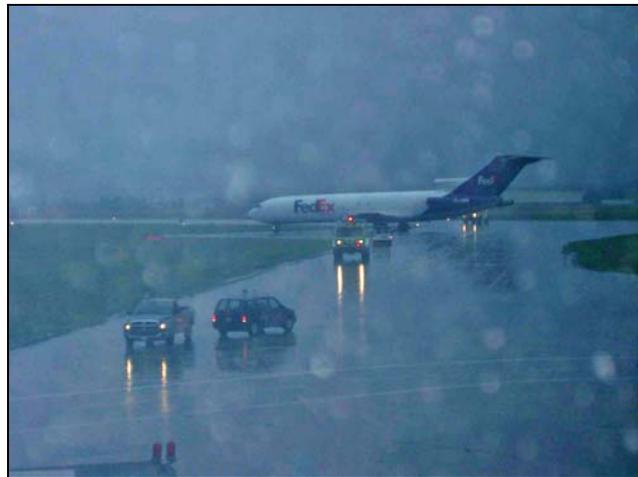
Photo 1 shows the aircraft moments after the landing. There was significant precipitation and standing water, which would have been conducive to aircraft hydroplaning. The Transport Canada Aeronautical Information Manual (AIM) notes that, when hydroplaning occurs, "it is known that a 10-knot, crosswind will drift an aircraft off the side of a 200-foot wide runway in approximately 7 seconds under hydroplaning conditions."

Photo 1. Aircraft moments after runway excursion

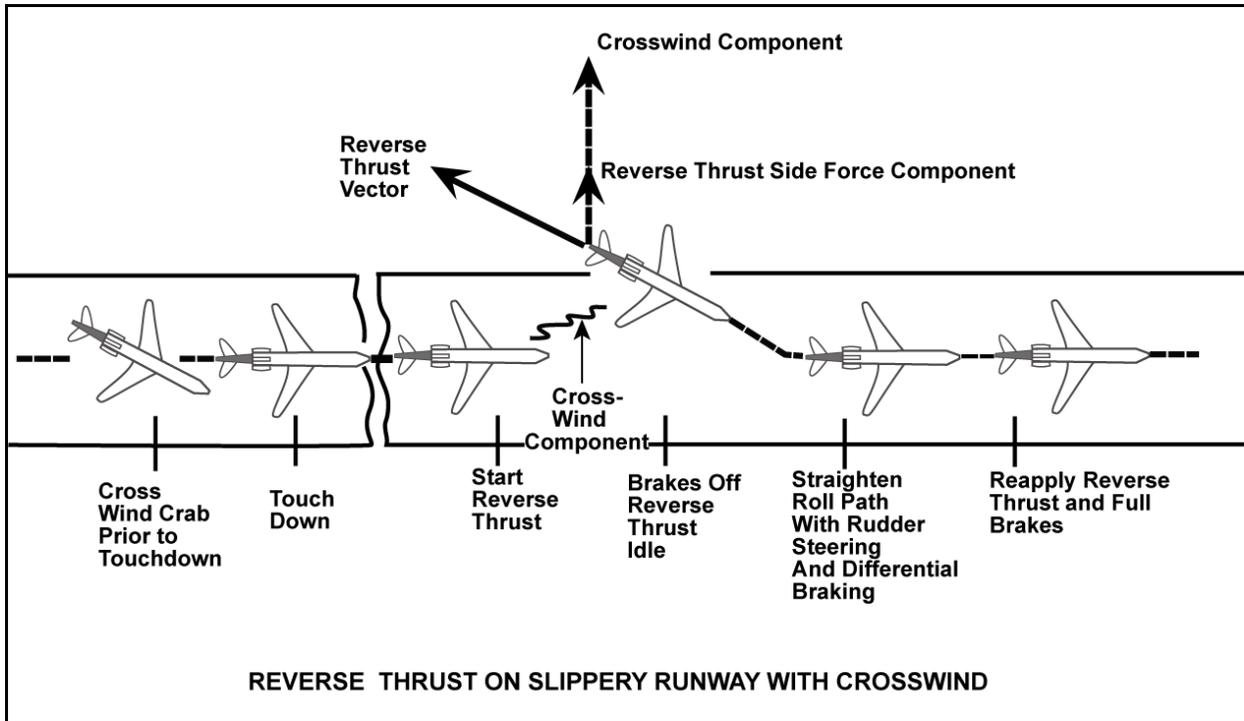
Appendix A – Jet Aircraft Technique for Directional Control when Hydroplaning

The reverse thrust side force and a crosswind can cause the airplane to drift to the downwind side of the runway if the airplane is allowed to weathervane into the wind. As the airplane starts to weathervane into the wind, the reverse thrust side force component adds to the crosswind component and drifts the airplane to the downwind side of the runway. Main gear tire cornering forces available to counteract this drift will be reduced when the anti skid system is operating at maximum braking effectiveness for existing conditions. To correct back to the centreline, reduce reverse thrust to reverse idle and release the brakes. This will minimize the reverse thrust side force component without the requirement to go through a full reverser actuating cycle, and provide the

total tire cornering forces for realignment with the runway centreline. Use rudder, aileron and differential braking, as required to prevent overcorrecting past the runway centreline. When established on a track that will regain the runway centreline, reapply steady brakes and reverse thrust as required to stop the airplane.

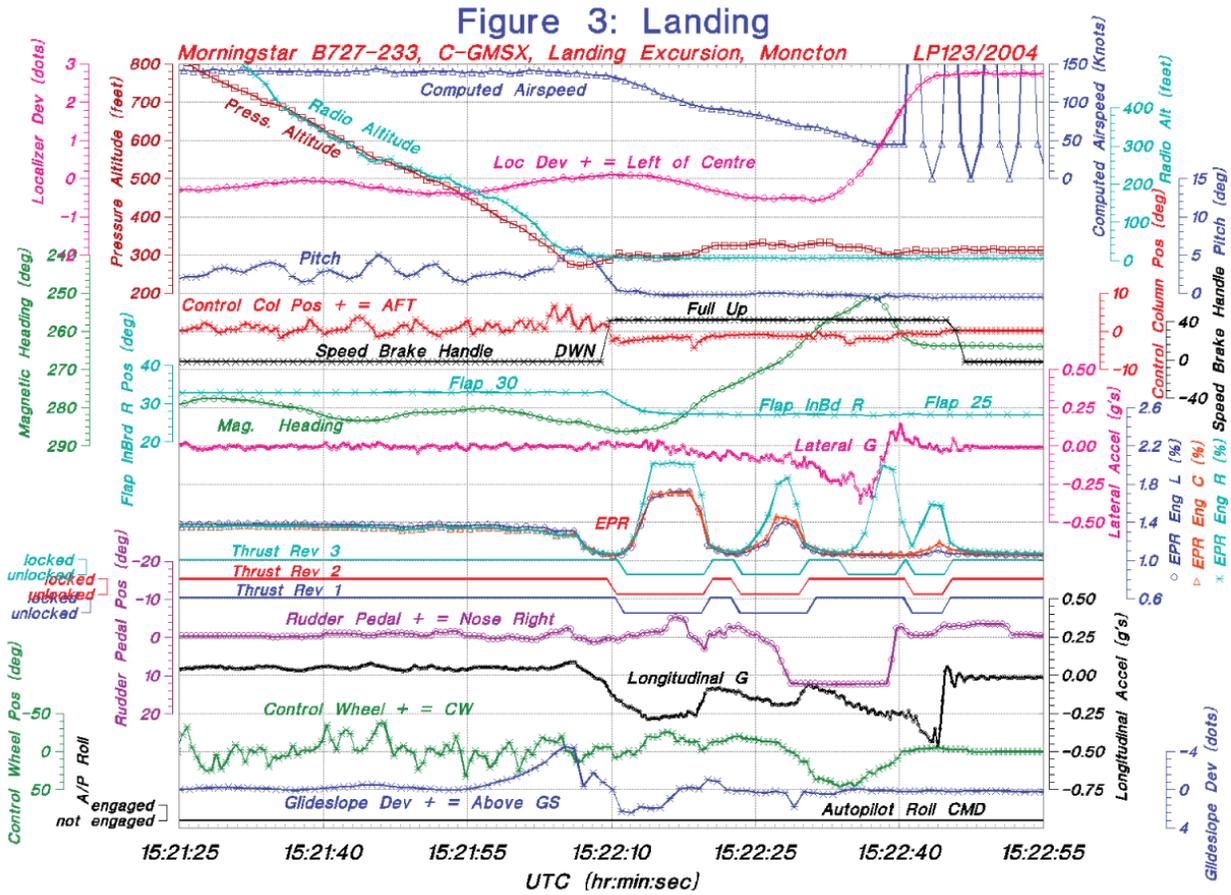
Appendix B – Flight Data Recorder Plot of Landing

The aircraft landed approximately 1400 feet from the runway threshold at 135 knots indicated airspeed (KIAS) on a heading of 284°M, four degrees left of the runway heading of 288°M. Immediately following touchdown, the speed brakes were manually deployed, the wing flaps were raised from 30° to 25°, and the thrust reversers were deployed, all in accordance with the operator's standard operating procedures (SOPs). Three seconds after touchdown, the aircraft began to weathercock to the left. Reverse thrust reached a maximum engine pressure ratio (EPR) of 1.7 on the number one and two engines, and an EPR of 2.0 on engine number three. The higher EPR on the number three engine had been apparent on previous landings, indicating that the number three thrust lever was likely out of adjustment. However, the mismatch value was approximately twice as much on the incident landing, suggesting that it was used to counter the weathercocking tendency.

The initial application of reverse thrust was maintained for four seconds. However, the aircraft continued to drift toward the right side of the runway and the aircraft heading continued to decrease. The thrust levers were stowed and redeployed twice more in an attempt to regain directional control and counter the drift to the right, but the aircraft remained right of the centreline. During this time, the pilot applied full right rudder and a significant amount of right control wheel input with no significant result. At about 70 KIAS, with the aircraft heading about 250°M, tire friction began to take effect, and the aircraft departed the left side of the runway.
