AVIATION INVESTIGATION REPORT

A05W0010

FAILURE TO REMAIN ON THE RUNWAY (REJECTED LANDING)

**JETSGO McDONNELL DOUGULAS DC-9-83 C-FRYH
CALGARY INTERNATIONAL AIRPORT, ALBERTA
20 JANUARY 2005**

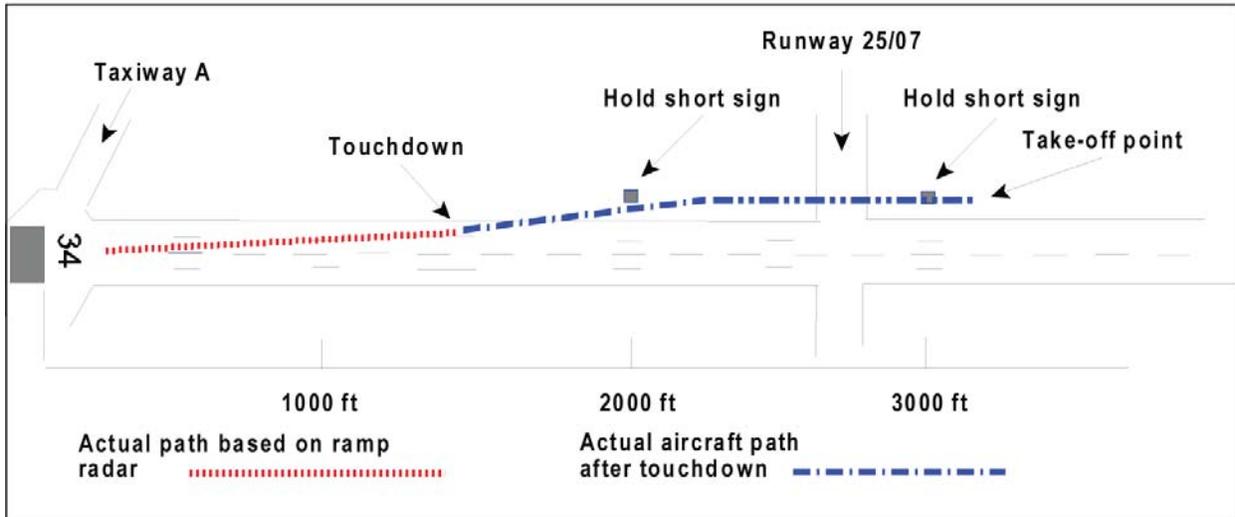
Figure 1. Overhead view of the runway – Calgary International Airport

At DH (1954:55), the captain looked up and called for a landing. The autopilot was disconnected at 1955:05, approximately 65 feet above aerodrome elevation. The PF rolled into a 10° bank to the left, resulting in a heading change of 5° to the left. The PNF noticed that the aircraft was drifting to the left and advised the PF. The PF acknowledged the PNF and continued with the landing. The aircraft touched down on the runway at 1955:13, approximately 1400 feet from the threshold of Runway 34 and about 80 feet left of the centreline, on a track of about 335° Magnetic (M) (see Figure 1). The aircraft departed the left side of the runway 1600 feet from the threshold, eventually paralleling the runway about 71 feet from the edge.

Take-off power was applied to initiate a go-around at 1955:17. While travelling through the grass, the aircraft's left outer flap struck a glancing blow to the hold short sign located south of Runway 07/25. JGO191 proceeded across Runway 07/25 and struck and destroyed the hold short sign north of Runway 07/25 with the left main landing gear before lifting off at 1955:25. The aircraft was on the ground for approximately 1800 feet and 11.5 seconds.

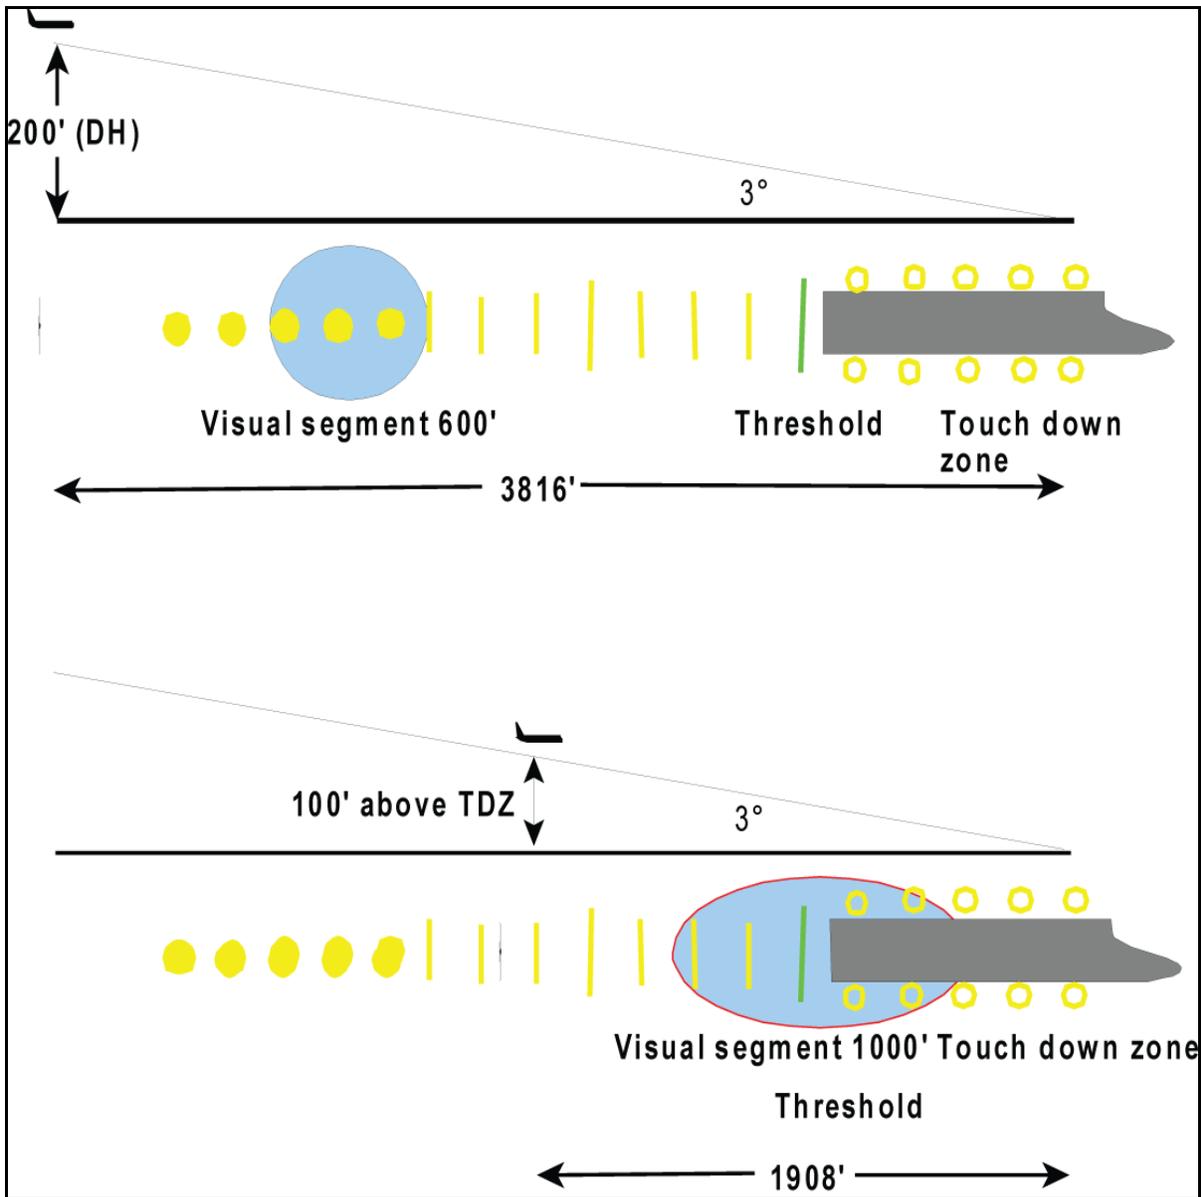
Figure 2. Available visual segment at 200 feet and at 100 feet on an approach

When pilots are making the transition from instrument to visual flight, their ability to judge the approach, flare and landing rollout will be dependent upon the length of the visual segment (that is, the distance ahead of the aircraft that the pilot can see). At a DH of 200 feet, on a 3° glide slope, the aircraft is 3816 feet from the touchdown zone ($3816' = 200 \div \tan 3^\circ$). Carmack (1972)⁵ points out that the downward vision angle of most transport aircraft is approximately 14°, which will significantly reduce the length of the visual segment. At a height of 200 feet agl, approximately 800 feet ($800 = 200 \div \tan 14^\circ$) in front of the aircraft will be obscured by the nose of the aircraft, and at 100 feet agl, the amount of obscured terrain will be approximately 400 feet

($400 = 100 \div \tan 14^\circ$). Given a 1400-foot RVR and assuming this to be representative of slant range visibility, this will provide a visual segment at a 200-foot DH of approximately 600 feet, and a visual segment of approximately 1000 feet at 100 feet agl. Carmack summarized the effect of this visual segment as follows: "A visual segment of 800 feet is insufficient to consider as visual conditions, so the aircraft must be flown by instruments below decision height."⁶
