AVIATION INVESTIGATION REPORT

A05W0059

COMPONENT FAILURE

LOCKHEED L382G HERCULES C-GHPW

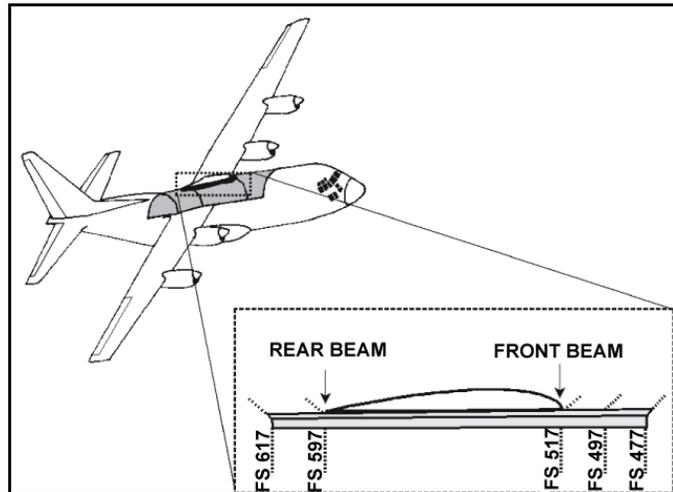
Figure 1. Attach angle location

After the aircraft landed, at 1312,¹ the crack was inspected; it had closed up and was not visible. The aircraft was subsequently flown unpressurized to a repair facility in Edmonton, Alberta. It was determined that the crack had propagated to 33 inches in length in the radius of the left attach angle, PN 390624-7, near fuselage station (FS) 577, butt line (BL) 61. Records indicate the attach angle had accumulated 35 789 hours time in service and had undergone 31 205 pressure cycles. The one-piece left and right wing-to-fuselage attach angles² secure the fuselage sidewall to the lower skin of the centre wing box beam in the aircraft. The attach angles are installed on the upper corners of the cabin, from forward of the centre wing at FS 477 to aft of the centre wing at FS 617 (see Figure 1). They provide a pressurization seal at the centre wing-to-fuselage juncture and support the fuselage sidewall against pressurization blow out (see Photo 1). Primary wing-to-fuselage

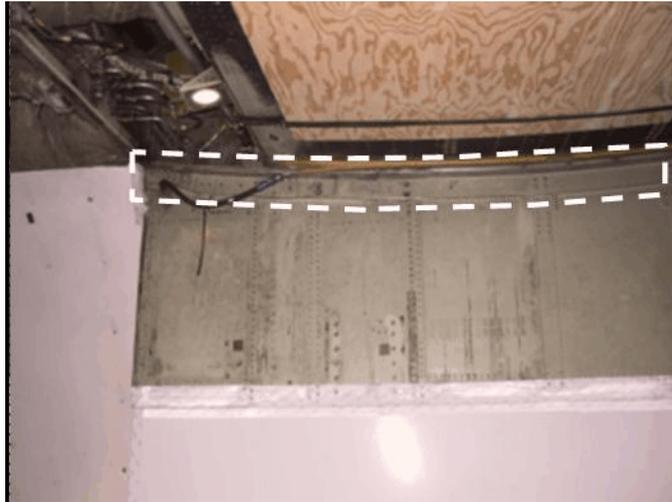
Photo 1. Dashed lines indicate wing attach angle.

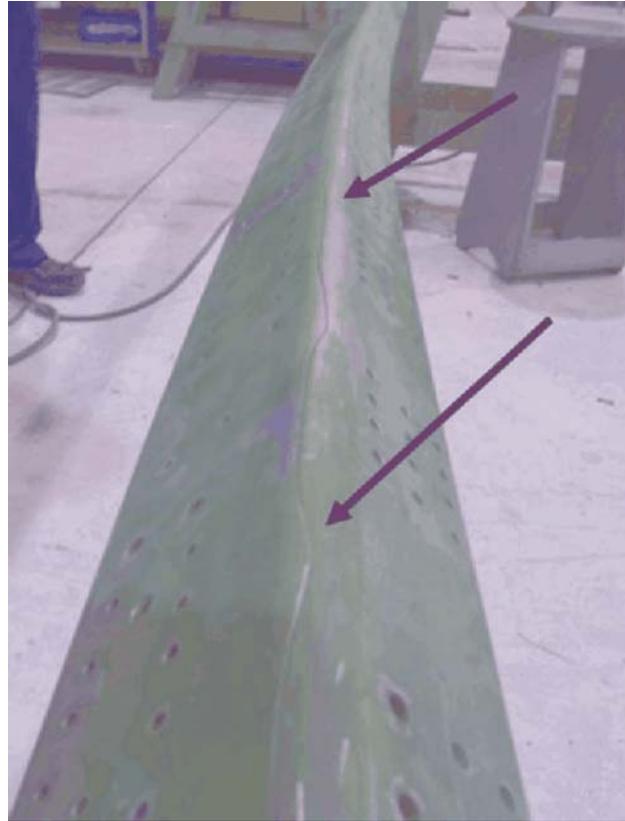
in the radius at the aft end of the attach angle, near FS 577, resulted from the initiation of three regions of fatigue cracking that had extended as a result of an overstress to form a single crack measuring 33 inches in length (see Photo 2). Measurements of crack growth rates suggested that the crack was growing slightly every time the fuselage was pressurized and had been active over a number of years. No indication of stress corrosion was found in the crack. In communications with Lockheed representatives during this investigation, they stated that stress corrosion cracking had been the mechanism of crack initiation in all previous attach angle failures. The number of failures was not made known to TSB investigators.

Photo 2. Arrows indicate crack in attach angle.

1. Fatigue crack initiation and propagation occurred in the bend radius of the left attach angle at FS 577, which resulted in failure of the component. The left wing-to-fuselage attach angle repair that was accomplished at FS 497 in 1987 extended the component installation time in service, with no suitable method to cover crack detection at FS 577.

Following the occurrence, First Air replaced the left and right attach angles on aircraft C-GHPW.

As a result of this occurrence, Lockheed Martin issued Revision 3 of Service Bulletin 382-53-61/82-752, dated 04 August 2005. Revision 3 of the SB specifically identified the need for a visual inspection of the wing-to-fuselage attach angles on applicable aircraft, to be accomplished within 30 days after receipt of the Service Bulletin to determine if repairs have been installed, and further recommended replacement of any previously-repaired attach angle within 365 days.
