**AVIATION INVESTIGATION REPORT
A06W0139**

LOSS OF CONTROL AND COLLISION WITH TERRAIN

**NORTH-WRIGHT AIRWAYS LTD.
CESSNA 337C SKYMASTER C-FWHP
FORT GOOD HOPE, NORTHWEST TERRITORIES, 23 nm E
16 AUGUST 2006**

Report Number A06W0139

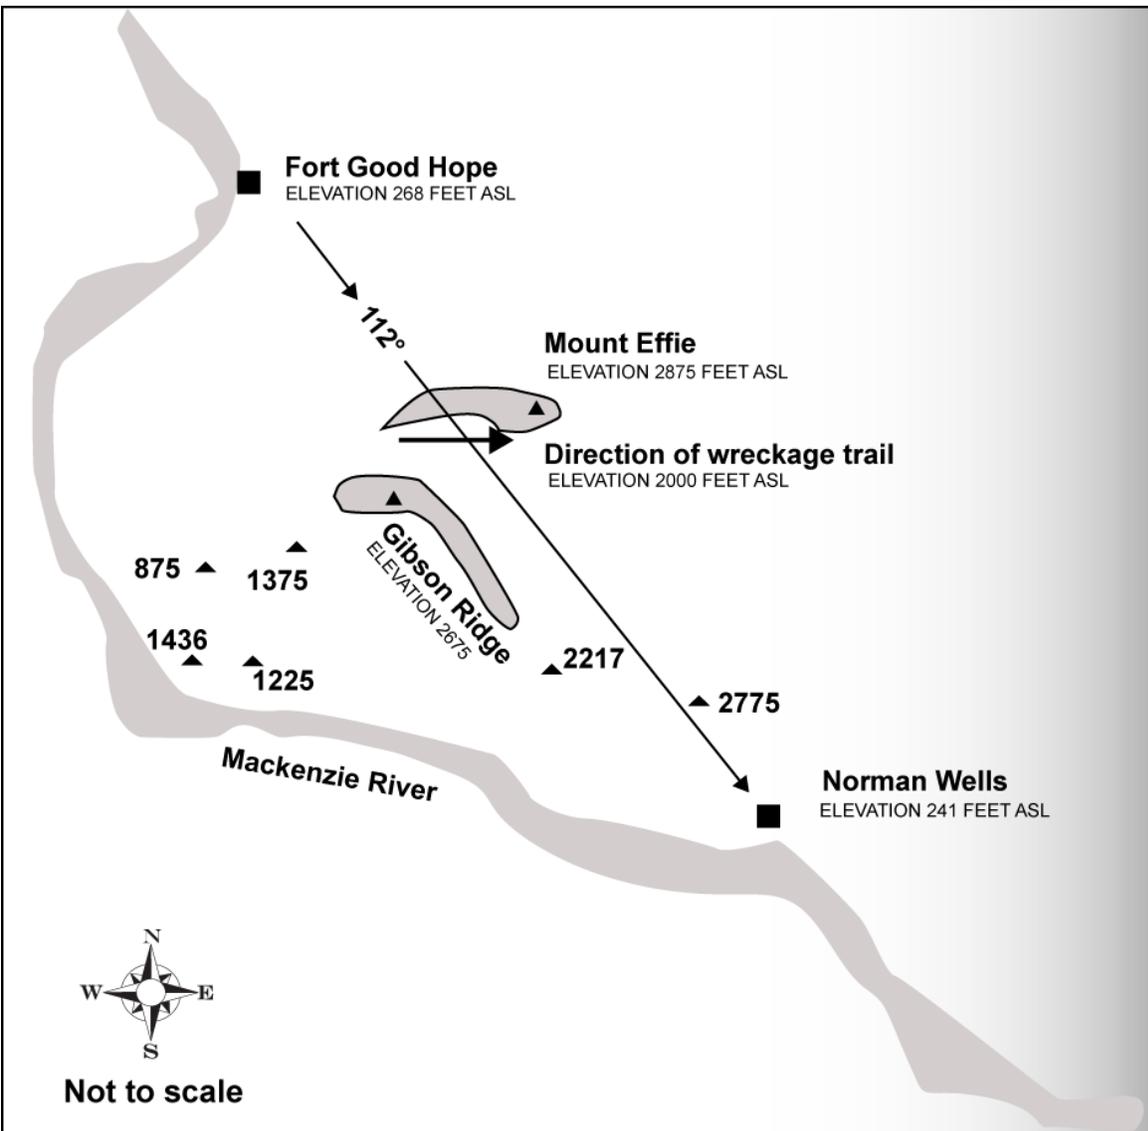
Figure 2. Fort Good Hope-Norman Wells geographic area

At 1345, the company initiated its overdue aircraft response, which included a radio communication search, followed by the dispatching of company aircraft at 1430. The wreckage site was located at 1616 on the southern slope of Mount Effie, 23 nm southeast of Fort Good Hope (see Figure 2).

There are numerous mountains in the area. Mount Effie is orientated in an east-west axis, perpendicular to the direct-line route from Fort Good Hope to Norman Wells. This formation is approximately 11 nm long and 3 nm wide. The feature has two peaks, one measuring 2875 feet

asl on the east side and the other measuring 2275 feet asl on the west side. The local VFR navigational chart (VNC) indicates that the maximum elevation figure (MEF) where Mount Effie is located is 3300 feet asl. The MEF is based on information available concerning the highest known feature in that area plus suitable factors to allow for inaccuracy and incompleteness of the topographical height information.

The wreckage site was located about 3 nm east of the direct route from Fort Good Hope to Norman Wells. The 60-foot wreckage trail runs parallel to the southern slope of Mount Effie, on a 50° magnetic (M) heading, at an elevation of 2000 feet asl. The aircraft descended in a nose-up attitude of approximately 20° resulting in the rear propeller striking the ground first. The bottom of the fuselage then absorbed the bulk of the impact force, resulting in the passenger cabin being compressed to two feet in height. The front propeller was broken off at the engine flange. The propeller tips had sustained damage that was consistent with power at the time of contact. Both engines were producing power at the time the occurrence.
