AVIATION INVESTIGATION REPORT

A08P0242

DUAL-ENGINE POWER LOSS - FORCED LANDING

**BILL DAUSE BEECH 65-A90 (KING AIR) N17SA
PITT MEADOWS AIRPORT, BRITISH COLUMBIA
03 AUGUST 2008**

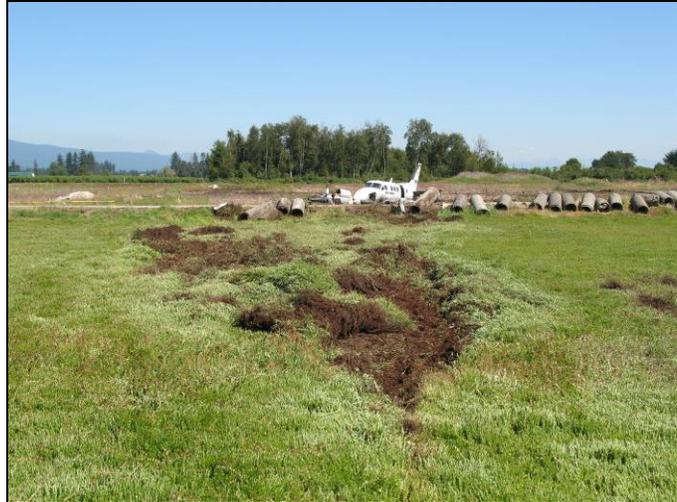
Photo 1. Accident site

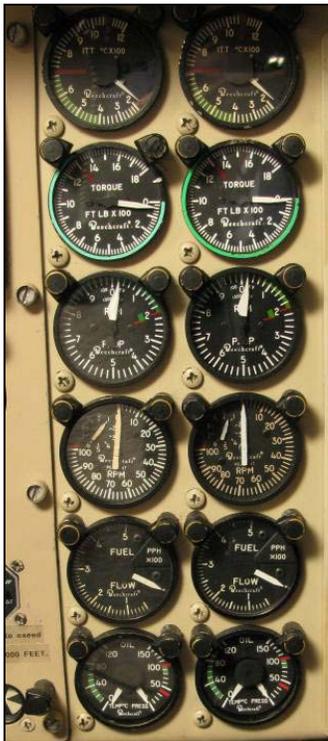
Recent King Air models have engine instrumentation mounted vertically (see Photo 2). With this layout, engine instrumentation is positioned in two vertical columns with the left engine instruments on the left and right engine instruments on the right. This layout makes identification of engine malfunction intuitive.

Photo 2. Vertical layout

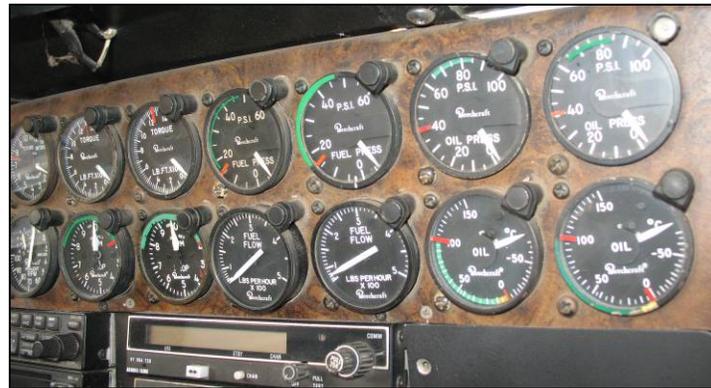
While the engine instrumentation on the occurrence King Air was arranged so that the left and right engine dials were grouped by function, the overall arrangement was horizontal (see Photo 3). This horizontal arrangement makes it difficult to readily identify and confirm which engine is malfunctioning.

Photo 3. Engine instruments horizontally arranged

A sudden yaw to the right is normally associated with a right-engine power loss. The King Air A90 emergency checklist requires that the pilot advance both power levers and confirm the power loss using engine instrumentation, then shut down the failed engine and feathering its propeller. Although the pilot verified the engines' instruments, he did not correctly identify the left engine as the failed engine. This was likely due in part to the horizontal layout of engine instrumentation that makes timely engine malfunction identification difficult. Moreover, the pilot had not received any training on the King Air for over two years, decreasing his ability to react appropriately. This resulted in the pilot erroneously shutting down the operating engine.

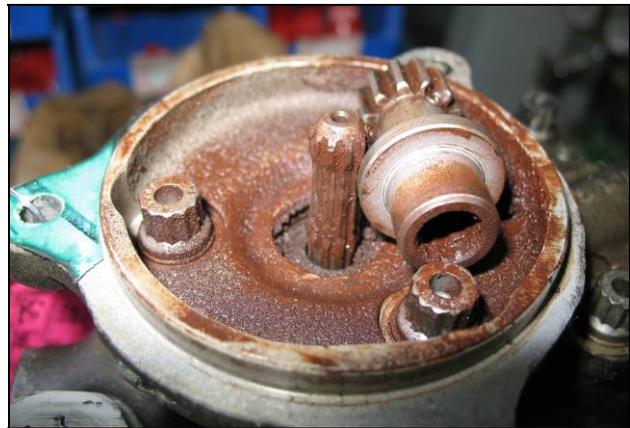
The left engine and its components were torn down, inspected, and tested with a TSB investigator present. The only significant anomaly found was that the high-pressure, engine-driven fuel pump drive splines were worn and corroded beyond the point of failure (see Photo 4 and Photo 5). Without fuel being supplied from the high-pressure fuel pump to the fuel control unit, the engine will shut down immediately.

Photo 4. Left engine drive splines and coupling

It was concluded that mechanical failure of the left-hand engine fuel pump drive splines resulted in the loss of power from that engine. The bang, the shuddering, and the yaw to the right that was experienced may have been caused by the left-hand engine fuel pump drive splines disengaging momentarily and then re-engaging. This disengagement would have caused the engine to flame-out,⁵ and the re-engagement would have caused a relight with a corresponding bang. This would have been accompanied by a surge of power which could have caused the aircraft to yaw to the right.

Because the engines were being operated "on condition," the left engine was operated more than 800 hours past the TBO required by the engine manufacturer. Had the 3600-hour overhaul been accomplished, or the phase inspection completed as required in the maintenance instructions, the spline wear and corrosion should have been detected.

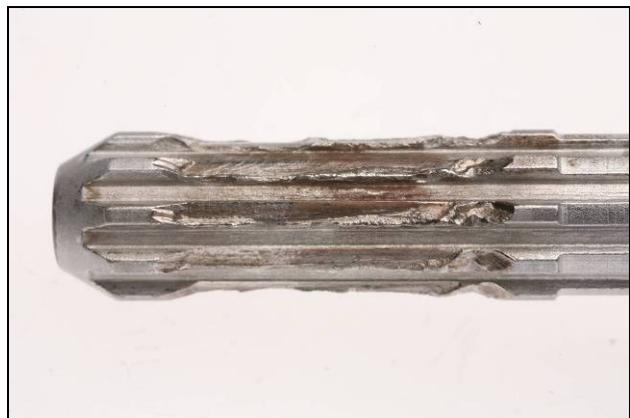
Photo 5. Close-up of external spline wear

One of the items listed on the maintenance check sheet required inspection of the high-pressure fuel pump of both engines. It indicated the following: "Engine-driven fuel pump coupling shaft - Inspect for fretting and/or corrosion when replacing outlet filter." While the inspection for the right-hand engine was initialled as completed by the Airframe and Power-Plant (A&P) mechanic, the same item for the left engine was marked as not applicable (N/A). The mechanic was not aware of the procedure in the PWC Maintenance Manual, which details how to inspect the splines in situ using a cotton swab.
