**AVIATION INVESTIGATION REPORT
A08P0265**

LOSS OF CONTROL – COLLISION WITH TERRAIN

**QUANTUM HELICOPTERS LTD.
BELL 206L (HELICOPTER), C-FRCL
LEGATE CREEK, BRITISH COLUMBIA
13 AUGUST 2008**

Report Number A08P0265

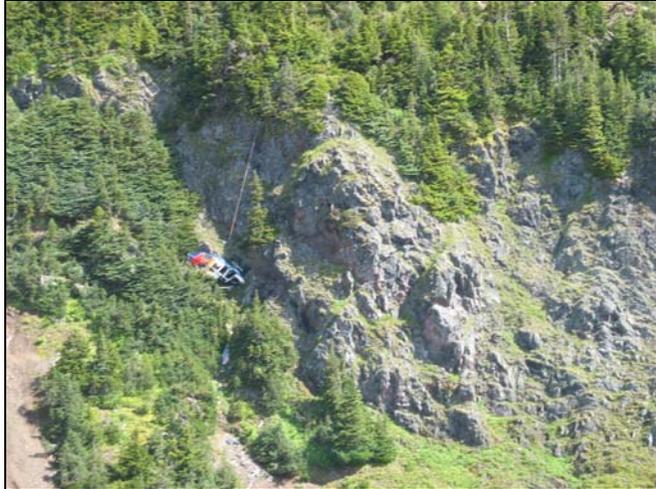
The accident site was initially observed by helicopter. The tail section was separated from the main wreckage, with many pieces strewn about the hillside, some above and some below the main wreckage (see Photo 1). The wreckage was recovered and transported to an examination facility.

Photo 1. Accident site.
