**AVIATION INVESTIGATION REPORT  
A11C0152**

**FREEWHEEL-ASSEMBLY MALFUNCTION DURING PRACTICE  
AUTOROTATIONAL LANDING**

**WISK-AIR LIMITED  
BELL 206B (HELICOPTER), C-GDPE  
THUNDER BAY, ONTARIO  
13 SEPTEMBER 2011**

Report Number A11C0152

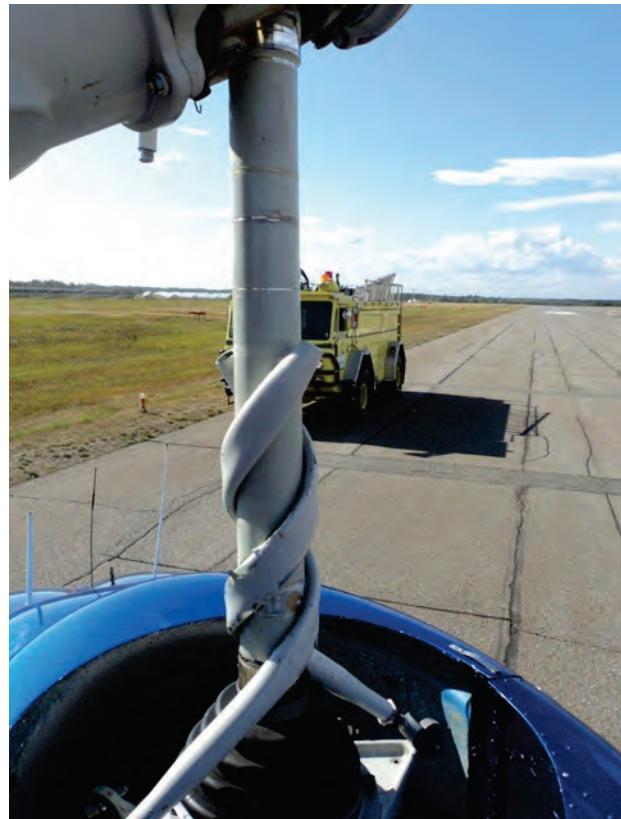
**Photo 1.** Mast and Pitch Links

Components removed for examination and testing included the engine, transmission and swashplate. The idler lever, drive link, collar set, pitch links, mast assembly, freewheel assembly and freewheel-assembly lubrication system were sent to the TSB Laboratory for examination. The magnetic chip plugs were removed from the main-rotor transmission and freewheel assembly. The chip plugs were not contaminated. Inspection of the transmission revealed no defects. The clamp half of the collar set (P/N 206-011-005-109) that connects the swashplate idler lever and drive link to the mast had failed. The stud that secured the drive link to the swashplate outer ring was bent opposite to the direction of rotation. There were some impact marks on the horns of the inner-ring control plate. The pitch links were wrapped around the mast in a counter-clockwise direction as viewed from above. The pitch links had failed at the upper end at a point coincident with the end of the internal threads. (Photo 1) Score marks on the mast aligned with the fractured ends of the

pitch links when the collective lever was fully raised. The main driveshaft (P/N 206-040-015-103) was examined visually and no defects were found.

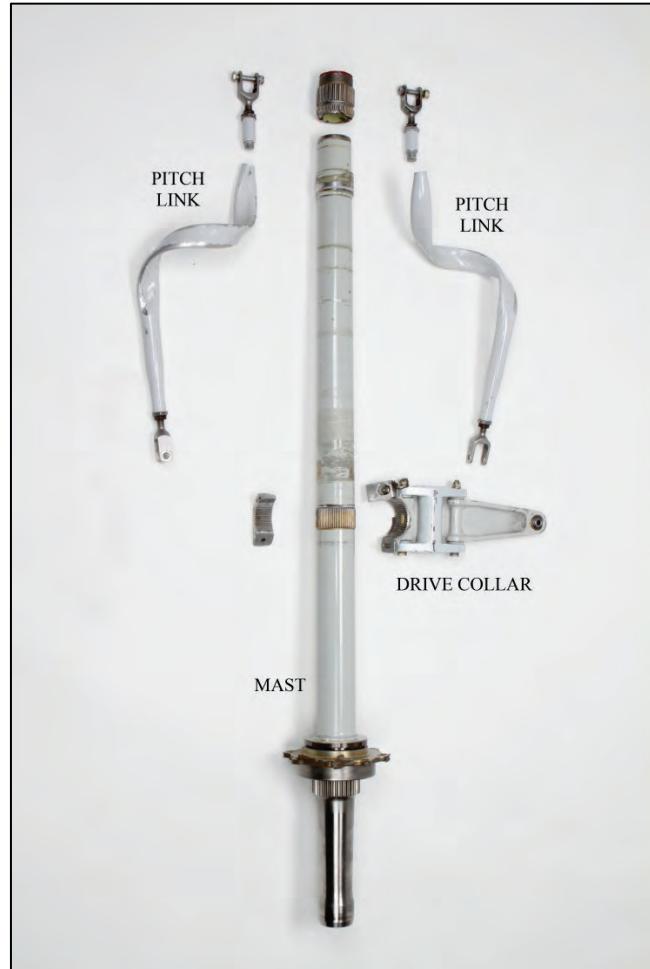
**Photo 2.** Separated mast

The mast (P/N 206-010-332-121) had failed below the main rotor attach splines (Photo 2). The splines exhibited signs of torsional yielding in that the lower splines were advanced in the direction of rotation approximately .040 inch in relation to the upper splines. The fracture surface of the lower portion of the mast was obliterated by rotation against the upper mast stub. The fracture surface of the upper mast portion was severely damaged by the lower mast spinning against it. Metal had been displaced and showed signs of local overheating (Photo 3). There were some fracture areas however that remained pristine. The mast diameter was measured at several places near the fracture and there were no indications that the mast

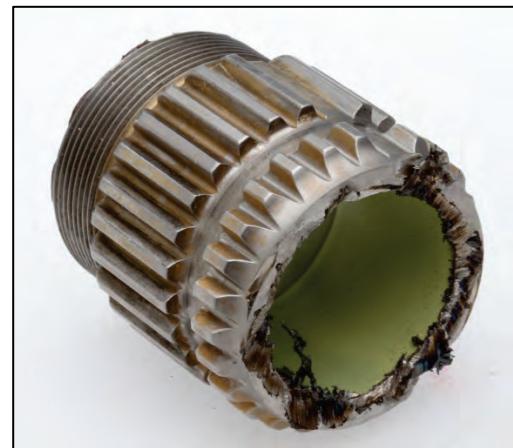
**Photo 3.** Upper mast stub fracture surface

was out of round, nor was any bending evident. Examination of the fracture surfaces of the upper mast stub revealed that the mast had failed in a ductile mode due to torsional stresses. The direction of fracture was consistent with the application of power from the engine. There were no signs of a pre-existing defect or progressive failure and material analysis results were consistent with specifications provided by the manufacturer.

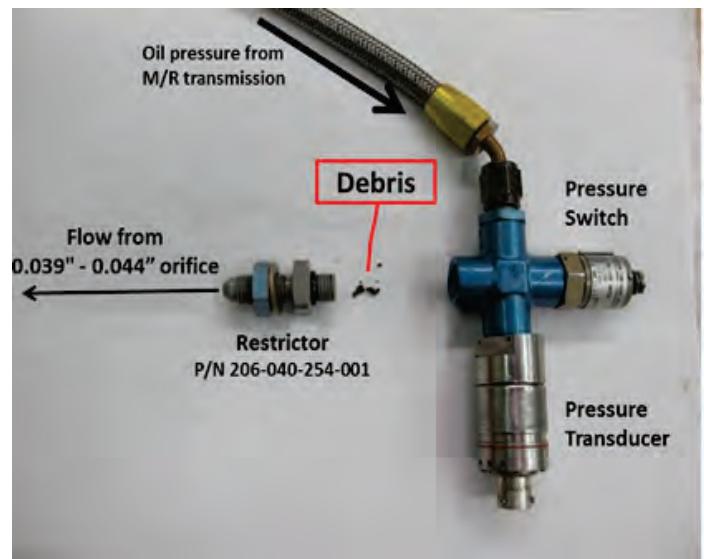
**Photo 4.** Restrictor and debris

The transmission was installed on 15 February 2002 after having been overhauled. Since then, the transmission had accumulated approximately 1783 hours. The transmission underwent a 1500-hour inspection in 2010 during which the transmission oil-cooler inlet- and outlet-piping would have been disconnected. During the investigation, the interior of the transmission was inspected and no debris or corrosion was noted. Some metal particles were found in the lower-mast-bearing support area. The inlet fitting and the outlet pipe were removed from the oil cooler and there were indications that corrosion had occurred in these areas. The TSB Laboratory examined the corrosion products and the coating damage on an anodized aluminum union fitting (P/N AN815-10D) and the bottom end of the tube (P/N 206-040-192-001) that connects the oil cooler to the main-rotor transmission. Metallurgical analysis showed that the aluminum- and magnesium-based corrosion products detected in the restrictor debris originated from the union fitting and tube, respectively.

Examination of the torque indicator revealed no useful information. Examination of the material blocking the outlet restrictor fitting (P/N 206-040-254-001) by SEM indicated that the material consisted mainly of corrosion products.

Bell TB 206-79-31 introduces a filter at the transmission oil outlet intended to prevent contamination of the restrictor. Although the filter was originally introduced to prevent particles of cut o-rings from contaminating the restrictor, it is likely that the filter would also be effective protection from other types of debris. This bulletin was optional and had not been incorporated, which increased the risk of contamination of the restrictor. The resulting reduction of oil flow may result in freewheel-assembly damage.
