AVIATION INVESTIGATION REPORT

A15Q0126

Loss of directional control and collision with terrain

6442927 CANADA INC. (operating as Héli-Nord)
Bell Helicopter 206B, C-GYBK
Sept-Îles, Quebec, 20 nm N
02 September 2015

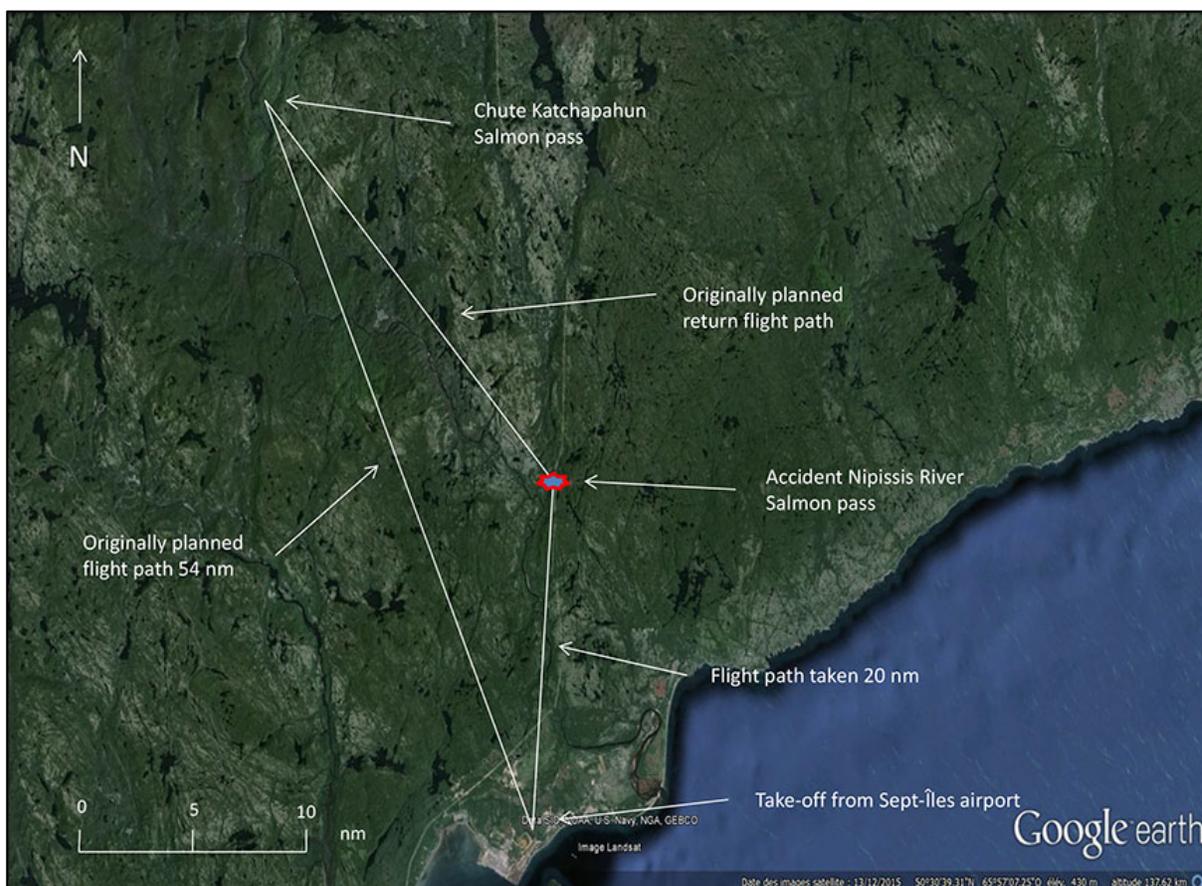
Figure 1. Flight path of C-GYBK (Source: Google Earth, with TSB annotations)

On the morning of the flight, the pilot had agreed to meet the chief pilot at the Héli-Nord facilities at the Sept-Îles, Quebec, airport (CYZV). The flight was scheduled for around 0830,¹ and the pilot arrived at around 0745. The contract specified that 6 passengers were to travel to 2 salmon passes on the Moisie and Nipissis rivers, which required the use of 2 helicopters. Each helicopter was to carry 3 passengers. The 2 aircraft were to go first to a salmon pass at Chute Katchapahun, Quebec, 54 nautical miles (nm) north of Sept-Îles, and on the return journey land at a second salmon pass on the Nipissis River, 20 nm north of Sept-Îles (Figure 1).

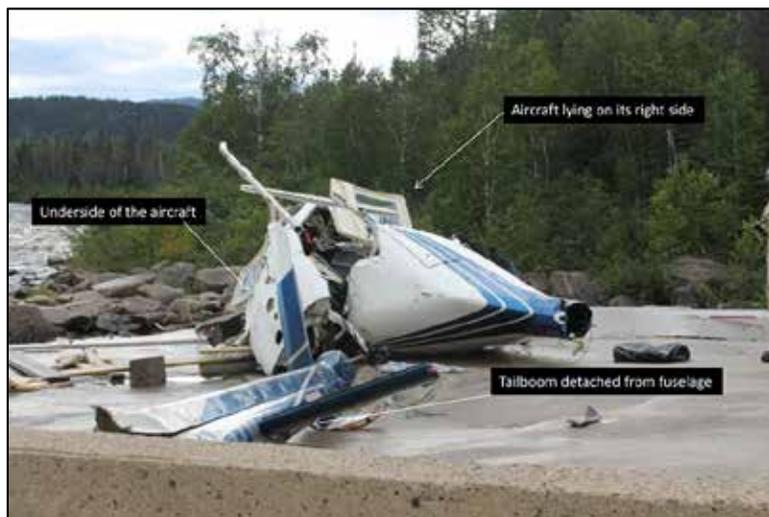
Figure 2. Aircraft wreckage

The helicopter collided with the rock nose down and rotating to the right. The engine did not stop immediately, and a minor fire broke out in the tailpipe but was immediately extinguished by persons on site. On impact, the tailboom detached and came to rest behind the aircraft (Figure 2). Severe damage to the skin on the rear of the right-hand side and the rear stabilizer was noted.

Damage to the skids confirmed impact on the right side, with the nose of the aircraft pointing toward the ground. All damage resulted from the impact with the rock. The floor of the aircraft was severed at the rear of the cabin, causing the fuel tank to split.

crashing, the TSB laboratory conducted a more thorough examination of the tail rotor system in November 2015, in the presence of representatives of Bell Helicopter and Rolls-Royce. No pre-existing damage was found. The investigators were able to determine that the anti-torque pedal control tubes that govern the movement of the tail rotor blades severed sequentially upon impact. One of the control tube breaks was at the full left pedal position, confirming that the left anti-torque pedal was fully applied at the time of impact with the ground.

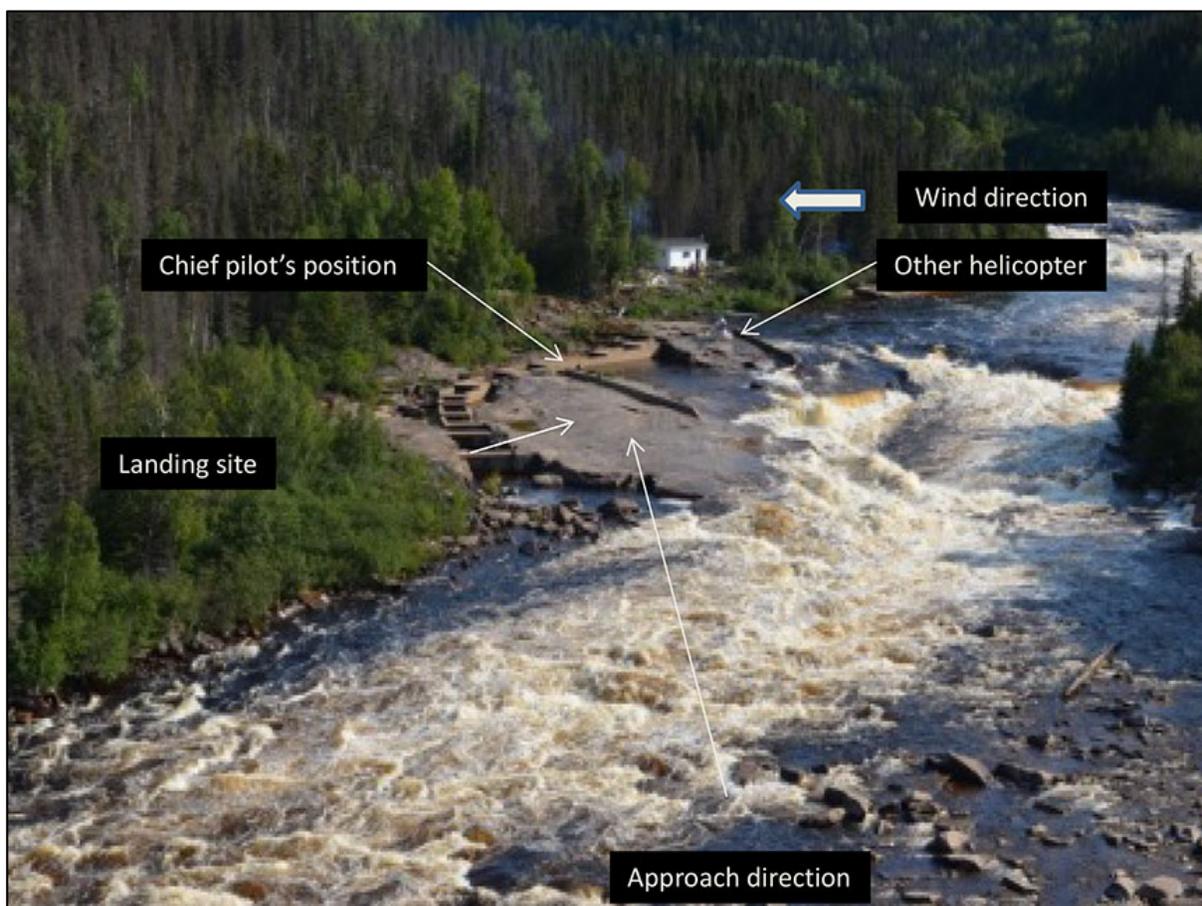
Figure 3. Landing site of C-GYBK (Source: M. Guay, with TSB annotations)

The site chosen for the landing presented challenges for an inexperienced pilot. The location was a large rock, with terrain ascending from the river, and there were mountains on either side of the river. In addition, this was the first time that the pilot had been there. The approach was over the Nipissis River, flanked by tall trees on either side, and a mountain covered with mature trees, a camp, the camp employees and the 3 passengers of the helicopter that had touched down a few minutes before were in front of the aircraft. The chief pilot had taken a position on the rock in front of the aircraft, as agreed. Figure 3 shows a photograph taken a few seconds before the accident, during the final approach.

The investigation found that the aircraft was being operated nearly at its maximum allowable weight. The photo taken a few seconds before the accident shows that the wind was light and was blowing from the right with a tailwind component.

Given the environment, this site presented challenges for a pilot with little experience: the rock was sloping, which required vigilance on landing, and the mountains on either side of the river afforded little space to carry out the procedure to recover tail rotor effectiveness, that is, applying full left pedal, moving the cyclic control stick forward and, if altitude is sufficient, reducing power.
