AVIATION INVESTIGATION REPORT

A16P0161

Collision with terrain

Bell 206B (Helicopter), C-FWHF

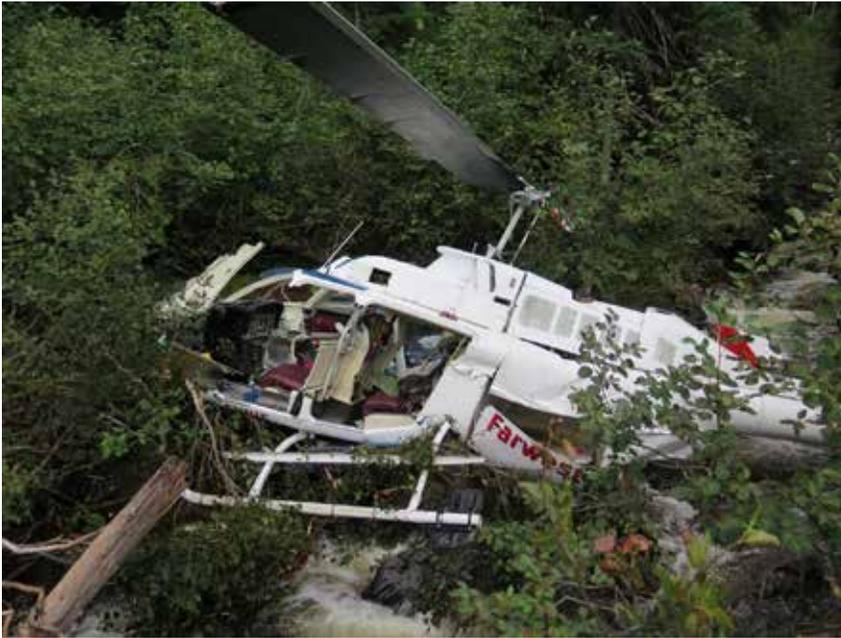
Figure 2. Aircraft wreckage

The helicopter was substantially damaged due to the collision with terrain (Figure 2).

Following a descent through trees, the helicopter collided with the terrain on either side of a small, boulder-strewn creek. Its main-rotor blades exhibited damage that was consistent with a very low rotor rpm at the time of ground contact. Red paint transfer resulting from contact with the vertical stabilizer was evident on one blade. The rotating components of the upper swashplate assembly had contacted the surrounding cowling. Scrapes were evident on the cowling, and some metal had been torn away.

Boulders supported the fore and aft sections of the fuselage, which spanned the creek and had collapsed downward near the doorposts and pilot seat. The aft landing gear cross-tube had penetrated the fuel-cell cavity, causing the fuel cell to rupture and leak. An undetermined quantity of fuel remained trapped in the folds of the cell.

The aft section of the tail boom had separated and lay in the creek, with the tail-rotor gearbox and tail rotor still securely attached.

The pylon plate and static stop were broken in several places and had separated from the roof. The isolation mount remained attached to the fuselage roof and drag link; however, the drag link had separated from the bottom of the main-rotor transmission.
