Marine Occurrence Report

Collision

Between the Bulk Carrier "OAKBY"
and the Seiner "PACIFIC CHALLENGER"
Juan de Fuca Strait, British Columbia
04 August 1993

Report Number M93W0007

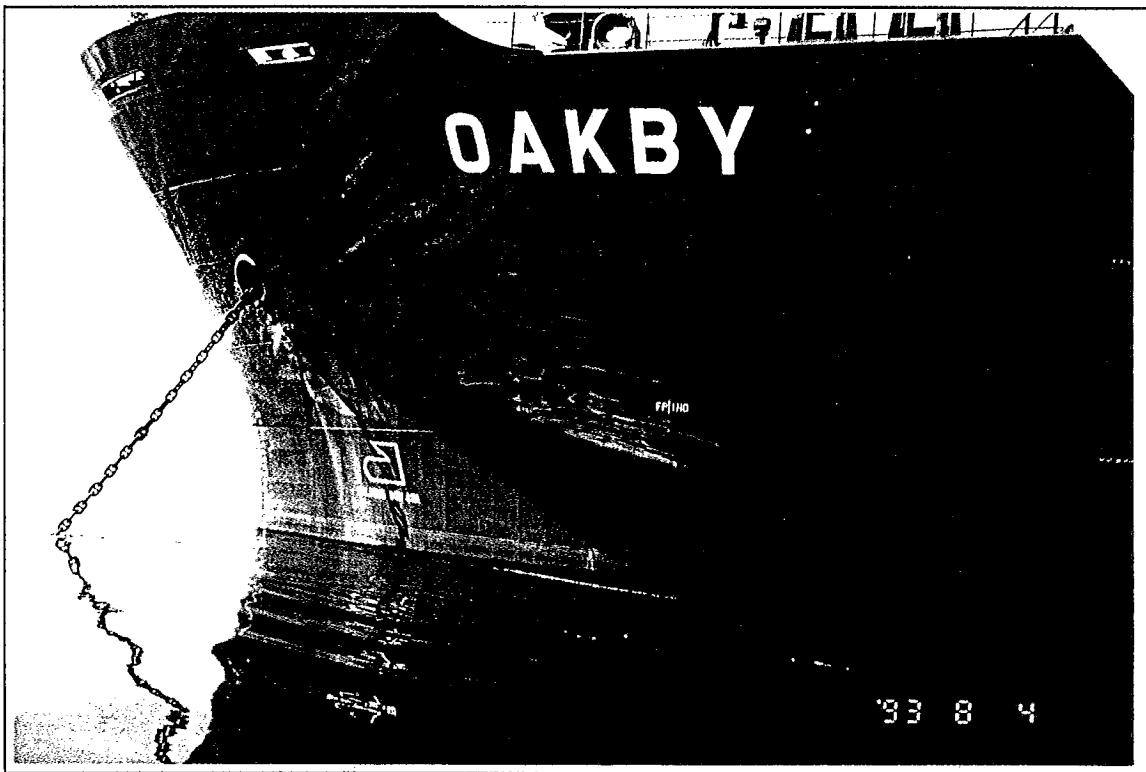
The vessels collided at 0206 in approximate position 48°23'N, 123°18.5'W. The angle of impact was about 70 degrees. The port bow of the "PACIFIC CHALLENGER" struck the port bow of the "OAKBY".

The "OAKBY" sustained no damage except for a few scratches.

"OAKBY", point of impact.

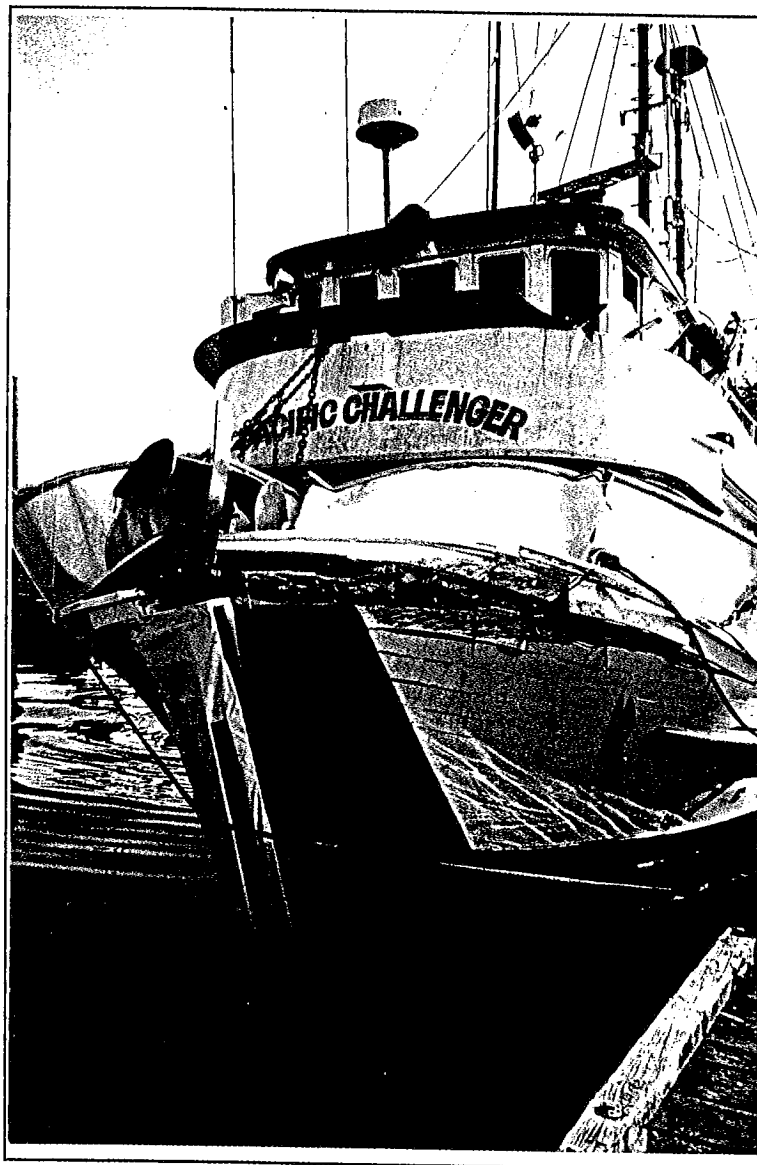
The bow of the "PACIFIC CHALLENGER" sustained substantial damage. The bulwark and anchor were bent in the impact. The wooden structures of the foredeck and hull were broken in several places. The side planks were separated and damaged at the forward end.

"PACIFIC CHALLENGER", damage, port side.

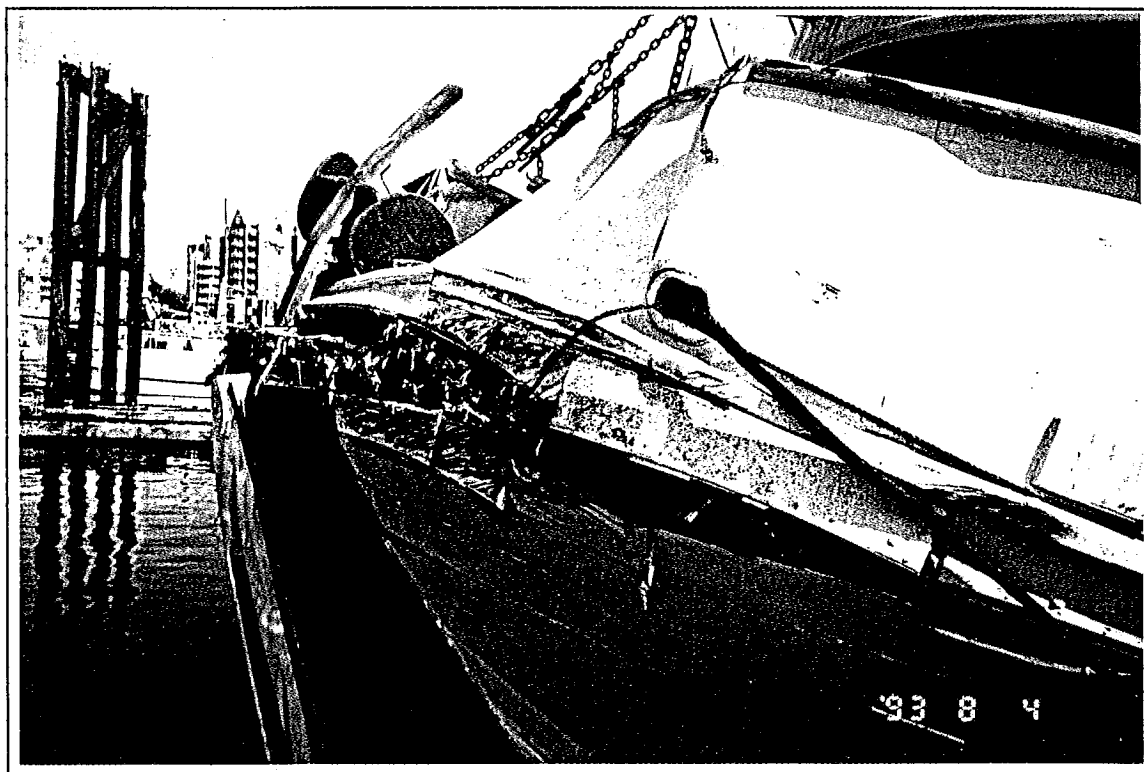
"PACIFIC CHALLENGER", damage, port side.

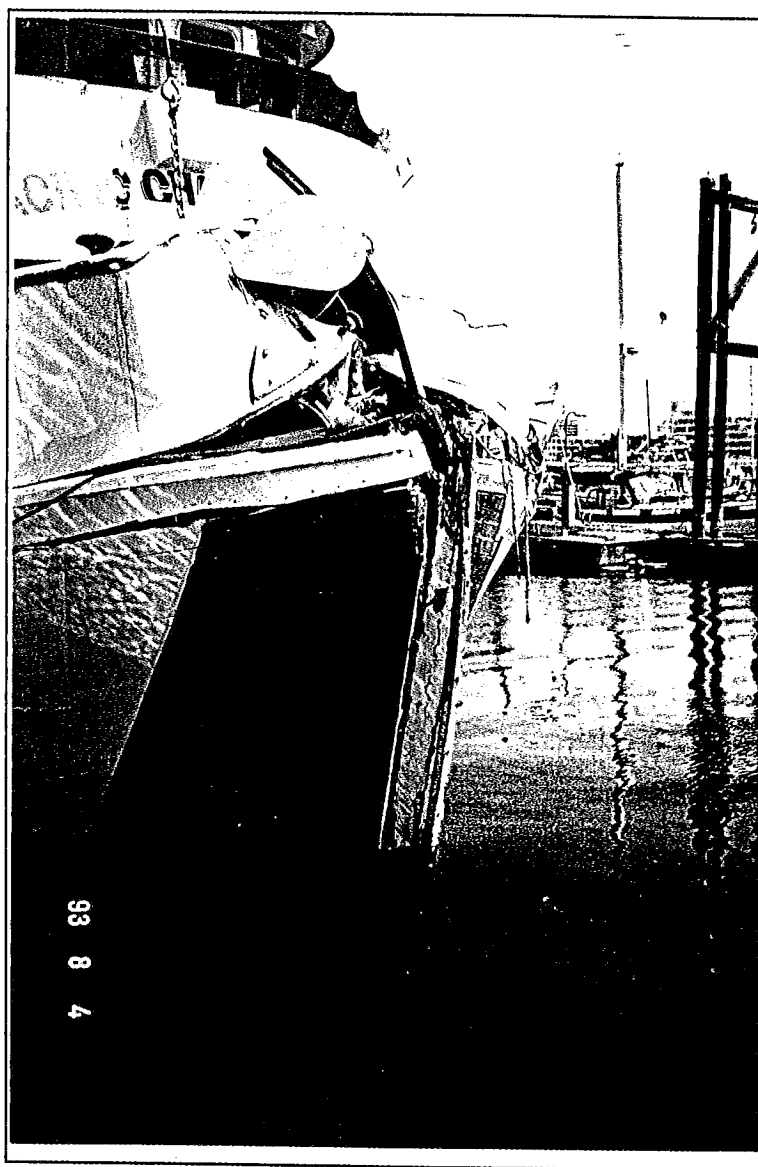
"PACIFIC CHALLENGER", damage, starboard side.
