MARINE INVESTIGATION REPORT

M04L0066

CAPSIZING

INFLATABLE RIVER RAFT

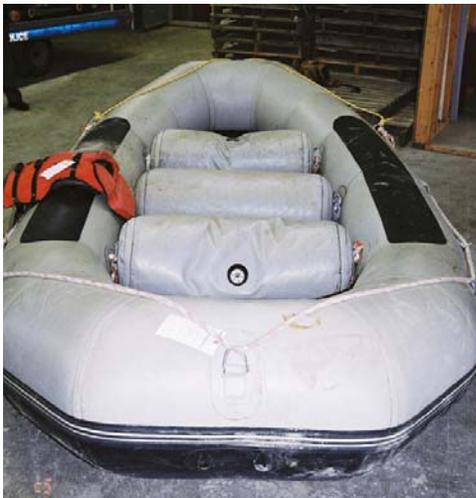
Photo 1. Front view of raft

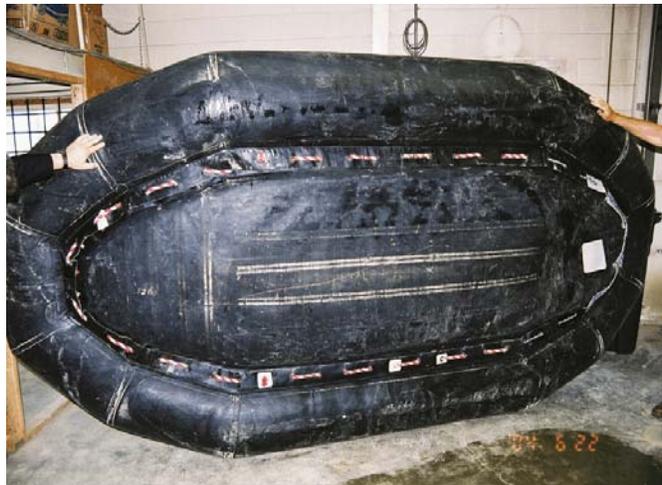
Photo 2. View of underside of raft

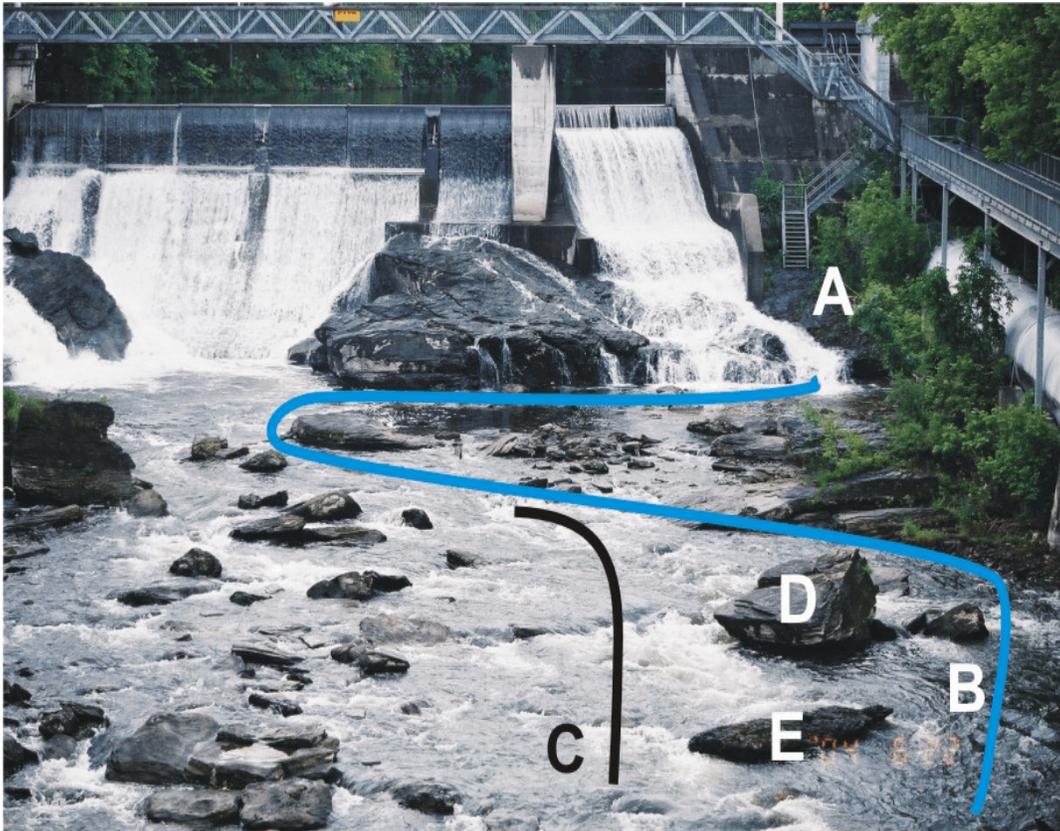
Photo 3. Abénakis Dam in background. The main route from point A to point B shows the descent taken on 11 June 2004. The secondary route to point C shows the route taken on the 19 June 2004 descent. Point D is the rock struck by the raft. Point E is the rock under which the passenger was found. Photo taken on 22 June 2004.

When the raft capsized, the force of the current most definitely led the body toward and held it under a rock (see photo 3, point E). After death, the passenger's body went into a state of hypotonia, that is, low muscular tension. The constant pressure of the current on the body of the unconscious passenger resulted in the victim losing his helmet and PFD.

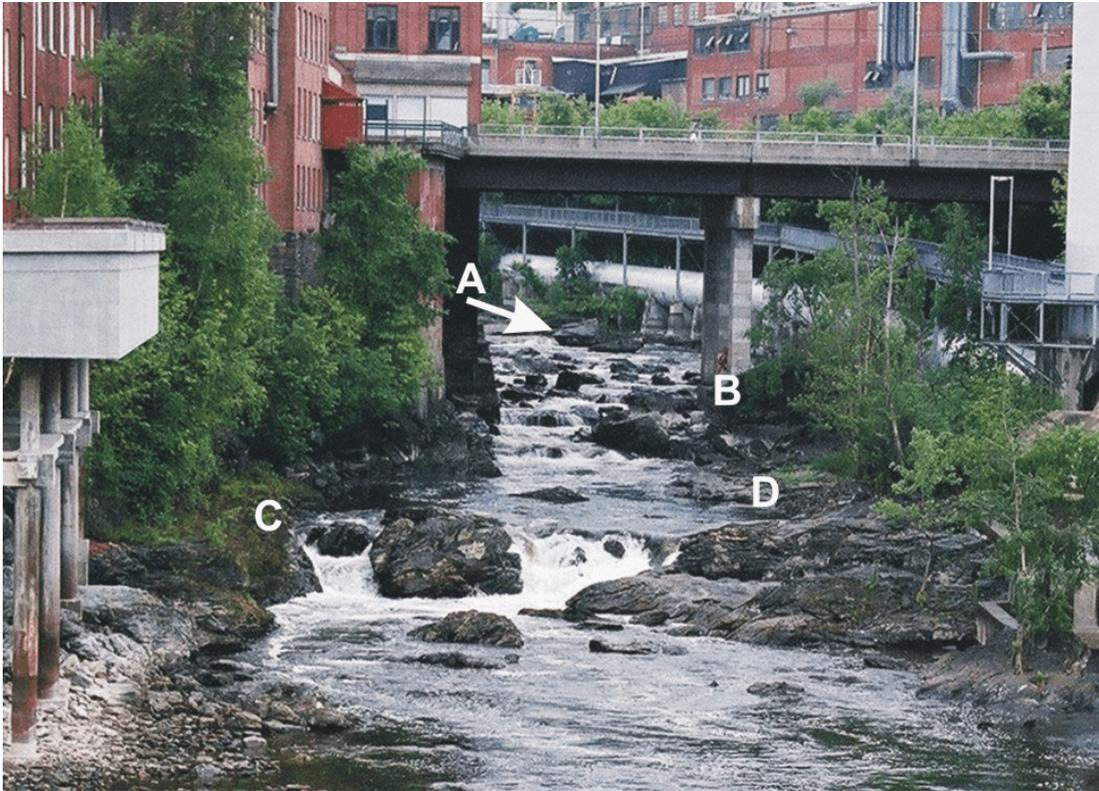
Photo 4. Drained Magog River (water level does not correspond to the level on 19 June 2004). Point A shows the rock where the capsizing occurred. Points B and C show the first and second ledge. Point D shows the location of the emergency team and kayaker.

The passenger's left foot was caught under a rock, and the direction of his body pointed downstream. No helmet or PFD was found on the victim. Just after the raft capsized, the events unfolded so rapidly that the disappearance of the victim was not noticed by the guide, emergency team, raft occupants, passengers, organizers and spectators.
