RAILWAY OCCURRENCE REPORT  
NUMBER R97H0009

DERAILMENT

VIA RAIL CANADA INC.  
PASSENGER TRAIN NO. 2  
MILE 7.5, CN WAINWRIGHT SUBDIVISION  
NEAR BIGGAR, SASKATCHEWAN  
03 SEPTEMBER 1997

Report Number R97H0009

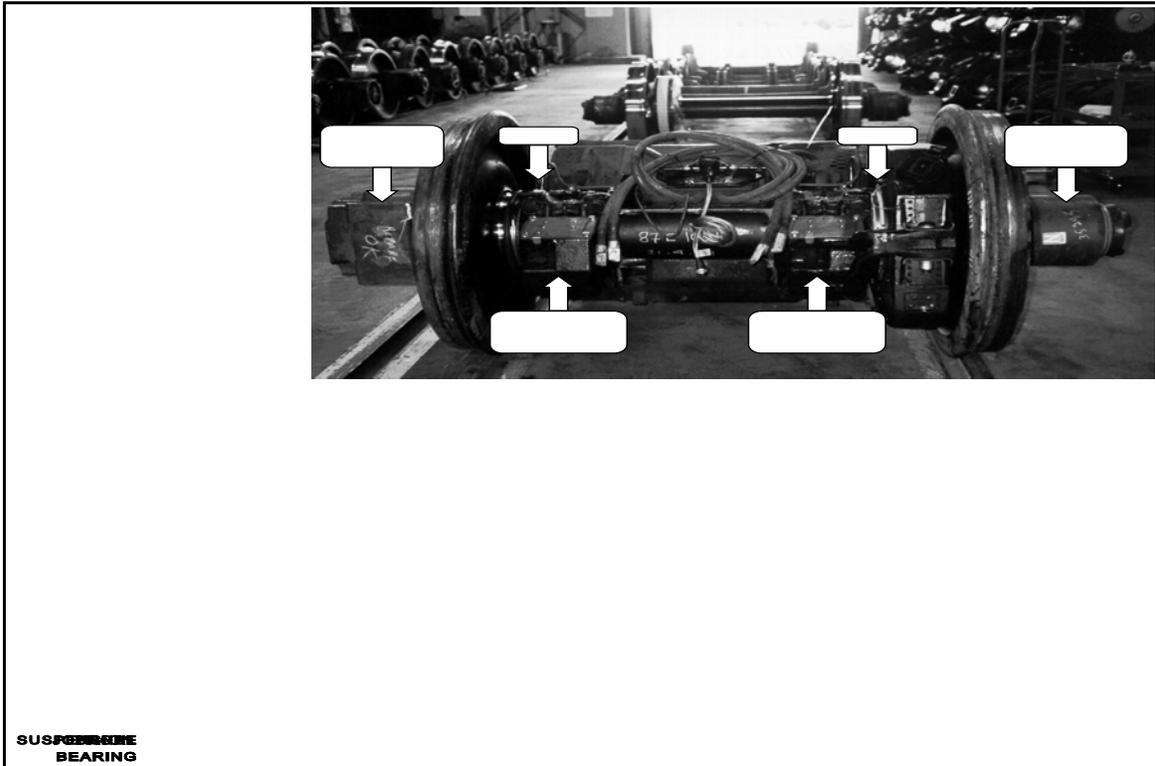
The train derailment initiated when the wheels of the lead axle of the trailing locomotive (VIA 6447) could no longer maintain gauge because of a fracture of the axle at a failed traction motor suspension bearing (Figure 2). Indication that the suspension bearing was in distress occurred well before the axle broke. An on-board hot bearing monitoring system activated an audible alarm in the controlling locomotive cab 35 miles east of Vancouver, but the system was subsequently disabled. The alarm activated about 29 hours before the derailment and less than two hours into the service life of a renewed traction motor/wheel set assembly.

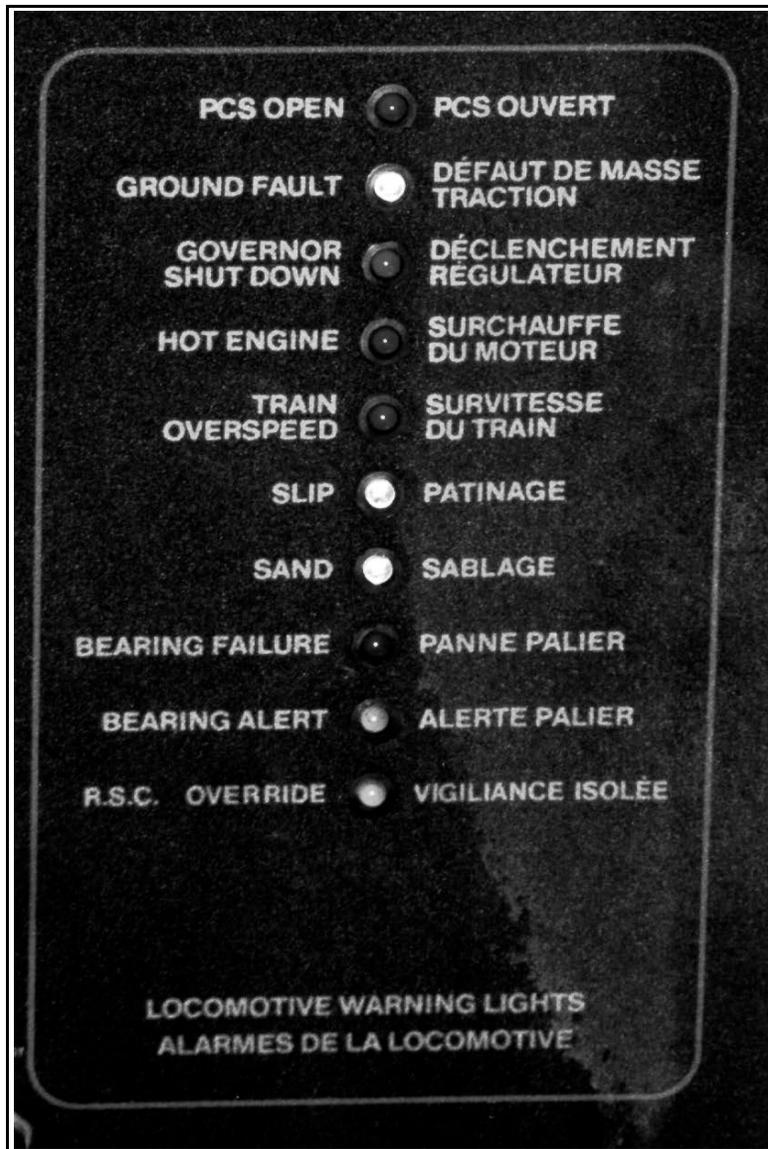
Engr 1 first went into the cab of the second locomotive (6437) and then into the cab of the third locomotive (6447) where a warning light was illuminated on the overhead console warning light panel. Without his reading glasses, he could not make out the text adjacent to the light on the panel. He radioed the second locomotive engineer (Engr 2), and from the description provided, Engr 2 concluded that the illuminated light corresponded to the "Bearing Alert" indication on the panel (Figure 3).

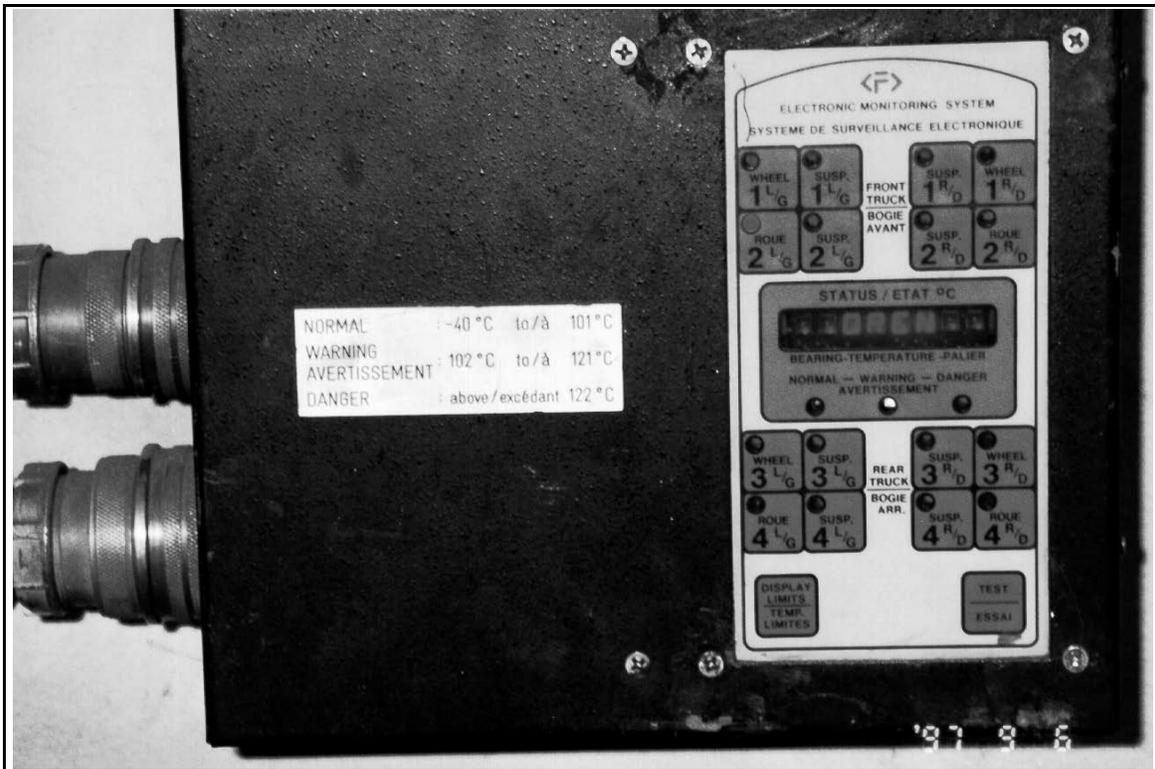
some recollection of prior discussions with fellow employees concerning a device related to a bearing monitoring system located in the short hood compartment of this type of locomotive. Engr 2 then went into the short hood and located the device (Figure 4).

On the front surface of the monitor (Figure 4), there is a system status display consisting of 16 membrane switches, one for each bearing, a status display window, normal, warning and danger light indications, a display limits switch and a test switch. When any of the membrane switches for the individual bearing probes is depressed, the temperature of the bearing is displayed, in degrees Celsius, in the status display window, unless a probe has malfunctioned. The bearing membrane switches also have "abnormal indicating lights" that illuminate to show the location of an abnormal condition. The normal, warning and danger lights are immediately beneath the status display window. The normal light displays green when there is no fault, and the system is functioning with all temperature sensors below 102 degrees Celsius. When the warning light displays yellow, there is an abnormality. A bearing may be in early stages of failure when operating between 102 and 121 degrees Celsius or there is a fault in the system. When the danger light is illuminated, a bearing has reached a temperature
