RAILWAY INVESTIGATION REPORT

R00Q0023

MAIN-TRACK DERAILMENT

MILE 9.58, SAINT-MAURICE SUBDIVISION

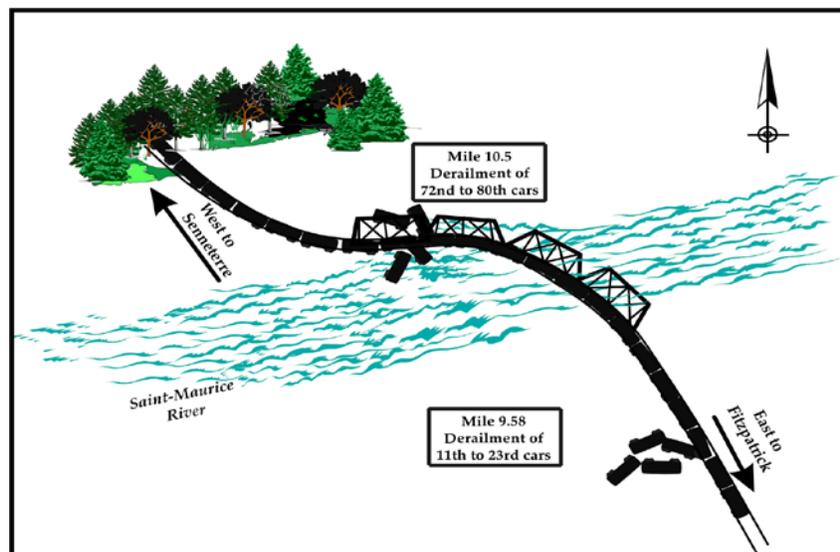
At about Mile 9.5, the train experienced an undesired emergency brake application. The event recorder indicates that, at the time of the emergency brake application, the train was travelling at 29 mph and the throttle was in the No. 2 position. After the train came to a stop, the crew carried out the emergency procedures prescribed by regulations and the conductor went to the tail end to determine the cause of the emergency brake application. He found that 13 gondola cars (11th to 23rd cars), loaded with wood chips, had derailed at Mile 9.58. Canadian National (CN) subsequently received a call indicating that one tank car was floating in the Saint-Maurice River. Personnel at the site discovered that nine other cars (72nd to 80th cars), including two covered cars loaded with paper, one empty hopper car, and six empty tank cars that had recently contained gasoline (UN 1203) or heating oil (UN 1202), also had derailed on the bridge over the Saint-Maurice River at Mile 10.15 (see Figure 1). Two tank cars were punctured, but only a minimal quantity of product spilled into the river. No one was injured as a result of the accident.

Some 400 feet of track was destroyed and two spans of the bridge were heavily damaged. One hopper car, 2 covered cars, 13 gondola cars and 6 tank cars were damaged. The hopper car was destroyed. All the damaged tank cars were 111A cars—the head of the tank on two of the tank cars was punctured, the head of the tank on another was deformed, and the shell of the three others was deformed. Damage to the top fittings was noticed on one of the tank cars.

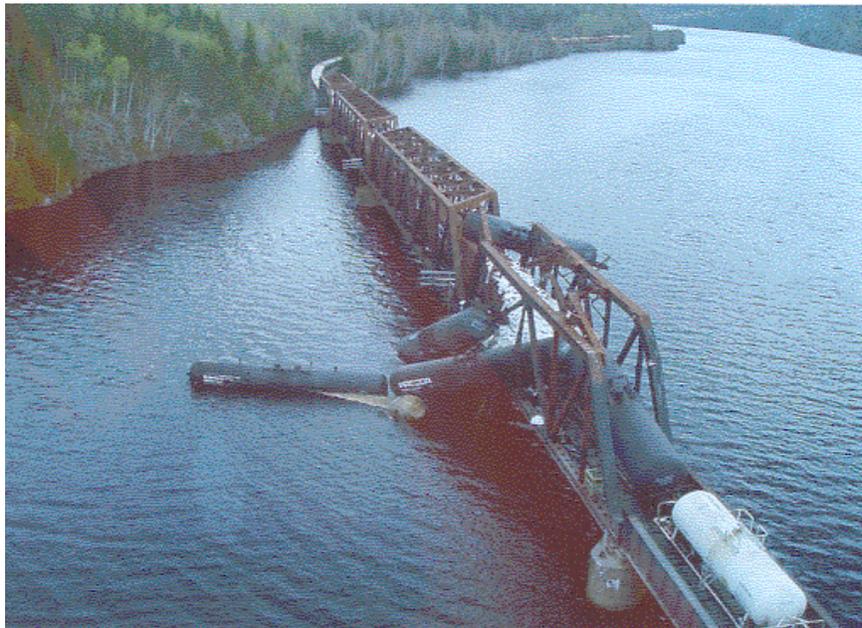
The hopper car and the empty tank cars were placed near the middle of the train (74th to 80th cars). The weight ahead of these cars was approximately 7 000 tons, and the weight behind was approximately 8 700 tons. The hopper car and three tank cars fell off the bridge and another tank car was left hanging from the bridge structure (see Figure 2). The hopper car was a cylindrical pressure-flow car with three outlet valves and no centre sill, and was constructed of 3/16-inch plate, Class AAR C-612.

The derailment of the 72nd to 80th cars was a result of the first derailment, which occurred at the head end of the train. When the 11th to 23rd cars derailed on the broken rail, the emergency brakes applied. The empty cars in the middle of the train were caught between the block of loaded cars at the head of the train, which were decelerating due to the braking force generated by emergency braking, and the sudden pile-up of the derailed cars and the cars behind them, whose brakes had not yet been applied. Due to the weight of the block of cars in the tail end of the train and the speed they were travelling, the resultant inertia applied high compression forces to the couplers, which led to the second derailment. Since the hopper car was empty and of light construction and had no centre sill, it was more vulnerable and consequently yielded first. Based on the damages observed on the hopper car, it was deformed by compression forces, was lifted, and struck the top chord of the bridge superstructure; the tank cars behind the hopper car piled on top of it, damaging the bridge structure and the covered cars further ahead.
