RAILWAY INVESTIGATION REPORT
R04H0009

CROSSING COLLISION

VIA RAIL CANADA INC.

MUNSTER, ONTARIO

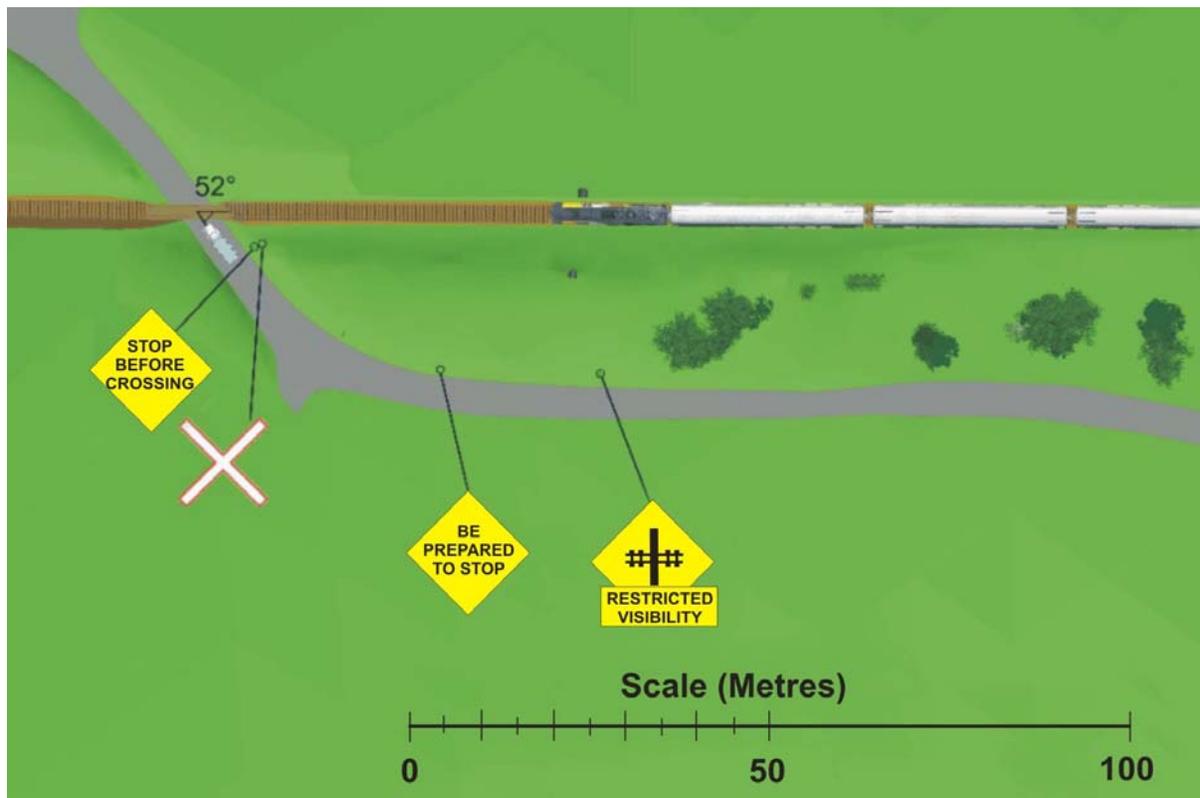
On 28 June 2004, westward VIA Rail Canada Inc. (VIA) train No. 49, en route from Ottawa, Ontario, to Toronto, Ontario, was travelling at 93 mph on the Smiths Falls Subdivision (see Figure 1). At 1836 eastern daylight time,¹ as the train approached the Kettles Road level crossing, the crew observed a northbound dump truck enter the crossing without stopping. The impact of the subsequent collision destroyed the truck and the lone occupant was fatally injured. With the train brakes in emergency, the train came to a stop approximately ½ mile west of the crossing. The truck was struck on the passenger-side door, just ahead of the truck box. The truck came to rest in the south ditch, west of the crossing.

Figure 1. Overhead schematic of Kettles Road crossing, approximately 10 miles southwest of the Ottawa suburbs, just east of County Road 3

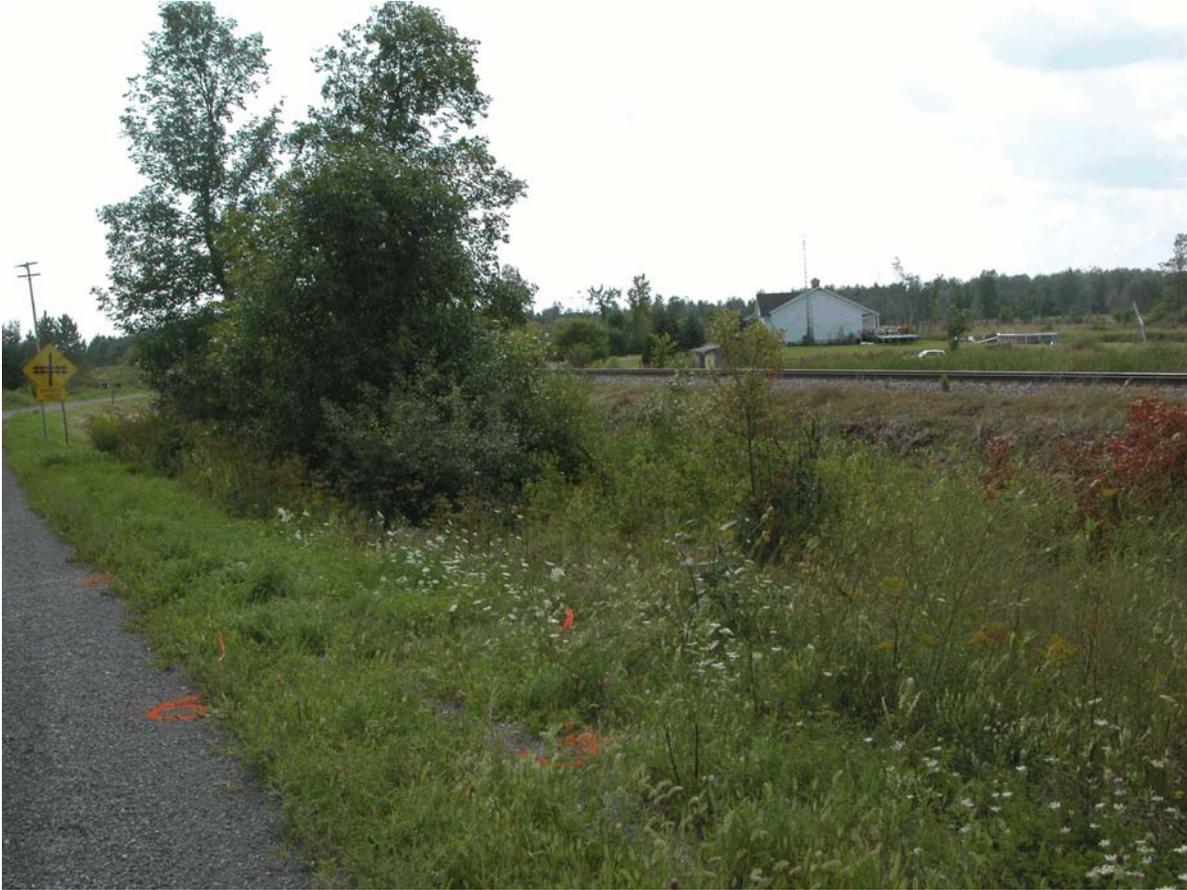
Photo 1. Driver's view to the right of the approach of Kettles Road crossing

The Kettles Road crossing was equipped with standard reflectorized crossing signs. For approaching traffic on Kettles Road, there was a sharp right-hand curve in the road just before the crossing. The road intersected the track at an angle of 52 degrees to the right side of an approaching northbound vehicle. The terrain approaching the crossing from the south was initially level, then changed to a 4.55 per cent ascending grade at the crossing within 16 m of the track.

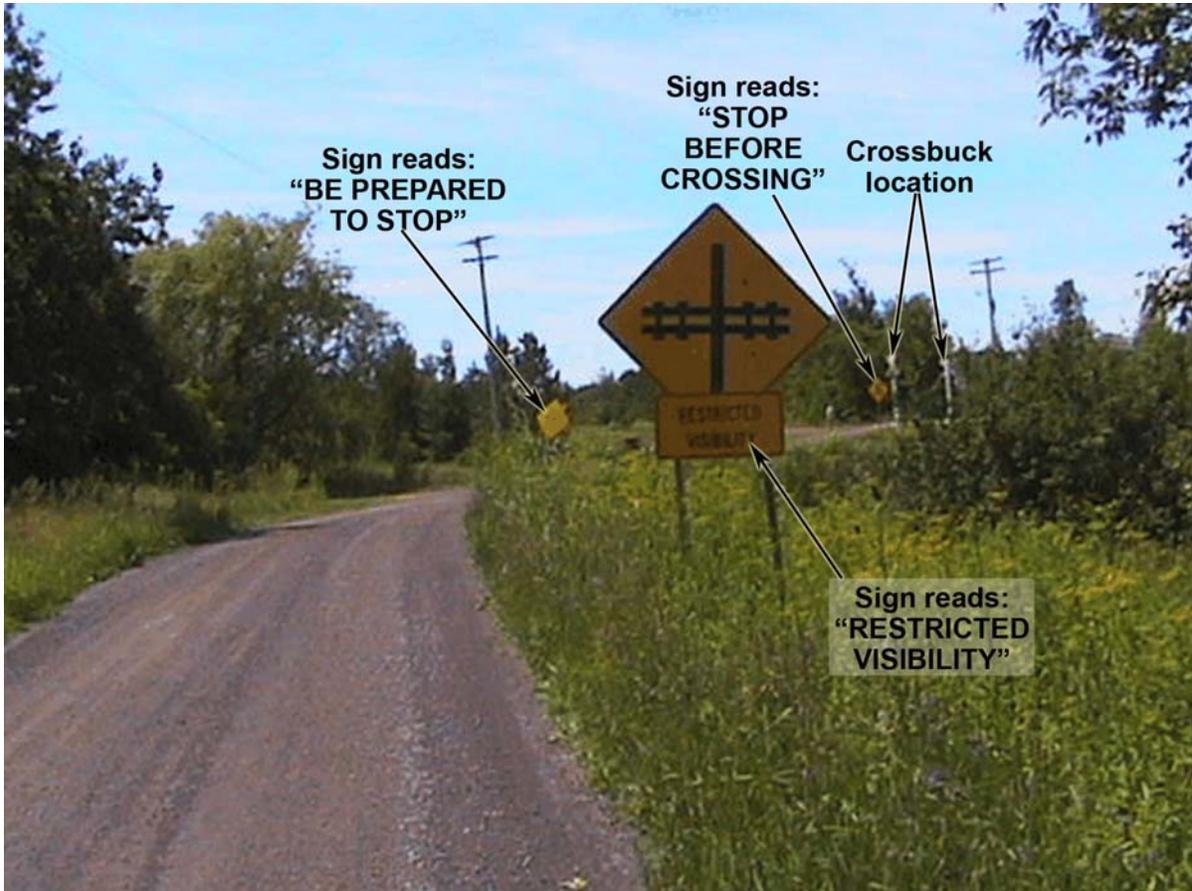
Advance warning signs had been installed in 1992 on the crossing approaches. These signs were the Ministry of Transportation of Ontario (MTO) scheme 2 signs, which indicated sequentially: Restricted Visibility, Be Prepared to Stop, and Stop Before Crossing (see Photo 2). These signs were intended as interim advisory measures, which were to be removed once a permanent improvement to the crossing was made. These warning signs are not regulatory signs, in that they are not enforceable. Scheme 2 signs are yellow-background, diamond-shaped signs with black markings and black lettering. Although the tab at the bottom of the first of the three signs correctly indicated restricted visibility, the sign's graphic indicated that the crossing was at a perpendicular angle to the approaches. Advance warning signs exist that depict acute-angled crossings.

Photo 2. Scheme 2 signs for the acute-angled crossing

At the Kettles Road crossing, the first of the three Ontario scheme 2 signs indicated that the road crossing was perpendicular to the track. But the road crossing is at an angle of 52 degrees, to the right side of an approaching northbound vehicle, and a more appropriate sign exists to indicate an angle crossing.

Since scheme 2 signs are designed and interpreted only as warnings, it is likely that many drivers encountering the "Stop Before Crossing" sign will not stop, unless they see an approaching train.

Although the advance warning signage schemes developed by Transport Canada and the MTO are intended to be used as interim advisory measures, the scheme 2 signs at the Kettles Road crossing had been in use for over 10 years.

Meetings were held between Transport Canada, the City of Ottawa, and VIA to discuss possible enhancements to the Kettles Road crossing. As a result of these meetings, the City of Ottawa retained a consulting company to undertake an environmental screening and preliminary design for the railway crossing. The proposed design included an improved intersection angle, road profile, asphalt surface, elimination of one private rail crossing, and the installation of railway crossing signals, bells, and short-arm gates. The outcome of the proposals to date includes the interim placement of modified advanced warning signs and stop signs. The grade of the crossing has been widened and paved, sight-lines have been improved, and the intersection angle is now 70 degrees. Installation of an automated crossing warning system consisting of flashing lights, bell, and gates was underway as of January 2006.

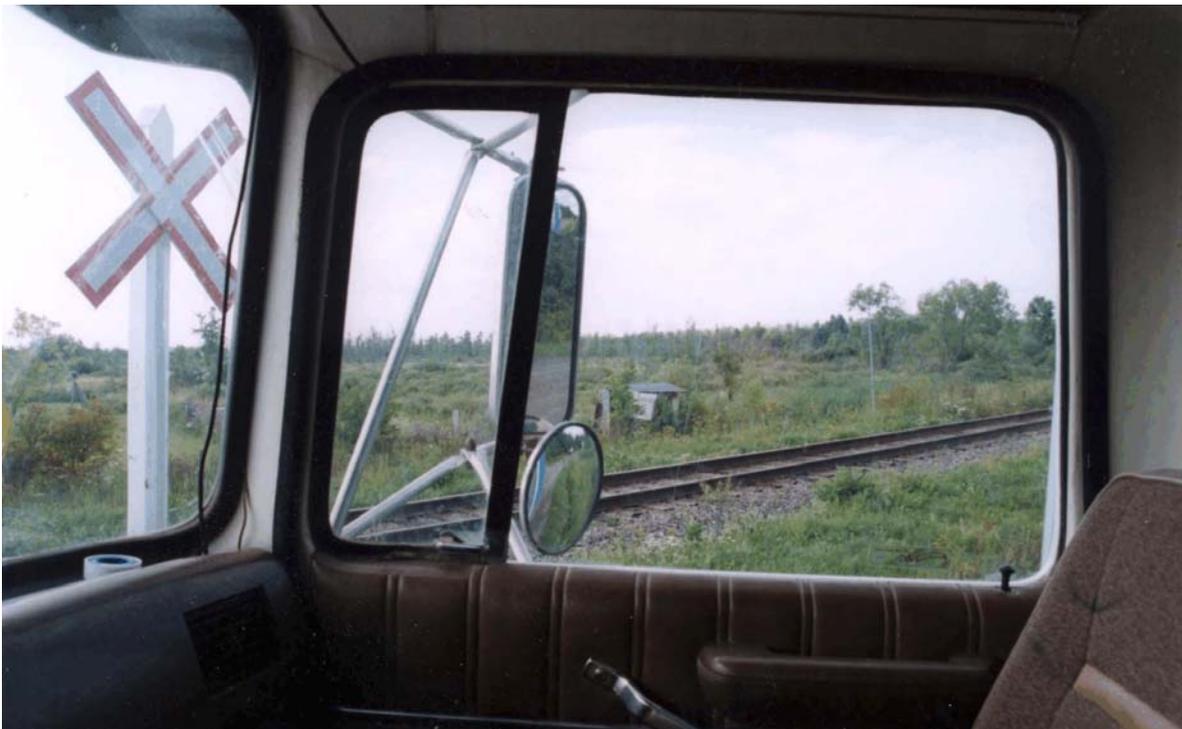
- For a driver of this style of Ford truck, travelling north, a westward train would only be visible when the train was approximately 200 feet (61 m) from the crossing (see Photo 3).

Photo 3. Driver's eastward view of tracks

As the truck reached the crossing, it was likely oriented at the 52-degree crossing angle. In this position, the driver's right view towards the east was obstructed by the truck's dump box. The only available sight-line towards the east was through the passenger-side window through which the train would have been visible to the driver only when it was approximately 200 feet (61 m) from the crossing. With the train travelling at 93 mph, this distance represented approximately 1.5 seconds of time before the collision. Therefore, the truck driver either did not see the train, or else saw it with too little time to react. The acute angle of the crossing, in combination with the lack of a rear window view, prevented the driver from observing the approaching train.

However, in either scenario, due to the restricted visibility caused by the acute angle, the train would only have been visible for 1.5 seconds prior to its entering the crossing, and audible for only one second. Therefore, without having sufficient visual or auditory cues of the approaching train, the driver drove onto the crossing, and the truck was struck by the train.
