RAILWAY INVESTIGATION REPORT

R04Q0006

MAIN-TRACK DERAILMENT

MILE 77.8, MONTMAGNY SUBDIVISION

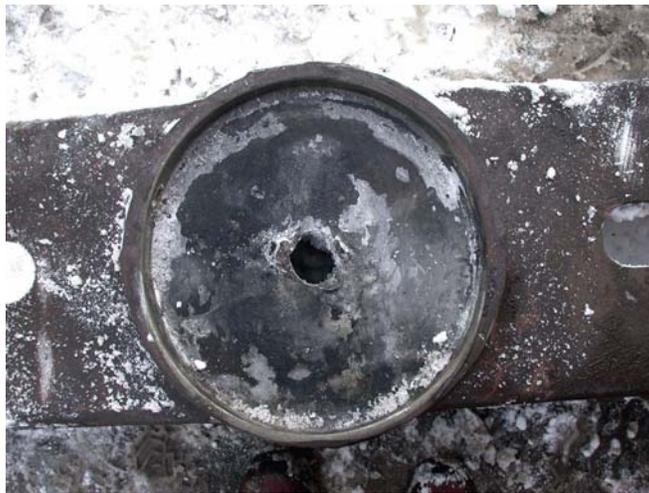
The first derailed car was an empty wood chip gondola car, CN 879261, the 7th car behind the locomotives. The car had been stripped of its brake equipment and trucks. The front portion of the body centre plate and the rim of the truck bolster centre bowl of the A-end of the car showed a matching wear pattern and polished contact faces. The centre pin holes in the centre plate casting and the body bolster were distorted in the direction of the train movement (see Photo 1). The distortion was fresh, with no corrosion present. The extensive damage to the truck and the scattering of components from similar trucks precluded its reconstruction.

The matching gouge marks on the truck bolster centre bowls and the centre plate on the A-end of car CN 879261 suggest that the car body centre plate had moved longitudinally and was riding on the lip of the bolster bowl. Therefore, the car body centre plate of the first derailed wood chip gondola car, CN 879261, was improperly seated in the bolster bowl. Although it is not clear that this would have made the car more susceptible to truck hunting and car body oscillation, the wear patterns and polished contact surfaces of the bolster bowl and car centre plate suggest that the trucks were subjected to high-speed truck hunting.

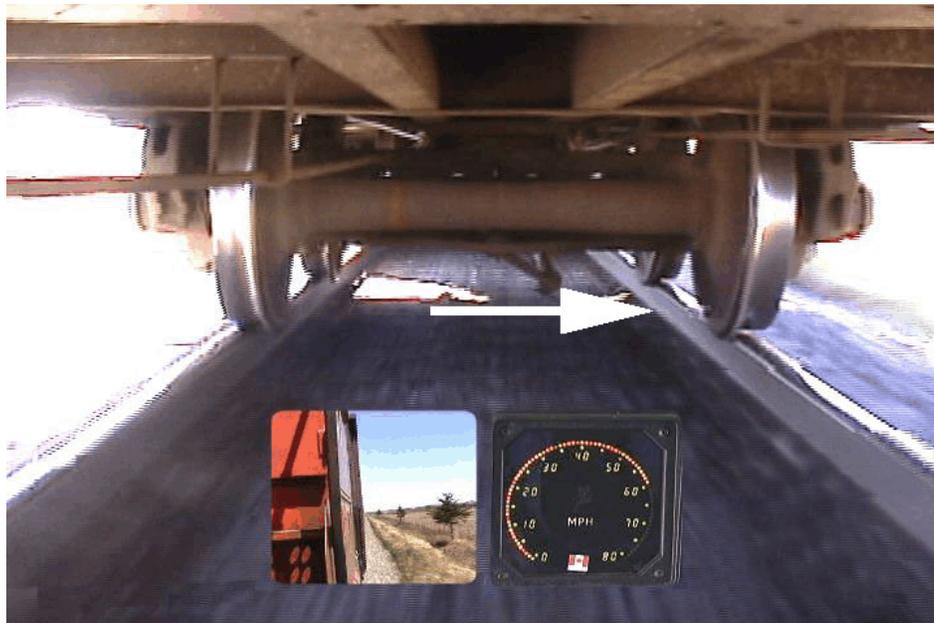
Truck hunting was observed on both test cars, with the onset beginning between 48 mph and 54 mph, depending on track condition and location. The hunting motion and car body side-to-side oscillation became more severe as speed increased, leading to visible hard flanging of the wheels, and initiation of wheel lift (see Photo 2).
