RAILWAY INVESTIGATION REPORT
R05E0008

CROSSING ACCIDENT

VIA RAIL CANADA INC.
PASSENGER TRAIN NUMBER 1
MILE 92.26, EDSON SUBDIVISION
MACKAY, ALBERTA
31 JANUARY 2005

Report Number R05E0008

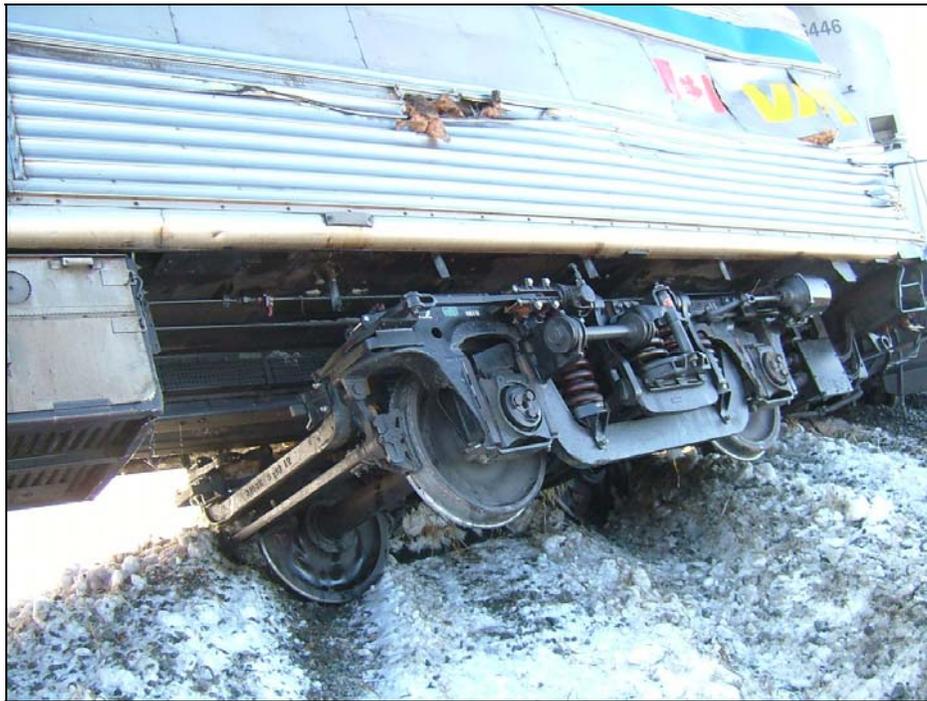
Both locomotives sustained significant damage that required removing them from service. The first three cars behind the locomotives came to rest at various angles and sustained significant damage. The remaining six cars stayed upright but derailed adjacent to the track, and all were damaged to some degree (see photos 1, 2, and 3).

Photo 1. View of damage to the north side of luggage car 8610

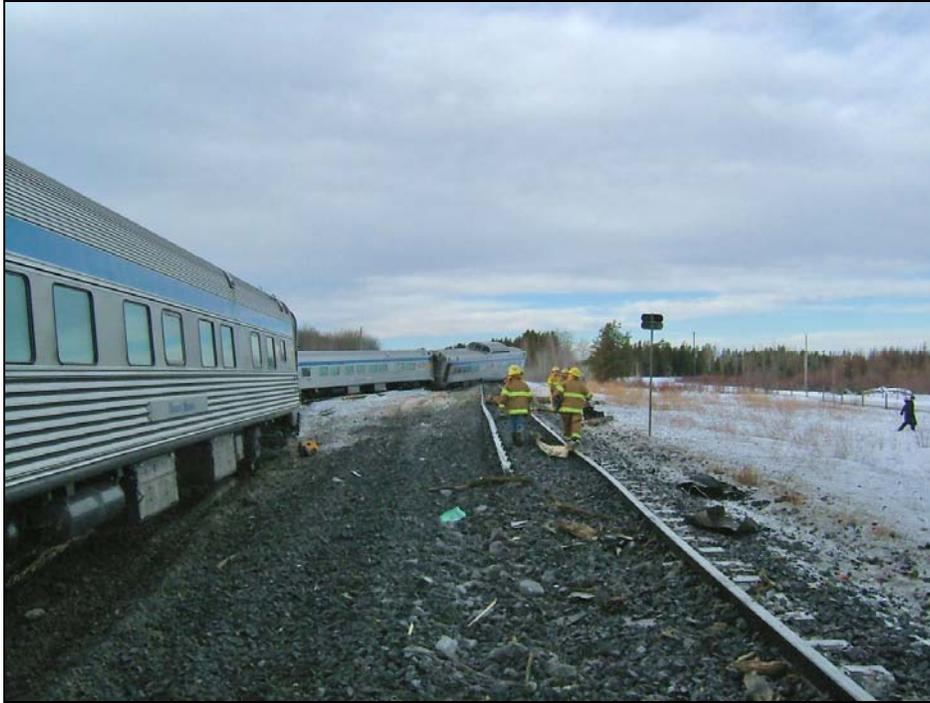
Photo 2. View of the derailment and associated track damage looking eastward from the crossing

Approximately 245 m of track west of the crossing required replacement.

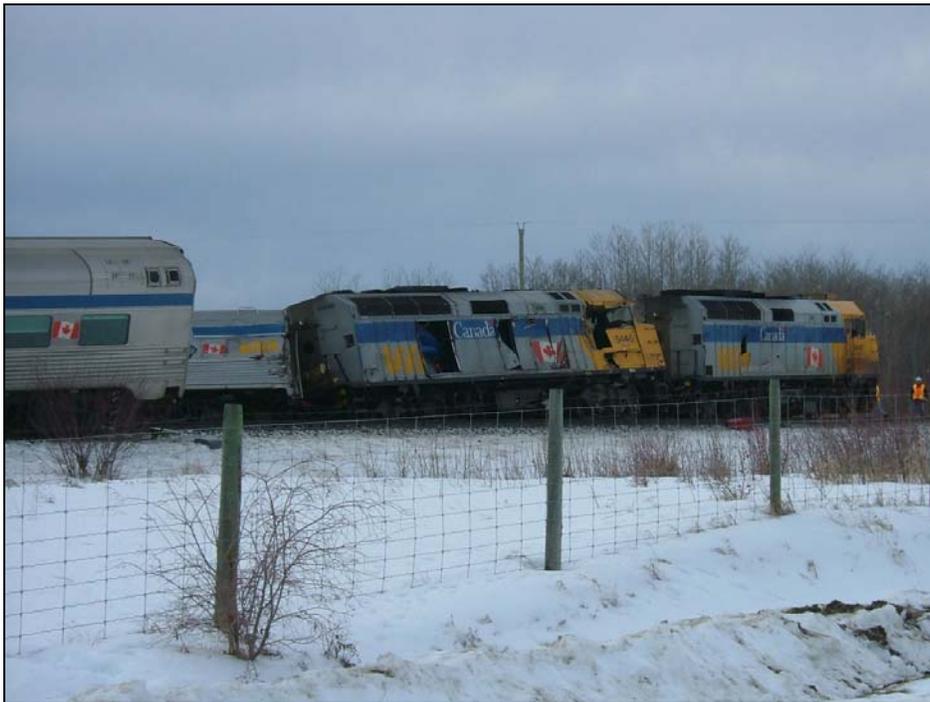
Photo 3. View of the damage to the north side of the two locomotives

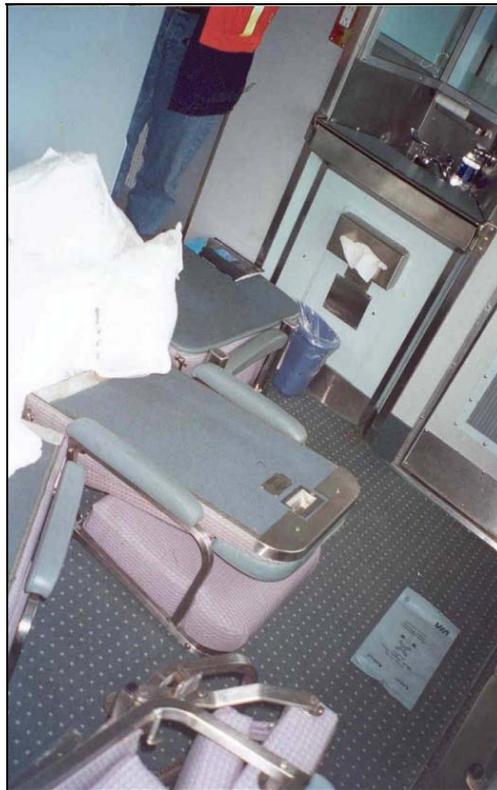
Specially designed windows provide occupants with emergency egress alternatives to the exit doors at the ends of the cars. Emergency exit windows are intended to remain freely accessible at all times. The armchair design increased the risk that an emergency exit would not be accessible. These large, heavy folding armchairs (weighing in excess of 66 pounds each) were not secured to the floor and slid around the sleeping compartments in cars 8717, 8340, and 8319. These chairs could have barricaded the doors, which are inward opening, and could have restricted access to the emergency exit windows in some of the sleeping compartments (see Photo 4).

Photo 4. Sleeping compartment with folding chairs
