RAILWAY INVESTIGATION REPORT

R05Q0040

CROSSING COLLISION

VIA RAIL CANADA INC.

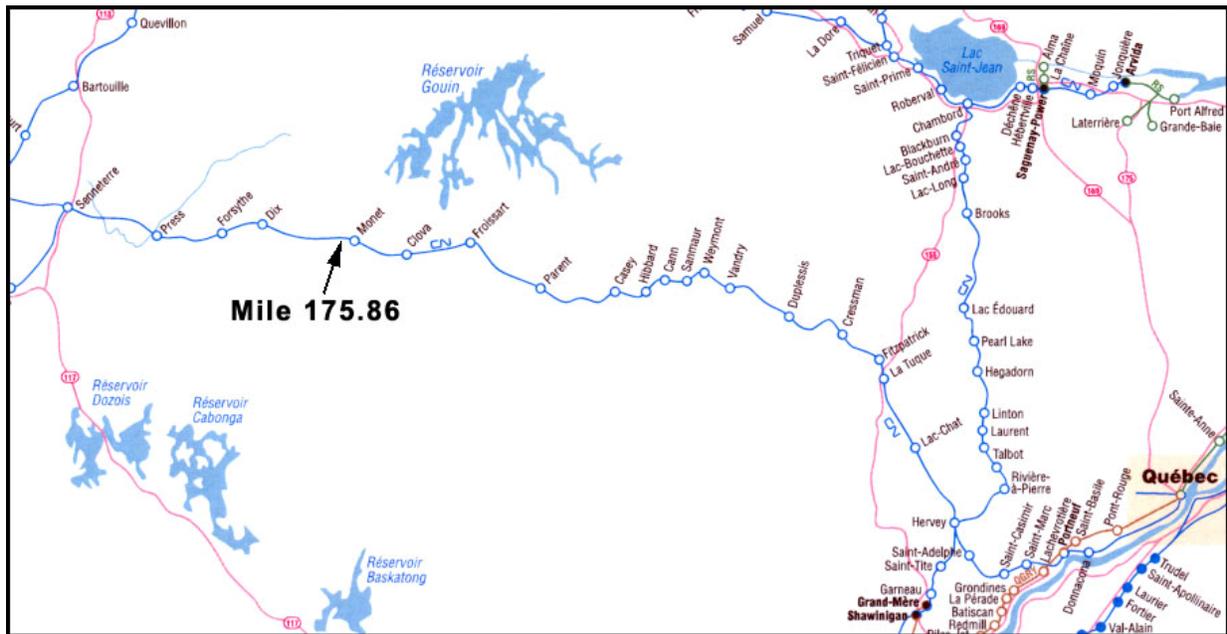
Figure 1. Accident site

While approaching the private crossing at Mile 175.86 (see Figure 1), located near the station at Monet, Quebec, the locomotive engineer suddenly saw a tractor-trailer entering the crossing from the south. The locomotive engineer had no time to sound the whistle or apply the brakes, and the locomotive struck the trailer, which was loaded with logs. The locomotive derailed and came to rest canted to one side beside the track. The locomotive fuel tank ruptured and about 1900 litres of diesel fuel spilled into the ditch. The first three cars derailed but remained upright on the track. The heavy truck tractor was pushed into the ditch on the north side of the crossing with only minor damage, and the trailer was completely destroyed.
