**RAILWAY INVESTIGATION REPORT**  
**R06Q0054**

**MAIN-TRACK DERAILMENT**

**CANADIAN NATIONAL**  
**FREIGHT TRAIN M-36831-03**  
**MILE 65.02, JOLIETTE SUBDIVISION**  
**CHARENTE, QUEBEC**  
**04 JUNE 2006**

Report Number R06Q0054

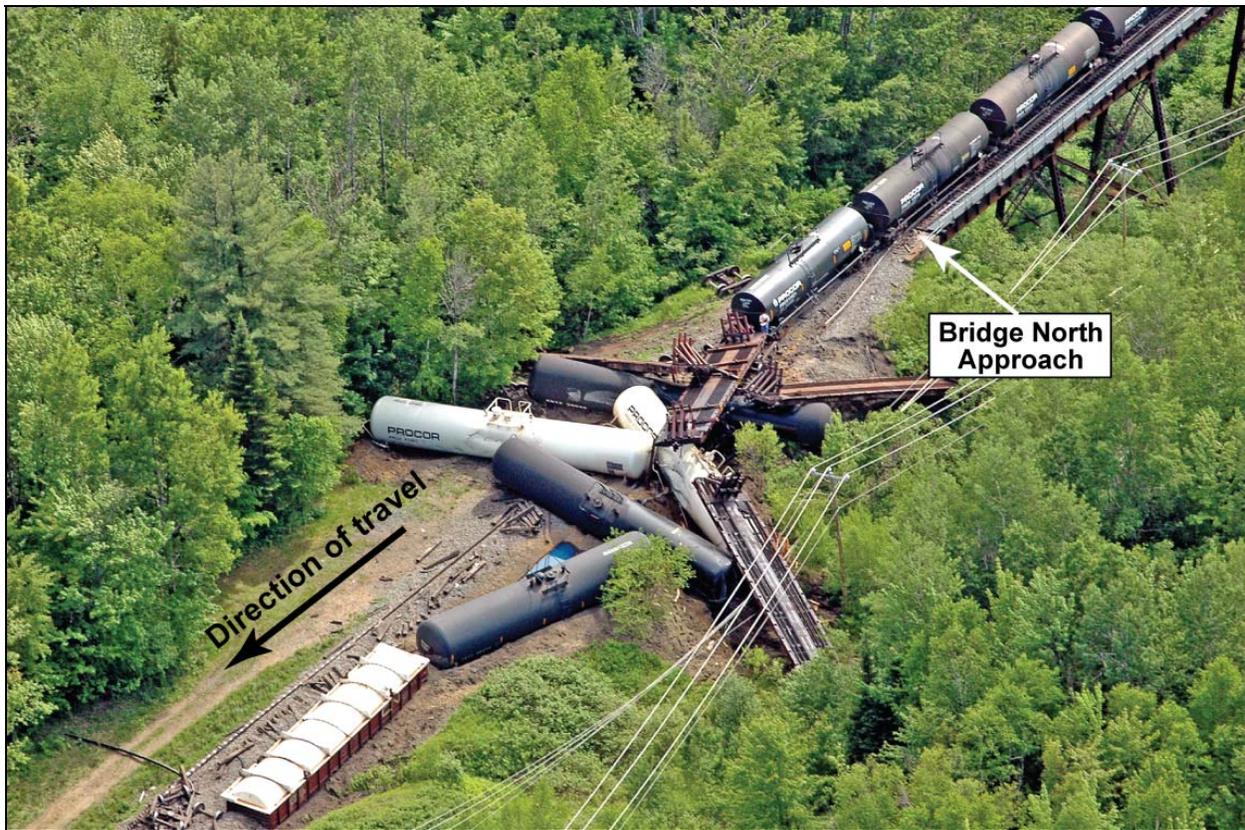
**Photo 1.** Accident site (Source: Newspaper *Le Nouvelliste*)

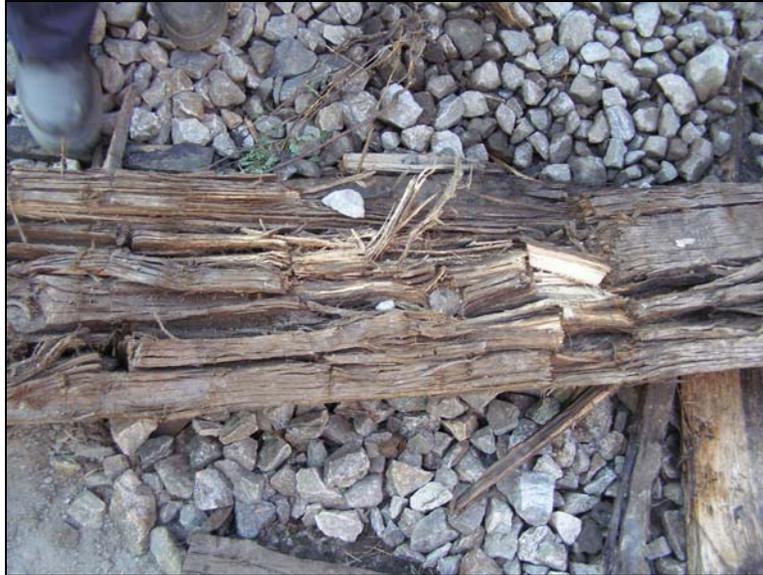
The north bridge approach, which comprises six approach ties, was heavily damaged by the derailment. The ties were dislocated and the wood fibres on their top surface had been shredded by the derailed wheels. The remaining portions of the ties displayed extensive old splits and decay (see Photo 2). The ties were double-spiked (that is, four spikes per tie plate).

**Photo 2.** Track tie from the north approach

The review of the inspection records and the examination of the ties in the field and of the bridge ties in the laboratory suggest that a cluster of ties in the area of the north abutment had reduced lateral strength. The approach track ties were deteriorated and were not renewed in 2005 when substantial work was carried out north of the bridge. Even though they were double-spiked, their holding capacity was not restored. Furthermore, some bridge ties were split and had loose spikes. These ties, with the two abutment ties (where no ties plates were installed) and the track approach ties, formed a section of track at the north end of the bridge of at least 12 feet where the lateral strength had been lowered.
