**RAILWAY INVESTIGATION REPORT
R07T0240**

MAIN TRACK TRAIN DERAILMENT

**CANADIAN PACIFIC RAILWAY
FREIGHT TRAIN No. 230-25
MILE 42.80, BELLEVILLE SUBDIVISION
TICHBORNE, ONTARIO
25 AUGUST 2007**

Report Number R07T0240

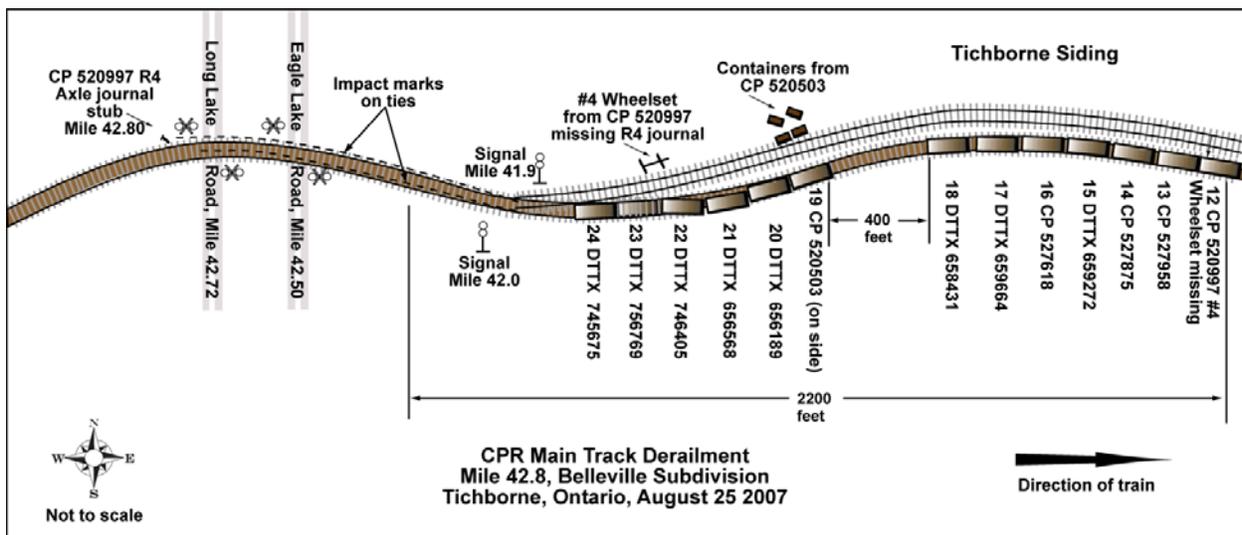
Figure 2. Diagram of derailment site

At the west end of the derailment site near the siding turnout, the mainline track had been displaced approximately two feet northward. Impact marks were observed on the track ties along the gauge side of the south rail and the field side of the north rail extending westward from the turnout. The marks were traced back, over two automated public crossings, to Mile 42.80 where the axle journal stub, with its roller bearing still attached, was located on the north (high) side of a right hand curve in the direction of travel (see Figure 2). The failed wheelset and severed axle journal stub, complete with the roller bearing, were sent to CPR's Test Department in Winnipeg, Manitoba, for failure analysis.

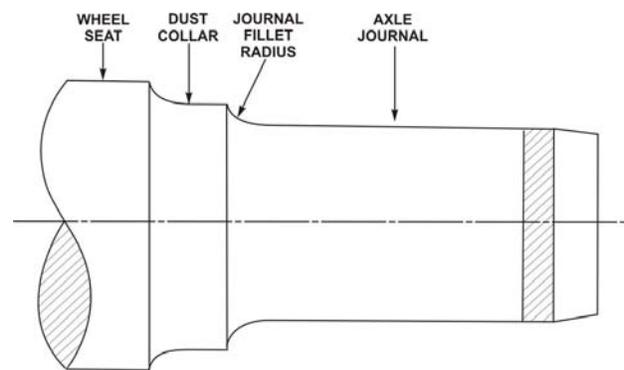
Figure 3. Freight car axle

During wheelset assembly, railway wheels are press-fit onto the axle wheel seats and then roller bearings are press-fit onto the axle journals. The axle wheel seat and journal have different cross-sectional diameters connected by two consecutive radii, the dust collar and the fillet radius, that transition from the larger diameter wheel seat to the smaller journal (see Figure 3). Both the dust collar and fillet radius require smooth, contoured transitions.

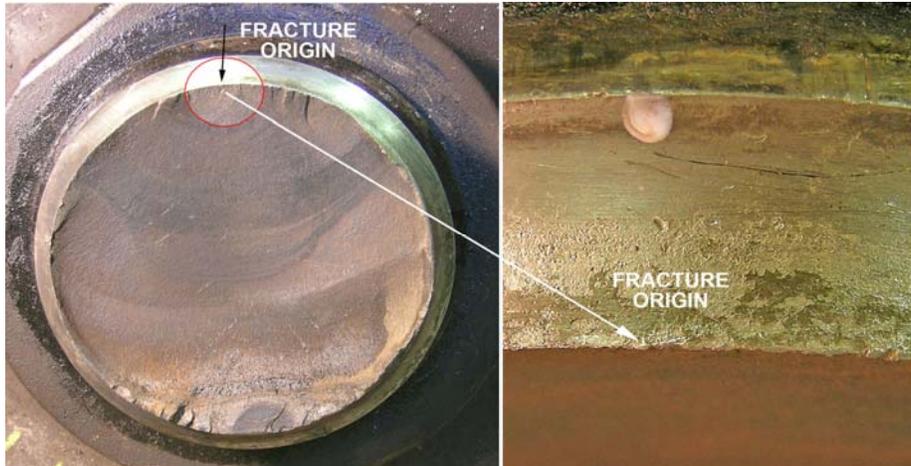
- The axle fractured in the area of the R-4 fillet radius, approximately 11 inches inboard of the end of the journal. There was no evidence of overheating. The fracture was perpendicular to the principal stresses acting on the axle. The fracture displayed primary and secondary fatigue cracks as well as a small, brittle failure zone which is normally associated with sudden or catastrophic failures. The fatigue fracture zones were characterized by beach marks which were traced back and identified an area of suspected fracture origin.

- The primary fatigue fracture originated at several corrosion pits on the fillet radius and propagated as multiple small fatigue cracks. These small cracks joined to form a common crack front. Driven by rotating bending stresses, the primary crack propagated in fatigue through approximately 80 per cent of the axle's cross-section over some finite period of time. Typical of rotating bending failures, a small secondary zone of fatigue was observed directly opposite the primary fatigue crack fracture origin (see Photo 1).

Photo 1. Exposed fracture surface identifying fracture origin and a close-up of corrosion pitting on the fillet radius (Source: CPR).

- Metallurgical examination confirmed corrosion products at the root of pitting on the fillet radius. No other anomalies were identified. The axle material conformed to the requirements of AAR Specification M-101 for Grade F steel. The microstructure consisted of a mixture of fine-grained pearlite and ferrite, which was consistent with the specified material and heat treatment.

The R-4 axle journal failed in fatigue which originated at several corrosion pits on the fillet radius and propagated as multiple small fatigue cracks. These small cracks joined to form a common fatigue crack front which progressed through approximately 80 per cent of the axle's cross-section over some finite period of time. The final failure occurred catastrophically, under normal service conditions, when the applied load exceeded the diminished strength of the journal's reduced cross-section.

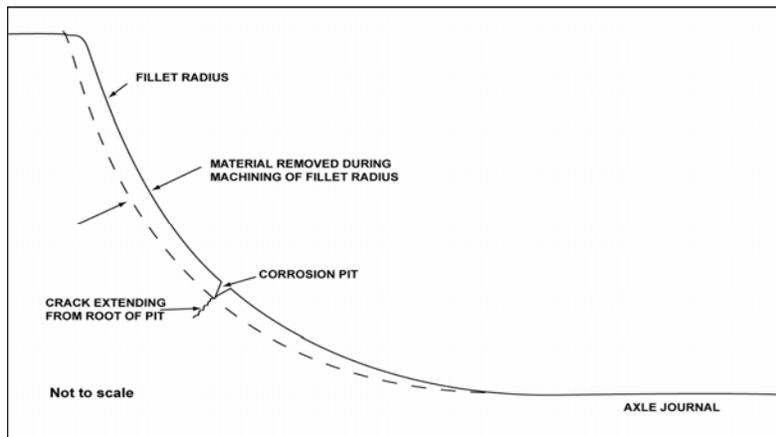
The fillet radius is a critical transition area of the axle that is subject to high loading and flexing during normal service as the weight of a freight car is transferred through the fillet radius to the wheel. Due to the loading, the fillet radius is notch sensitive and surface imperfections or subsurface cracking within the area can become nucleation points for fatigue crack development. Corrosion pits are typically "U" or "V" shaped. Applied loads tend to focus at the root of the pit which in turn initiates small fatigue cracks. Such cracking may still be present after the fillet radius pitting is removed (see Figure 4). The cracks tend to remain tight and are not detectable by visual inspection alone. Therefore, additional non-destructive testing methods such as ultrasonic or wet magnetic particle testing are required to consistently detect such cracks.

Figure 4. Potential effect of machining on pitting in the fillet radius
