**RAILWAY INVESTIGATION REPORT
R10W0123**

CROSSING ACCIDENT

**CANADIAN PACIFIC RAILWAY
FREIGHT TRAIN 290-14
MILE 13.85, EMERSON SUBDIVISION
GRANDE POINTE, MANITOBA
14 JUNE 2010**

Report Number R10W0123

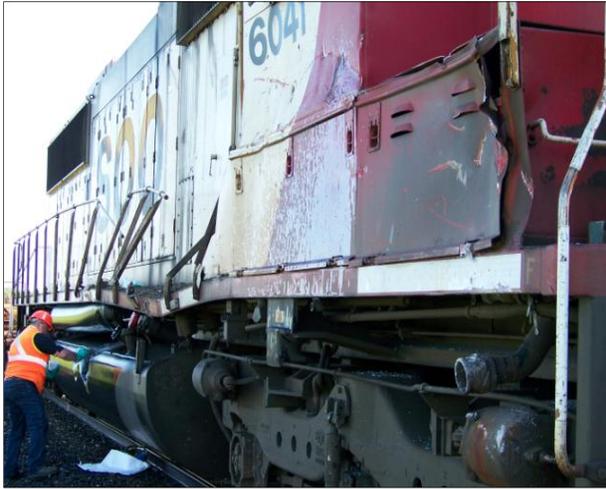
Photo 1. Locomotive SOO 6041

The right (west) side of locomotive SOO 6041 sustained impact damage (see Photo 1). The right front step sill and grab iron were damaged and there was a large dent near the mid-point of the locomotive frame and fuel tank. The first 5 car bodies behind the locomotives derailed upright, straddling the west rail. This was followed by a gap of about 240 feet which led up to an additional 17 car bodies that had derailed in various positions (see Figure 2).

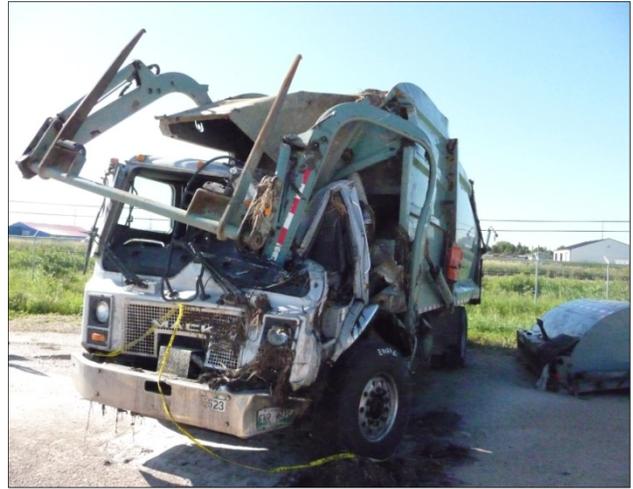
Photo 2. Mack Garbage Truck

The truck was essentially destroyed (see Photo 2). The front driver side of the cab was crushed and the bottom corner of the driver side rear tail gate was damaged. Gouges, scrapes and black paint marks were observed on both the front and rear of the truck.

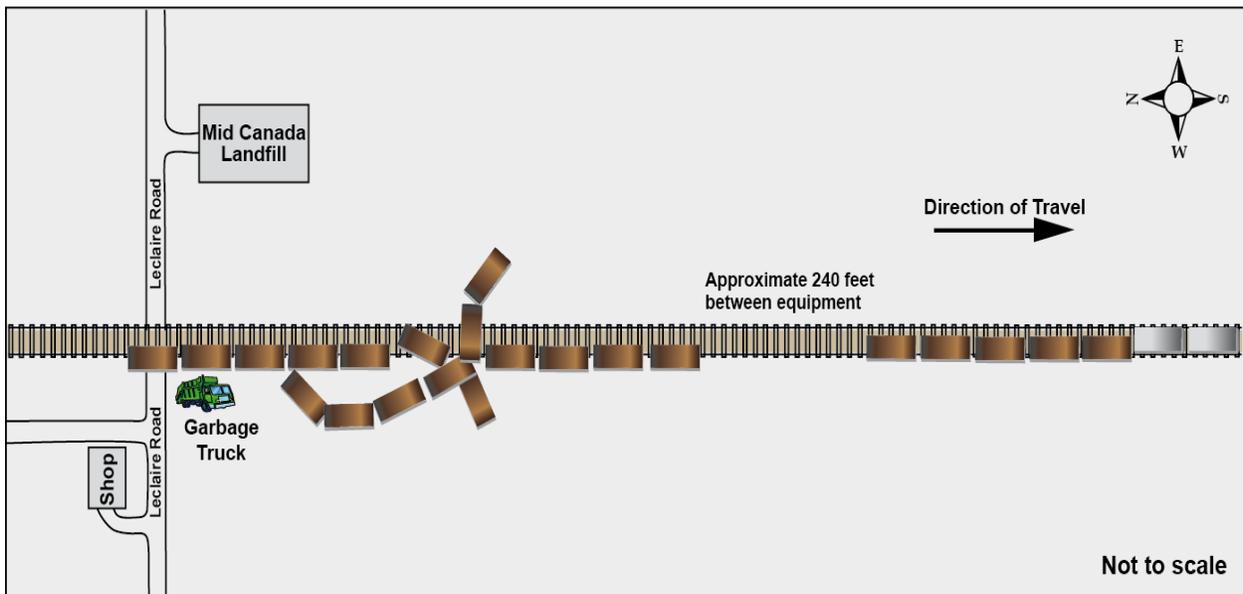
Figure 2. Site diagram

Approximately 10 feet north of the crossing, wheel marks were observed along the web of the east rail, extending southward into the crossing. The crossing and about 520 feet of track to the south were destroyed and an additional 500 feet of track further south was damaged. Beyond the destroyed track, wheel impact marks were observed between the rails, and just west of the west rail, on the ties leading up to the point where the locomotives came to rest.

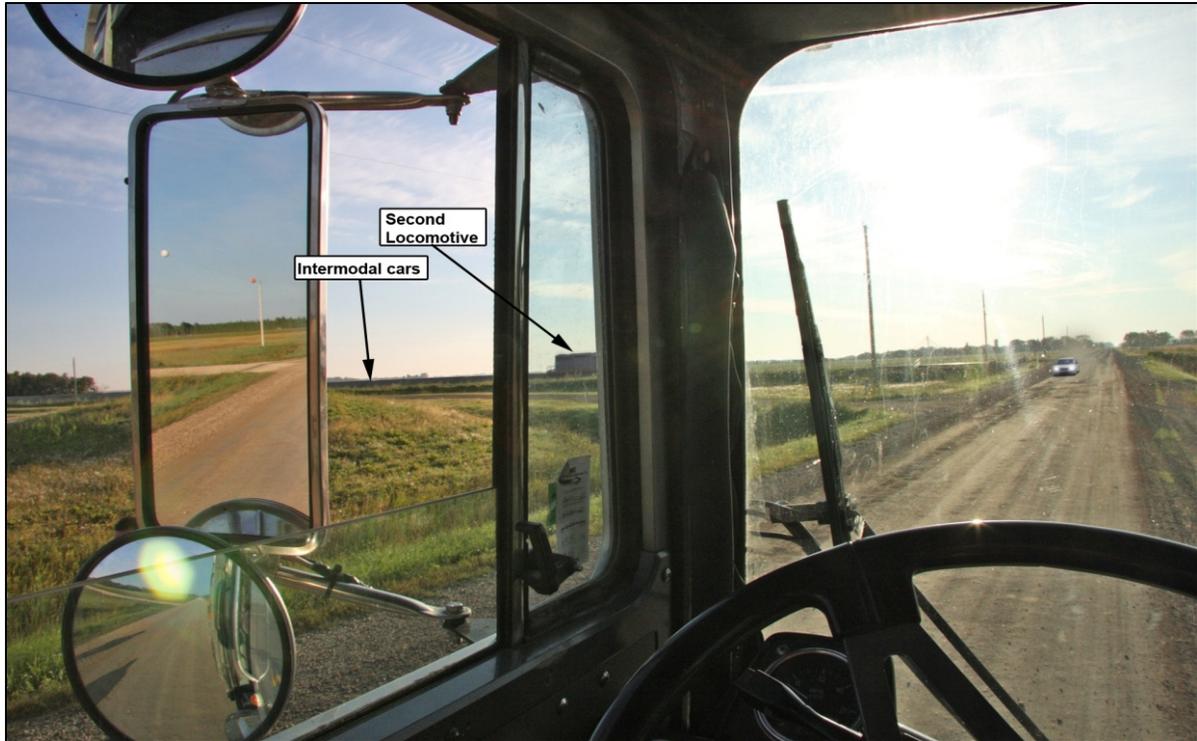
- The measured sightlines met the TC *Minimum Railway/Road Crossing Sightline Requirements For All Grade Crossings Without Automatic Warning Devices (G4-A)*.
- The average ambient noise in the truck cab driving on the gravel road without the radio playing was in excess of 95 dB(A).
- The pillar between the truck's windshield and side window, the side mirrors and window frame obstructed the driver's field of view to the north (see Photo 3).
- With the position of the sun at the time of the accident, the empty intermodal cars at the head-end of the train blended into the background which made it difficult to distinguish the train from other features on the horizon.

Photo 3. Simulated view approaching the crossing. The precise position of the vehicles and the environmental conditions may not be identical to those of the accident.

The presence of the building on the northwest corner of the crossing limited the amount of time that the driver had available to notice the train. Furthermore, similar to other TSB investigations, the TSB accident simulation determined that the pillar between the truck's windshield and side window, the large side mirrors and window frame obstructed the driver's field of view to the left. Similar arrangements are common on many North American trucks.
