**RAILWAY INVESTIGATION REPORT  
R13T0122**

**MAIN-TRACK DERAILMENT**

**CANADIAN PACIFIC RAILWAY  
FREIGHT TRAIN 119-01  
MILE 112.70, PARRY SOUND SUBDIVISION  
WANUP, ONTARIO  
02 JUNE 2013**

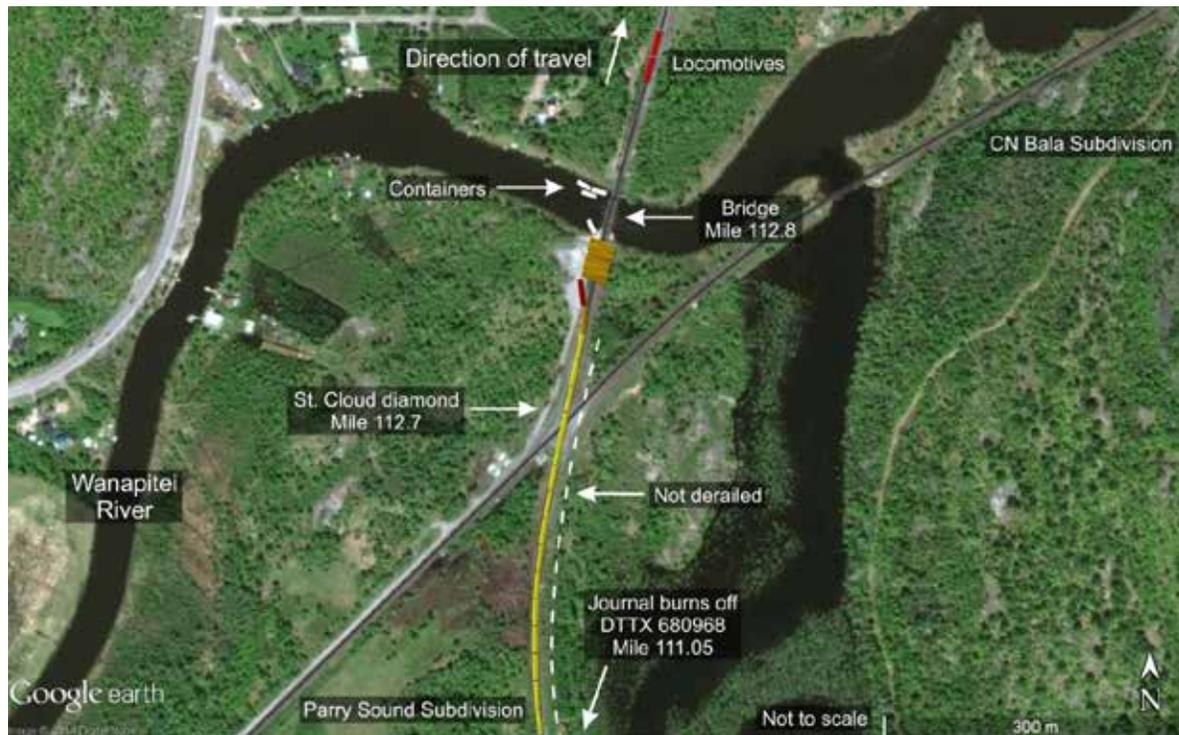
Figure 2. Derailment area diagram

the derailed cars impacted the south end of the Wanapitei River railway bridge at Mile 112.80 (Figure 2).

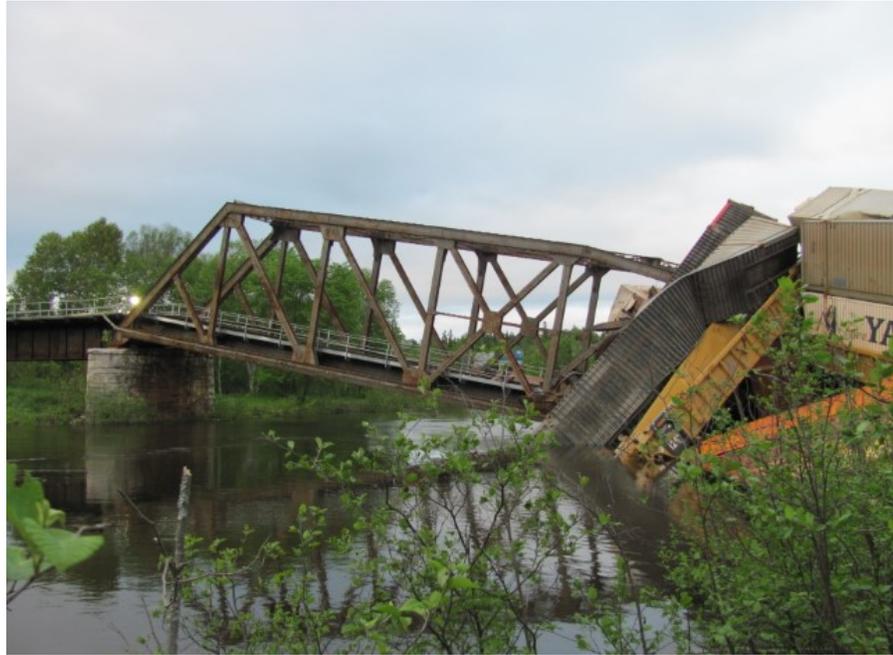
Site examination determined that the 1<sup>st</sup> to 6<sup>th</sup> cars (involving 12 car bodies and 20 containers) had derailed. As a result of the impact from some of the derailed cars, the south end of the bridge was knocked off the abutment (Photo 1).

The south bridge abutment, bridge seat, and west wing wall were damaged extensively while the ballast wall and through truss bridge span were destroyed.

Photo 1. Collapsed south end of the railway bridge

5. Some of the derailed cars impacted the bridge at Mile 112.80, knocked the south end of the bridge off the abutment, and severely damaged the bridge.

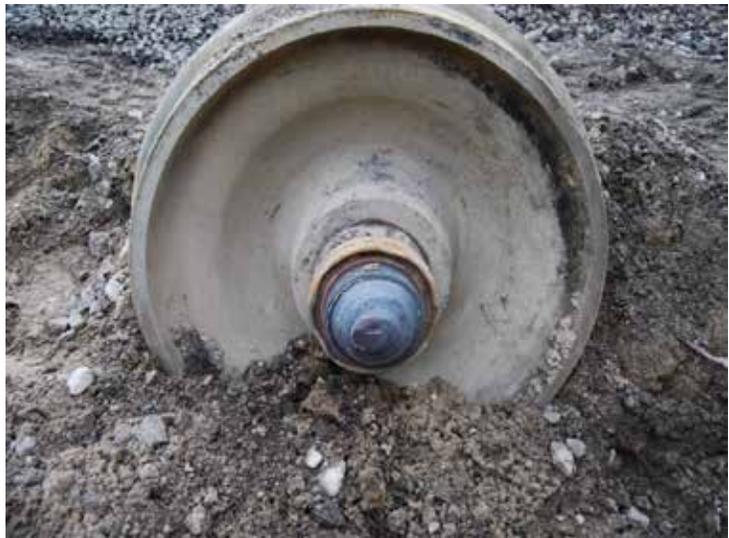
On the 1<sup>st</sup> derailed car (DTTX 680968), the lead axle in the trailing truck (No. 3 position) had a burnt-off axle journal (BOJ) in the L3 position (Photo 2). The underside of the related truckside spring seat was heavily smeared and gouged.

Photo 2. DTTX 680968 L3 wheel and burnt-off axle journal

The accident occurred as a result of the catastrophic failure of the L3 roller bearing and subsequent burnt-off axle journal (BOJ) on the lead wheelset of the trailing truck of car DTTX 680968, which was the first car behind the locomotives.

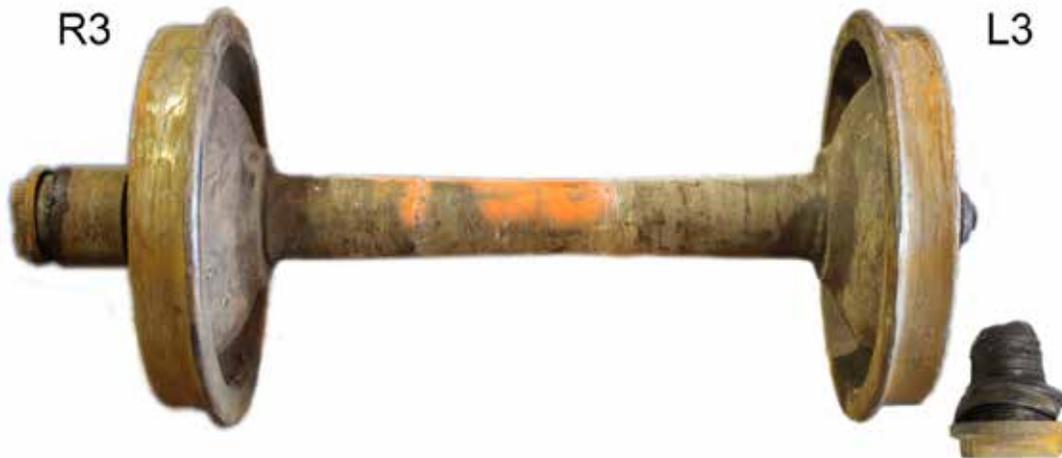
A detailed teardown examination was completed on the No. 3 wheelset from car DTTX 680968 (Photo 3) at the TSB Laboratory.

Photo 3. No. 3 wheelset as received

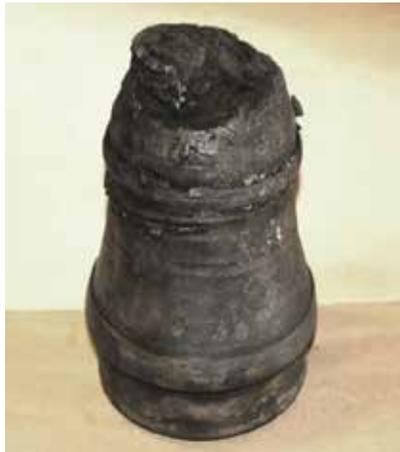
The L3 axle journal had burnt off the axle approximately 5 inches from the axle journal fillet radius. The remaining axle journal profile was typically conical in shape tapering down to a 4-inch diameter at the point of separation. The BOJ stub had been slightly elongated as it extruded outboard during failure. The separation surface features on the outboard portion of the journal were characteristic of torsional deformation.

Photo 4. Failed burnt-off axle journal stub

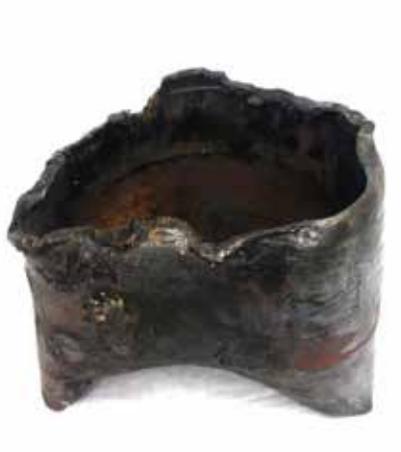
- The cup was 29 years old.
- The remaining components were essentially destroyed and all exhibited severe heat discolouration, smearing, and plastic deformation (Photo 4, Photo 5 and Photo 6).
- Due to the severity of the damage, it was not possible to determine the precise cause of the roller bearing failure.

Photo 5. Outer ring (cup)

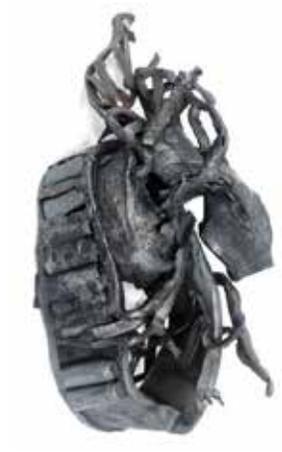
Photo 6. Outboard cone assembly
