RAILWAY INVESTIGATION REPORT R15H0092

Main-track derailment

Huron Central Railway

01 November 2015

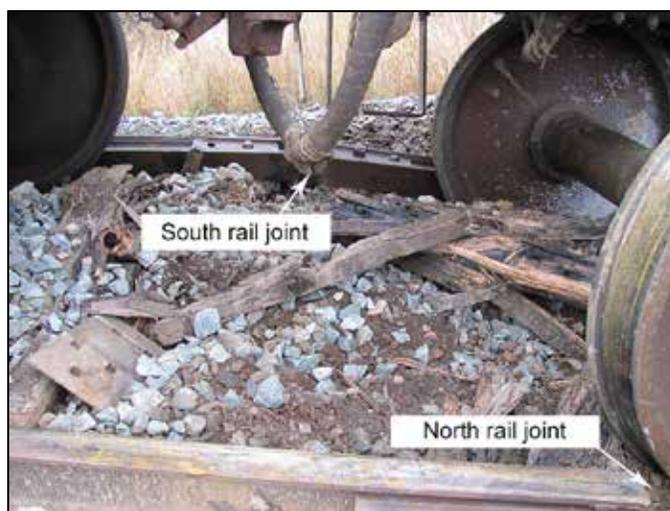
In the direction of travel, the first marks on the rails were located at Mile 72.08 at 2 adjacent rail joints on the north rail and the south rail, which were staggered by less than 5 feet (Photo 1). The north rail joint was broken in half with the east-end rail in place and the broken joint bars still attached while the west-end rail was located under the derailed cars with the broken joint bars attached. The south rail joint remained intact and rolled to the field side. Both joints were recovered and forwarded to the TSB Engineering Laboratory for a detailed examination.

Photo 1. Adjacent joints near the derailment site

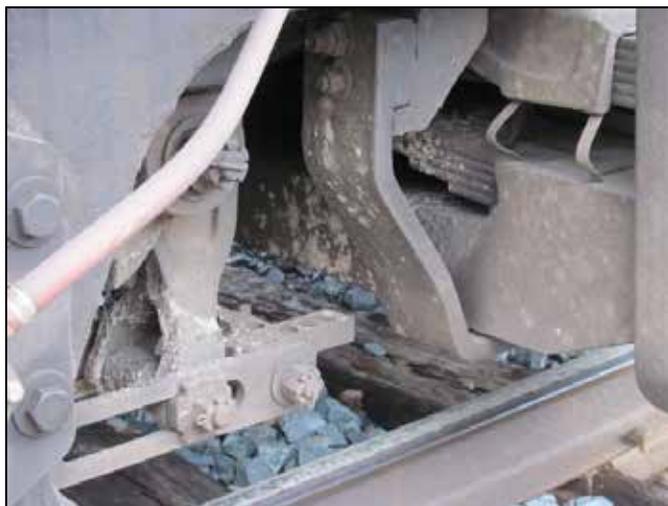
All 3 locomotives derailed upright. Two wheels (R3 and R4) from the lead locomotive (HCRY 2008) derailed and 6 wheels (R1, R2, R3, R4, L3 and L4) from the second locomotive (HCRY 800) derailed. The second locomotive also sustained minor damage to the rear ladder and pilot from rubbing along the rail. All wheels from the third locomotive (HCRY 3800) derailed, and that locomotive sustained damage to its fuel tank, which rubbed along the head of the rail. There was mud on the rail head between the derailed cars and the lead wheel of the lead locomotive. There was also mud on the underside of the lead locomotive at the leading truck and fuel tank on the south side (Photo 2).

Photo 2. Mud on the underside of the lead locomotive

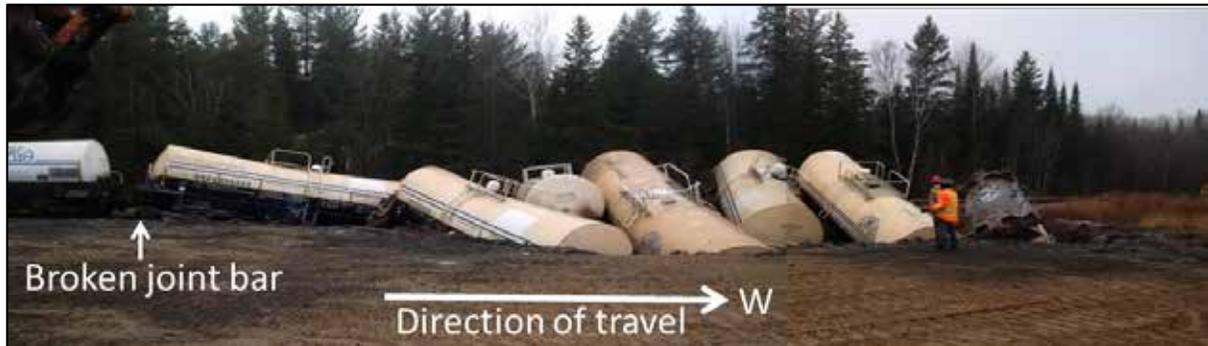
The 1st to 8th derailed cars, all loaded with sodium carbonate,³ came to rest in various positions (Figure 2). The 1st derailed car was overturned and laying north of the roadbed. The 2nd to 6th cars were jackknifed in a pile-up, resting where the roadbed had collapsed. The 7th car was upright just west of the broken rail joint with its A-end angled on the south-side embankment, resting against the 6th derailed car. The 8th car was standing just east of

the joint with only its B-end derailed. A small amount of sodium carbonate had been released in the area around the cars.

Figure 2. Tank cars derailed in various positions

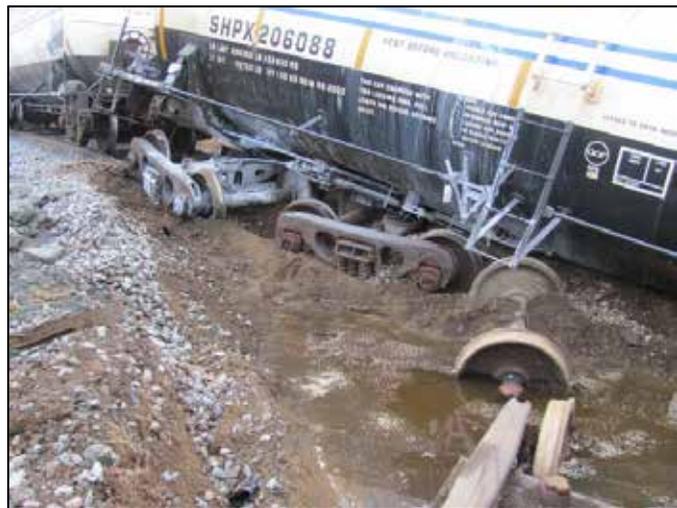
The roadbed was destroyed for a distance of approximately 225 feet beginning immediately west of the broken joint. At the bottom of the roadbed collapse, where the derailed cars came to rest, some of the cars and their appliances were partially submerged in about 2 feet of water and clay soil material (Photo 3). Directly north of the roadbed, water was running rapidly and was of considerable depth. To the south of the roadbed, standing water was observed in a treed area.

Photo 3. Derailed cars and appliances partially submerged

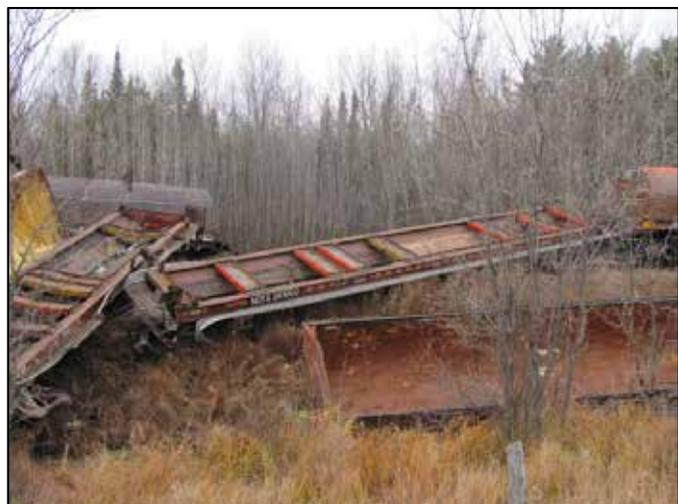
An additional 5 cars, empty covered gondola cars (cars 24 to 28), also derailed (Photo 4). The 24th car derailed upright and angled north of the roadbed. The 25th car was lying perpendicular to the track on the north embankment. The other 3 cars derailed in an upright position along the track. At this location, the north rail was rolled to the north and was damaged for approximately 150 feet. There was only minor damage to the south rail.

Photo 4. Additional derailed empty covered gondola cars

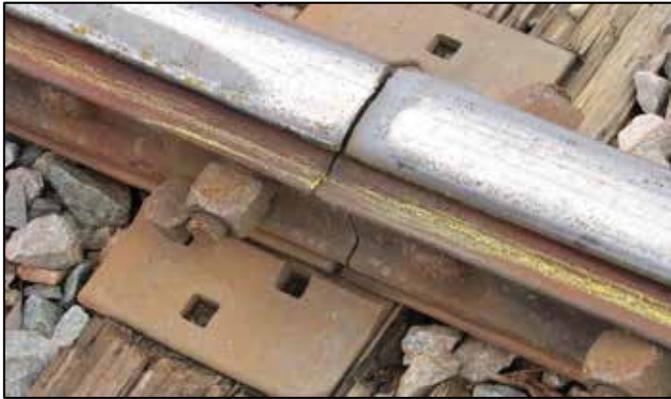
An on-foot examination of the track between Mile 71.0 and Mile 72.5 identified a total of 39 joint defects. These defects included 10 cracked or broken joint bars (Photo 5). One cracked joint bar was located at a rail joint that had been marked during a rail flaw test due to the presence of an internal rail defect. The remaining joint defects included loose, bent or missing bolts (Photo 6) and broken or missing tie plates (Photo 7). At the time of the occurrence, no slow orders were in effect at that location.

Photo 5. Broken joint bar

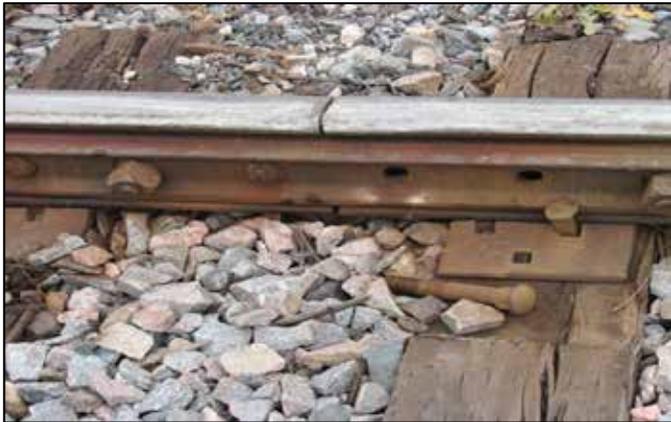
Photo 6. Missing bolts

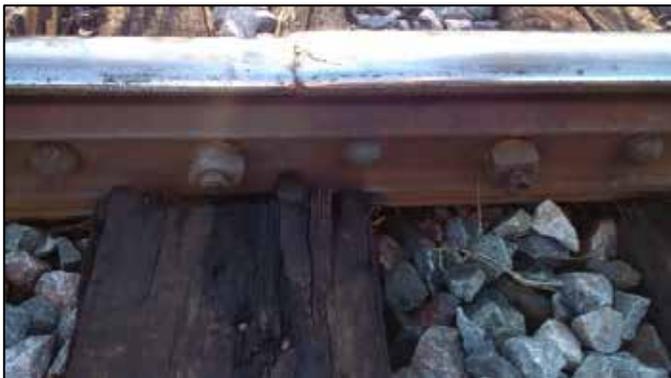
Photo 7. Missing tie plate

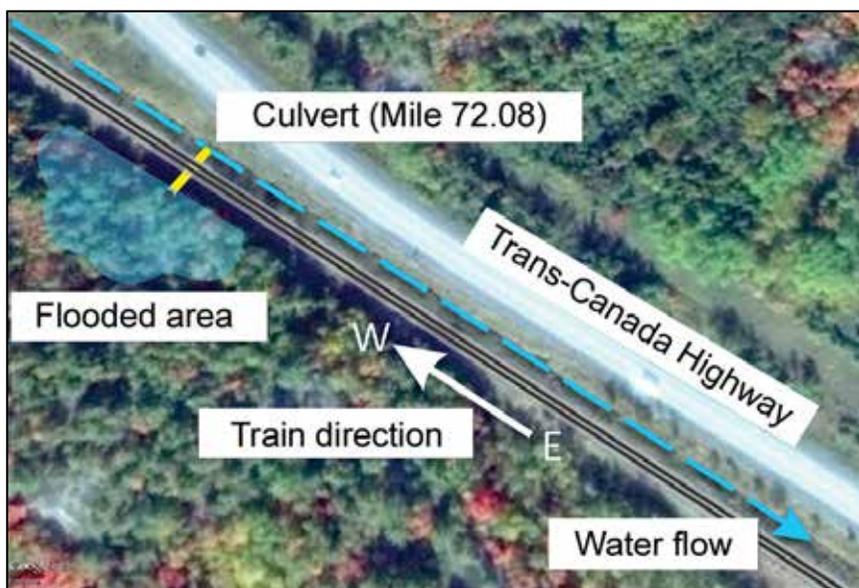
Much of the track on the Webbwood Subdivision was located in swampy, low-lying areas. In the vicinity of the occurrence, on the north side of the track, there was an eastward water flow year round at varying depths, depending on the amount of precipitation, snow melt and any obstructions such as beaver dams (Figure 3).

Figure 3. Water flow in the occurrence area (Source: Google Maps, with TSB annotations)

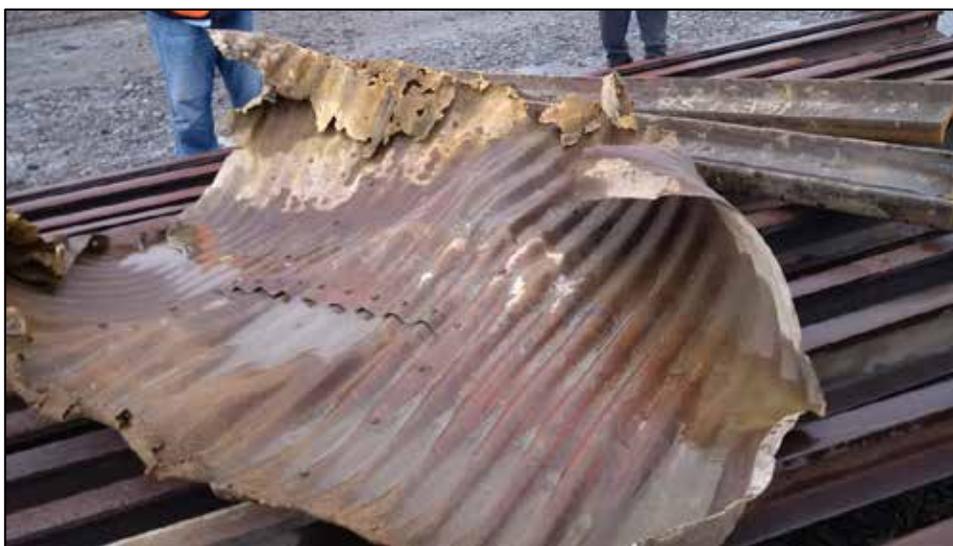
- Drainage, which normally occurred from the south side to the north side of the track, had been restricted or completely blocked, despite having a culvert at Mile 72.08.
- The culvert had either collapsed, sunk, and/or had become plugged.
- The corrugated steel pipe extensions contained large areas of rust-through corrosion (Photo 8) and had separated from the concrete box culvert, which had allowed subgrade material to fall into the gaps.

Photo 8. Section of culvert containing rust-through corrosion

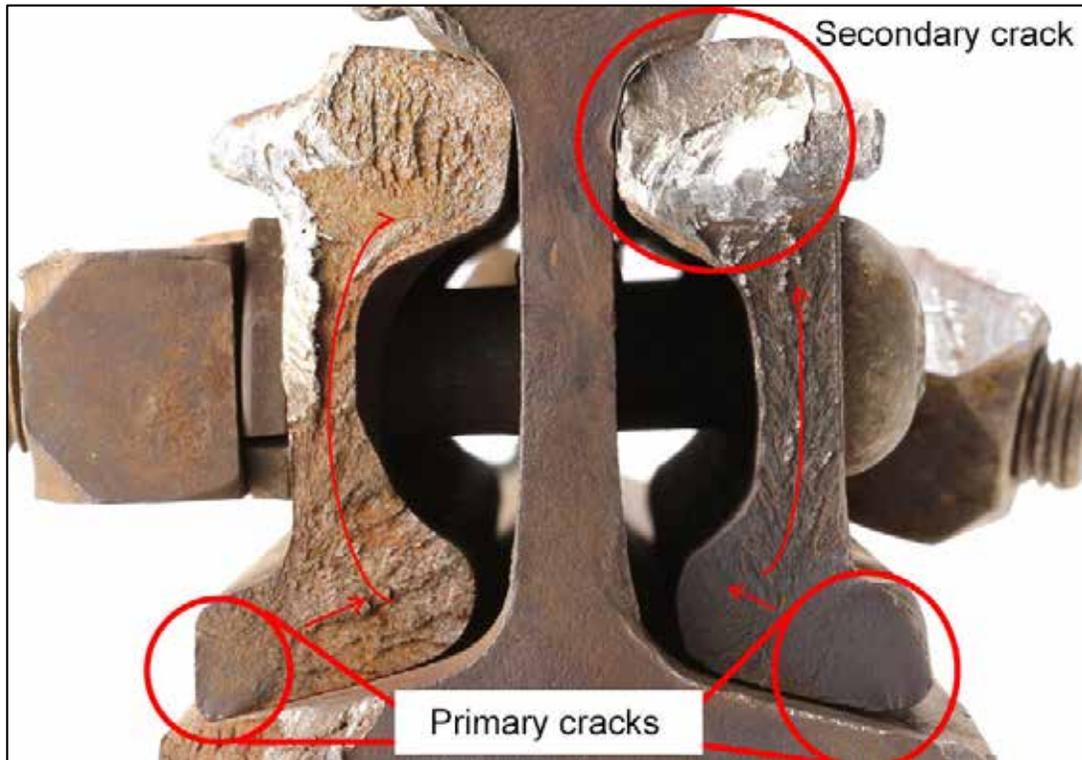
- The north rail joint bar materials met the specified strength requirements.
- The north rail joint bars failed due to overstress extension of fatigue cracking (Photo 9).
- Fatigue cracking of the north rail field side joint bar initiated along the lower outside edge.
- Fatigue cracking of the north rail gauge side joint bar initiated along the lower outside edge as well as at fretted areas at the upper fishing surface.
- Fretting between the north rail gauge side joint bar and the parent rail occurred due to relative movement between the joint bar and the parent rail.

Photo 9. Pre-existing primary and secondary cracks in rail joint bars (arrows showing extension of fatigue cracking)

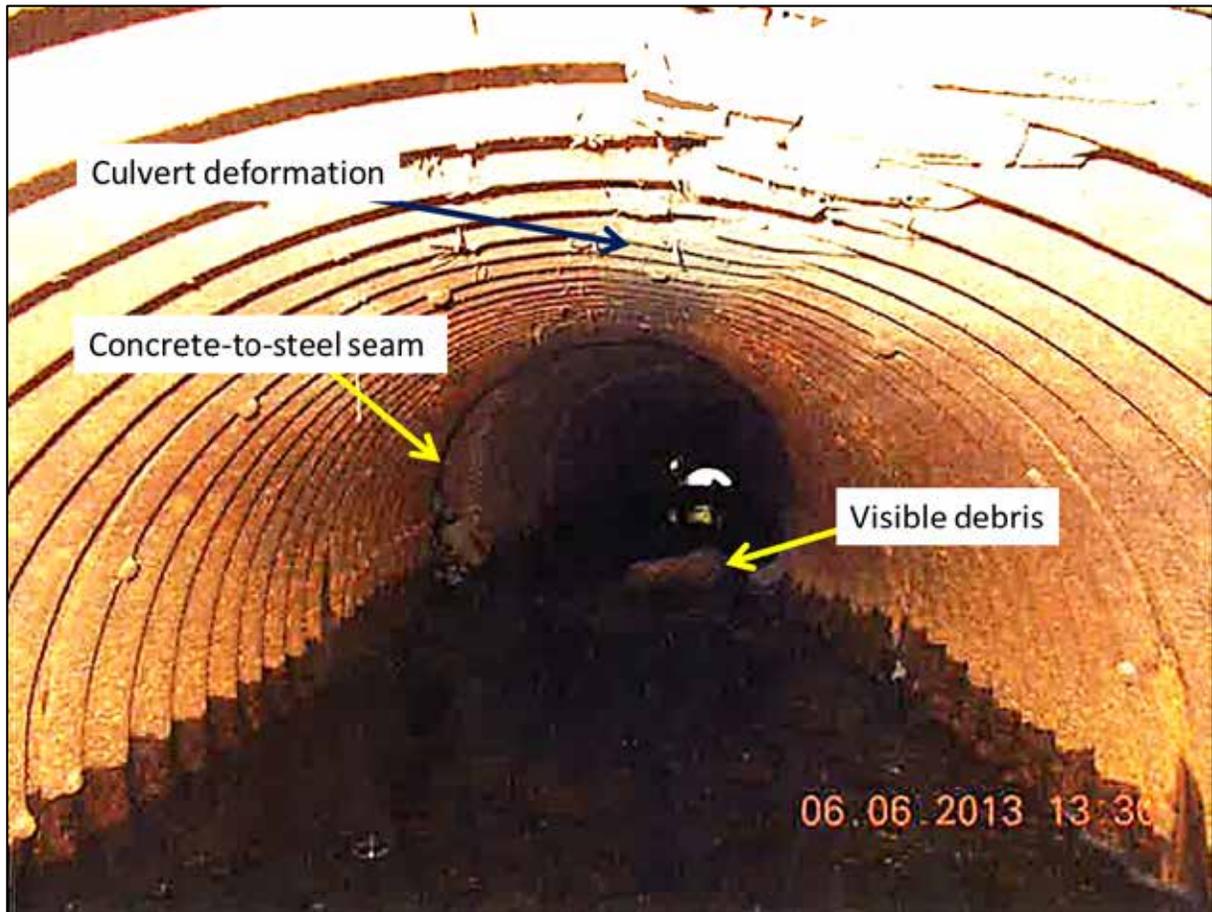
In June 2013, during the most recent culvert inspection, the culvert at Mile 72.08 was assigned a rating of 3 (poor), as all structural and hydraulic components, including the seams and material, were assessed as being in poor condition (Figure 4). With a rating above 2, repair work was not required nor performed to improve any of the culvert components.

Figure 4. Culvert at Mile 72.08 during June 2013 inspection. Note: brightness adjusted for easier identification of defects. (Source: Huron Central Railway inspection report, with TSB annotations)
