RAILWAY INVESTIGATION REPORT R15V0183

Main-track train collision

Canadian Pacific Railway
Freight trains 602-242 and 113-01
Mile 62.0, Mountain Subdivision
Beavermouth, British Columbia
06 September 2015

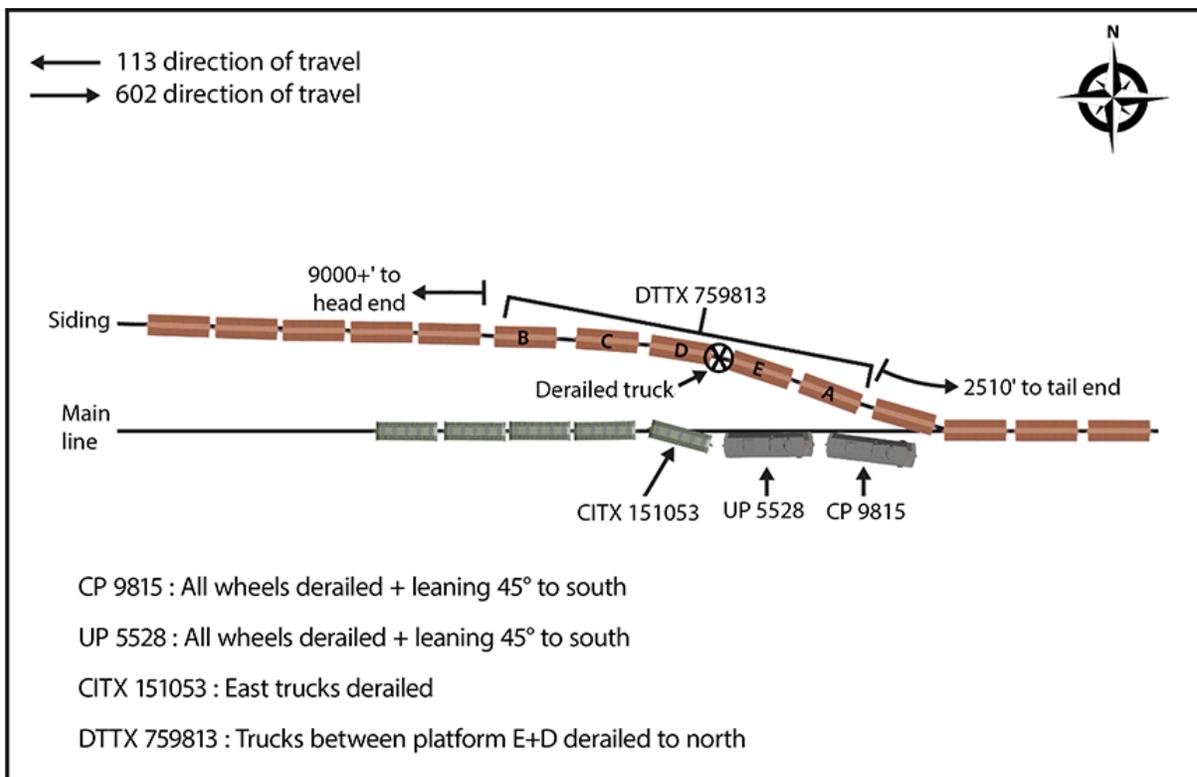
Figure 3. Collision site diagram

As a result of the collision, the 2 lead locomotives from train 602 (CP 9815 and UP 5528) came to rest at a 45° angle, leaning to the south against the rock face, immediately adjacent to the east siding switch (Photo 1). The first car (CITX 151053) behind the 2 locomotives derailed upright and was also leaning to the south. On train 113, one set of trucks on the 64th car (DTTX 759813) derailed (Figure 3). The conductor of train 602 received a serious injury. No dangerous goods were released.

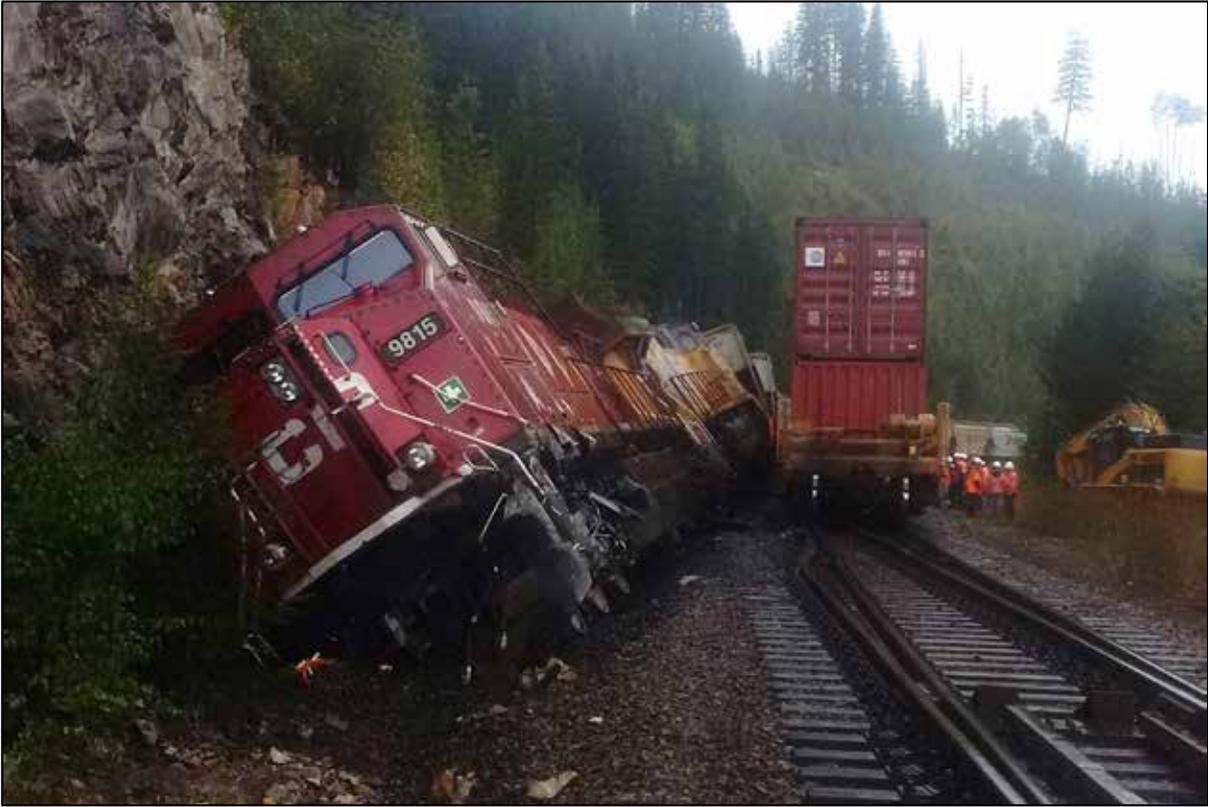
Photo 1. Both locomotives of train 602 derailed at east end of Beavermouth siding (facing west)
