**AVIATION INVESTIGATION REPORT  
A11C0102**

**RUNWAY OVERRUN  
BEAVER AIR SERVICES LIMITED PARTNERSHIP  
(MISSINIPPI AIRWAYS)  
CESSNA 208B, C-FMCB  
PUKATAWAGAN, MANITOBA  
04 JULY 2011**

Report Number A11C0102

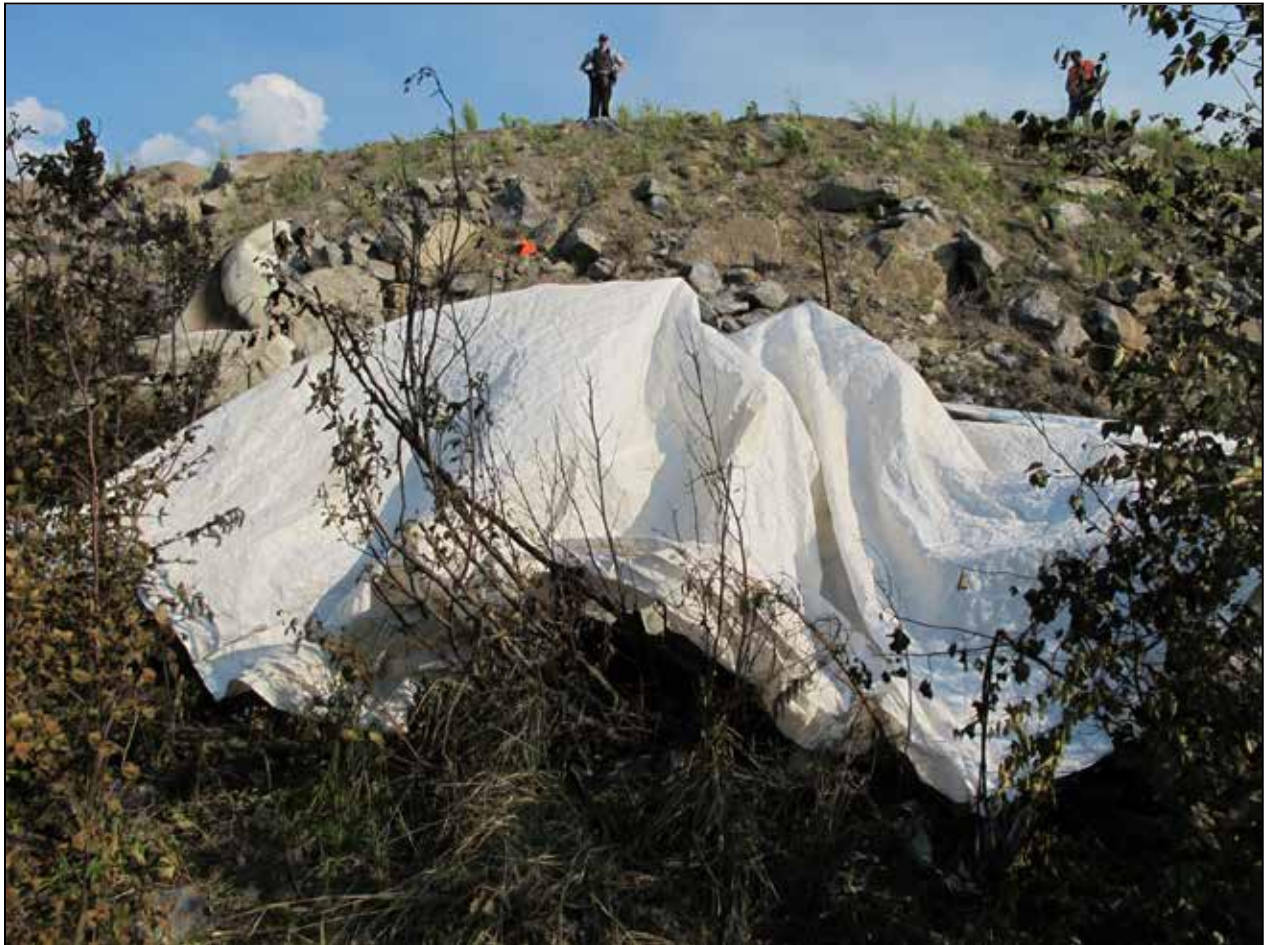
**Photo 1.** Accident site, looking back at the end of Runway 33 (Pukatawagan Airport)

Beyond the turnaround area, the prepared surface gives way to an embankment which descends into a ravine. The slope of the embankment is approximately 30° to 45° and is comprised of gravel, rocks, and large boulders. The slope descends about 20 feet vertically, and then reverses sharply into the contour of a ravine.

The airport runway had been used successfully for Cessna 208 and other aircraft operations for some time. However, during the runway overrun, the steep 20-foot drop-off and sharp slope reversal contributed to the impact damage that led to the deceased passenger's injuries and the fuel system damage that in turn caused the fire. The aircraft's orientation at the bottom of the slope exacerbated the heat effect and the speed at which the fire spread. The hostile terrain at the end of Runway 33 contributed to the occupants' injuries and fuel system damage that in turn caused the fire. This complicated the passenger evacuation and prevented the rescue of the injured passenger.

3. The steep drop-off and sharp slope reversal at the end of Runway 33 contributed to the occupant injuries and fuel system damage that in turn caused the fire. This complicated passenger evacuation and prevented the rescue of the injured passenger.
4. The deceased passenger was not wearing the available shoulder harness. This contributed to the serious injuries received as a result of the impact when the aircraft reached the bottom of the ravine and ultimately to his death in the post-impact fire.
