**AVIATION INVESTIGATION REPORT  
A13C0073**

**COLLISION WITH WATER**

**CUSTOM HELICOPTERS LTD.  
BELL 206B (HELICOPTER), C-GQQT  
GULL LAKE, MANITOBA  
01 JULY 2013**

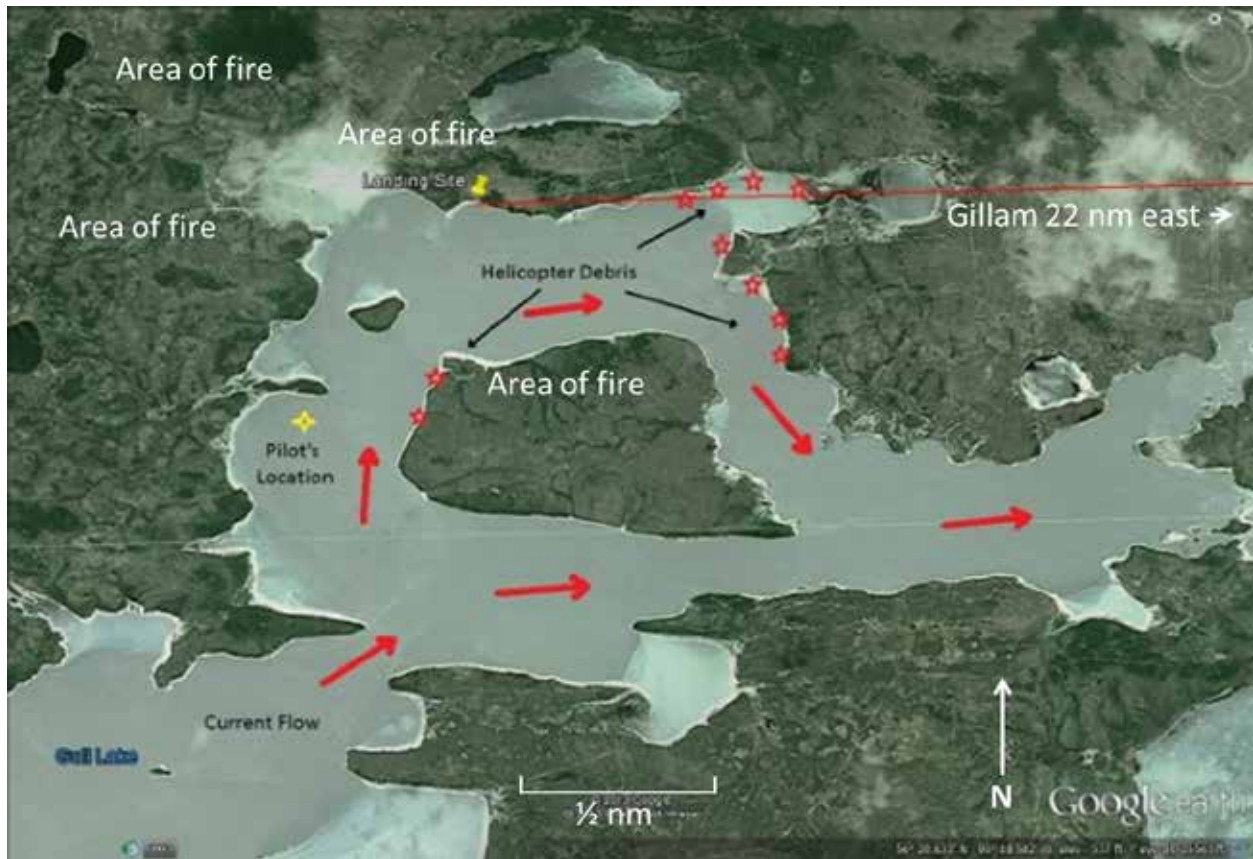
Debris from the helicopter was found the following day along the shoreline of Gull Lake about ½ nm east, downstream from the pickup site (Figure 1).

Figure 1. Map showing debris locations (indicated by red stars)
