# Air Transportation Safety Investigation Report A18O0096

## IMPACT WITH TERRAIN

Bellanca 8KCAB, C-GDLP  
Toronto/Buttonville Municipal Airport, Ontario  
12 July 2018

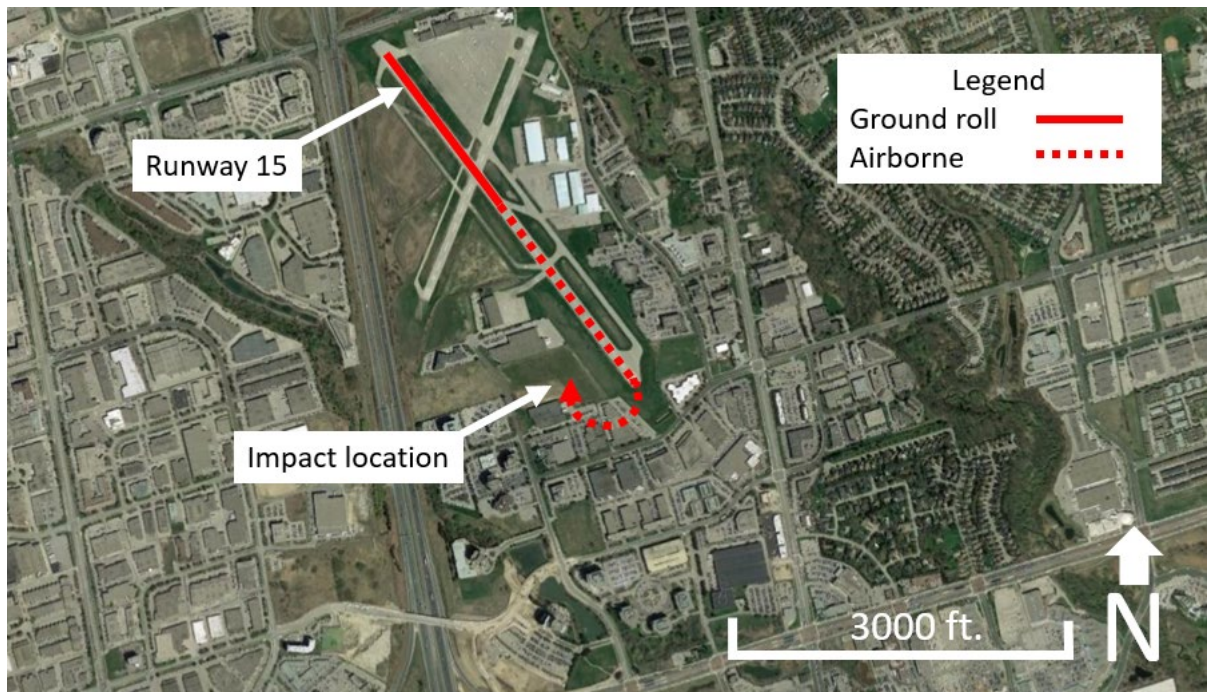
CYKZ is located in a built-up area, and is surrounded by residential and commercial buildings (Figure 1). When an aircraft is departing Runway 15, the pilot has very few, if any, suitable locations to carry out a forced landing successfully in the event of an emergency.

Figure 1. Runway 15 departure area at CYKZ and occurrence aircraft's flight path (Source: Google Earth, with TSB annotations)
