# Air Transportation Safety Investigation Report A19C0053

## COLLISION WITH TERRAIN

Piper PA-12S Super Cruiser, C-FYDN (private)  
Domain Lake, Ontario  
28 May 2019

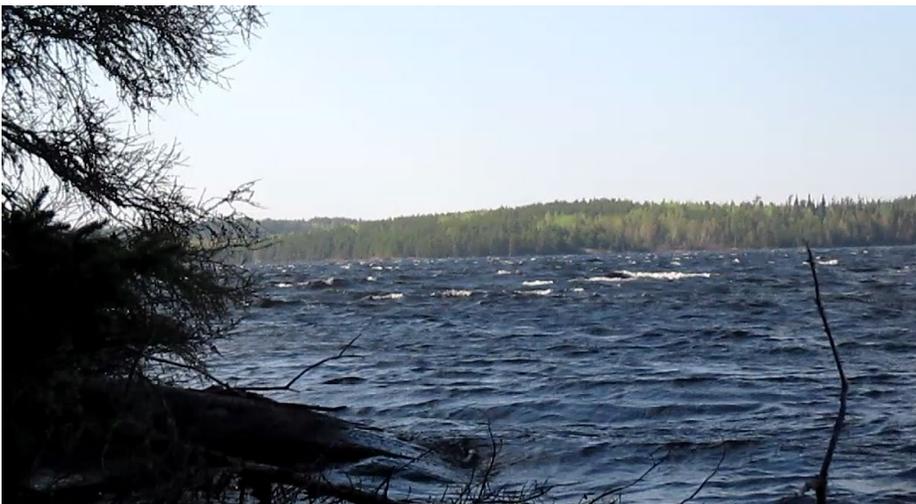
As the canoeists continued their journey around the shore of Optic Lake, they experienced difficult paddling conditions due to strong southwesterly winds and high waves (Figure 2).

Figure 2. Choppy water on Optic Lake at 1711 (Source: Third party, with permission)

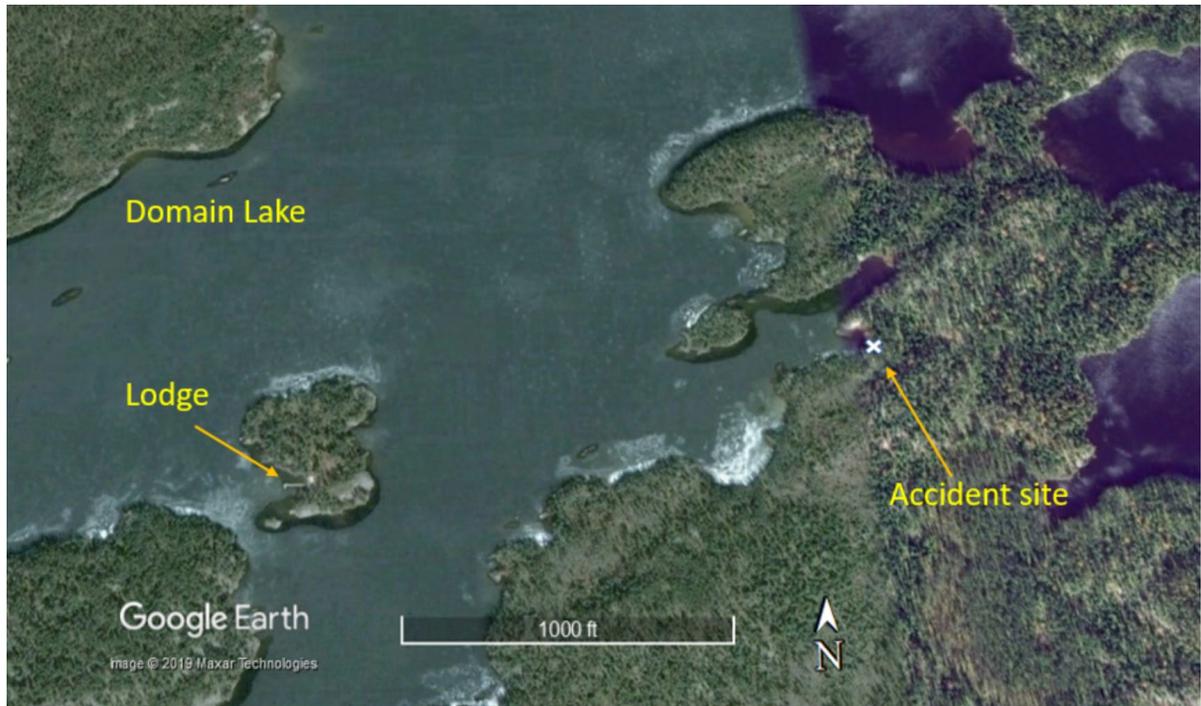
The aircraft collided with trees and terrain on the shore of Domain Lake (Figure 3) on a southeasterly heading, with a nose-down attitude of approximately 30°. The aircraft struck trees and then a granite rock at an elevation of 1394 feet ASL.

Figure 3. Accident site (Source: Google Earth, with TSB annotations)

Before impacting the granite rock, the propeller cut through a tree, indicating that the propeller was rotating and that the engine was producing substantial power at the time of impact. There was no wreckage trail.
