Air Transportation Safety Investigation Report A19P0176

LOSS OF CONTROL AND COLLISION WITH TERRAIN

Privately registered
Piper Aerostar PA-60-602P, C-FQYW
Gabriola Island, British Columbia
10 December 2019

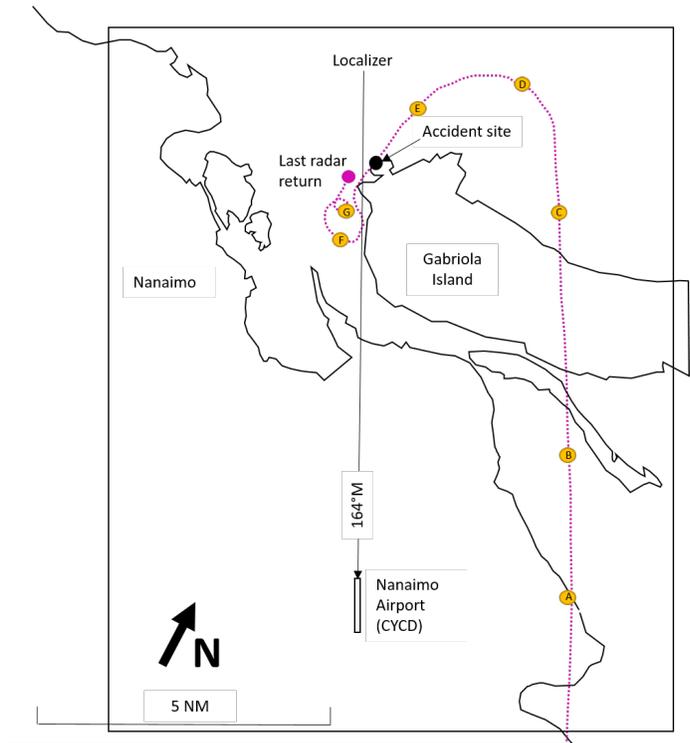
Figure 1. Flight path of occurrence aircraft based on radar data (Source: TSB)

At 1804:47, the aircraft reached an altitude of 2700 feet ASL and a ground speed of 60 knots. The aircraft continued its right turn and began to lose altitude. The controller instructed the pilot to gain altitude if he was able to; however, the pilot did not acknowledge the instruction. The last encoded radar return for the aircraft was at 1805:26, when the aircraft was at 300 feet ASL and travelling at a ground speed of 120 knots (Figure 1).

Point	Time (PST*)	Ground speed (knots)	Radar altitude (feet ASL)
A	1758:44	180	5000
B	1759:43	210	4000
C	1801:14	210	3000
D	1801:58	220	2000
E	1802:41	190	1900
F	1804:03	80	2400
G	1804:47	60	2700
Last radar return	1805:26	120	300
