AIR TRANSPORTATION SAFETY INVESTIGATION REPORT A20W0016

LOSS OF PITCH CONTROL ON LANDING

Canadian Pacific Railway Company
Bombardier CL-600-2B16 (Challenger 605), C-GKCP
Calgary International Airport, Alberta
23 February 2020

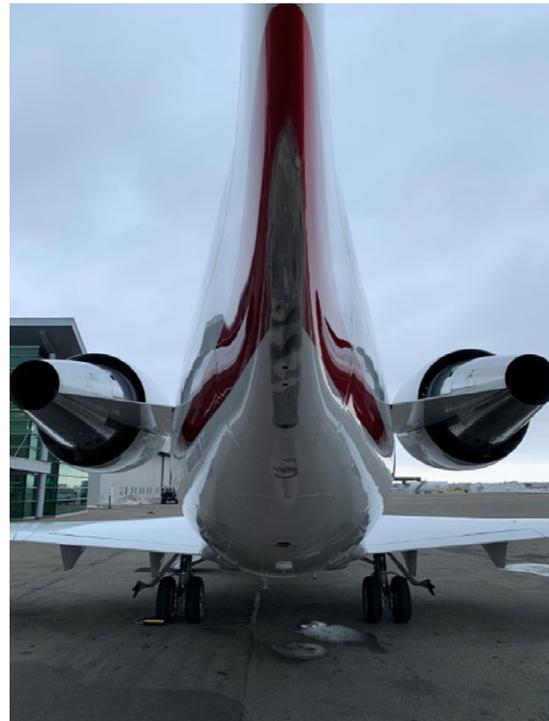
During the landing roll, the rear fuselage and tail cone made contact with the runway surface. As a result, the aft fuselage fuel drain mast broke off the aircraft and the lower skin of the tail fairing received significant abrasion damage (Figure 1).

The lower forward fuselage sustained significant structural damage when the nose landing gear made contact with the runway after the aircraft pitched up. The left and right lower fuselage skins adjacent to the nose landing gear were deformed. Several fuselage frames were damaged in the lower forward fuselage, and there was deformation of both the left and right nose landing gear upper torque box structure due to the overload experienced during impact with the runway.

Figure 1. Rear fuselage damage (Source: Canadian Pacific Railway Company)

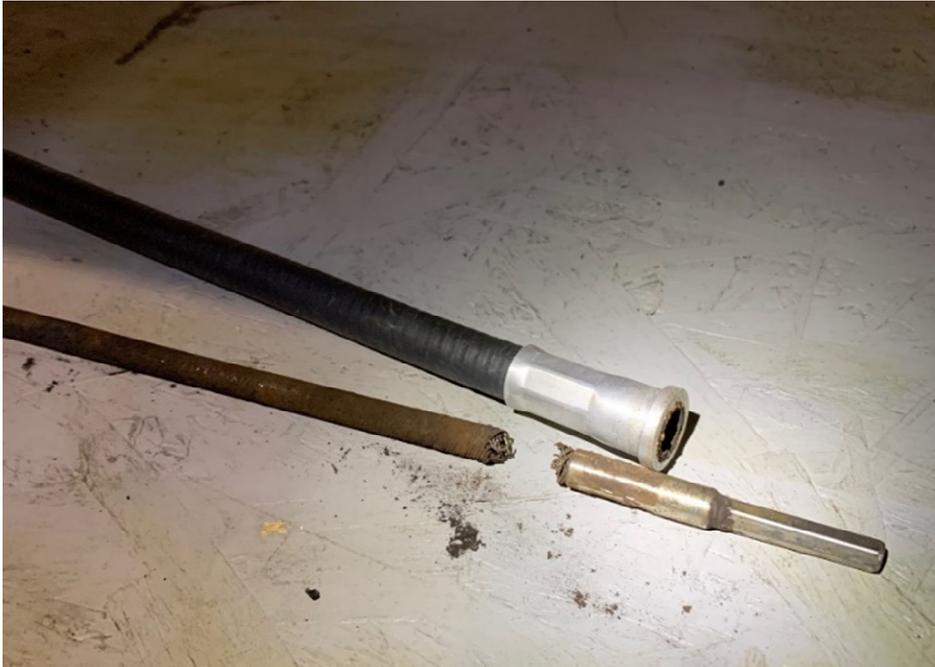
Figure 2. Occurrence aircraft's failed flap flexible drive shaft (Source: Canadian Pacific Railway Company)

The TSB Engineering Laboratory conducted a detailed examination of the part, which revealed 2 puncture holes in the protective outer casing under the data plate for the part. These holes were likely introduced as an unintended consequence during the manufacturing process of the drive shaft assembly, when the data plate was being installed. These holes would have allowed water moisture to enter the flap flexible drive shaft housing cavity, allowing corrosion to begin. In addition, both the inboard and outboard segments of the inner drive shaft showed significant corrosion and lack of lubrication.

Following the occurrence, the TSB Engineering Laboratory's detailed examination of the failed flap flexible drive shaft revealed 2 puncture holes in the protective outer casing under the data plate. These holes allowed the cavity to breathe with repeated changes in altitude, introducing contaminants and condensation that led to corrosion over time. Also likely contributing to the significant corrosion of the ends of the flexible drive shaft core, was moisture ingress into the drive shaft casing from the drive shaft to flap actuator interface.

Moisture entered the flap flexible drive shaft casing, likely through the undetected puncture holes and the drive shaft casing to flap actuator interface, which led to the subsequent corrosion and failure of the inner drive shaft.

As the occurrence aircraft's actual annual utilization was approximately half of that expected by the manufacturer, the calendar time interval between maintenance inspections increased. As a result, the corrosion that developed was not detected because the shaft had not yet reached the 2400 flight-hour maintenance interval.
