AIR TRANSPORTATION SAFETY INVESTIGATION REPORT A21C0052

LOSS OF CONTROL AND COLLISION WITH TERRAIN

Helicopter Transport Services (Canada) Inc.
Bell 214ST (helicopter), C-GDYZ
Nipigon, Ontario, 14 NM NE
07 June 2021

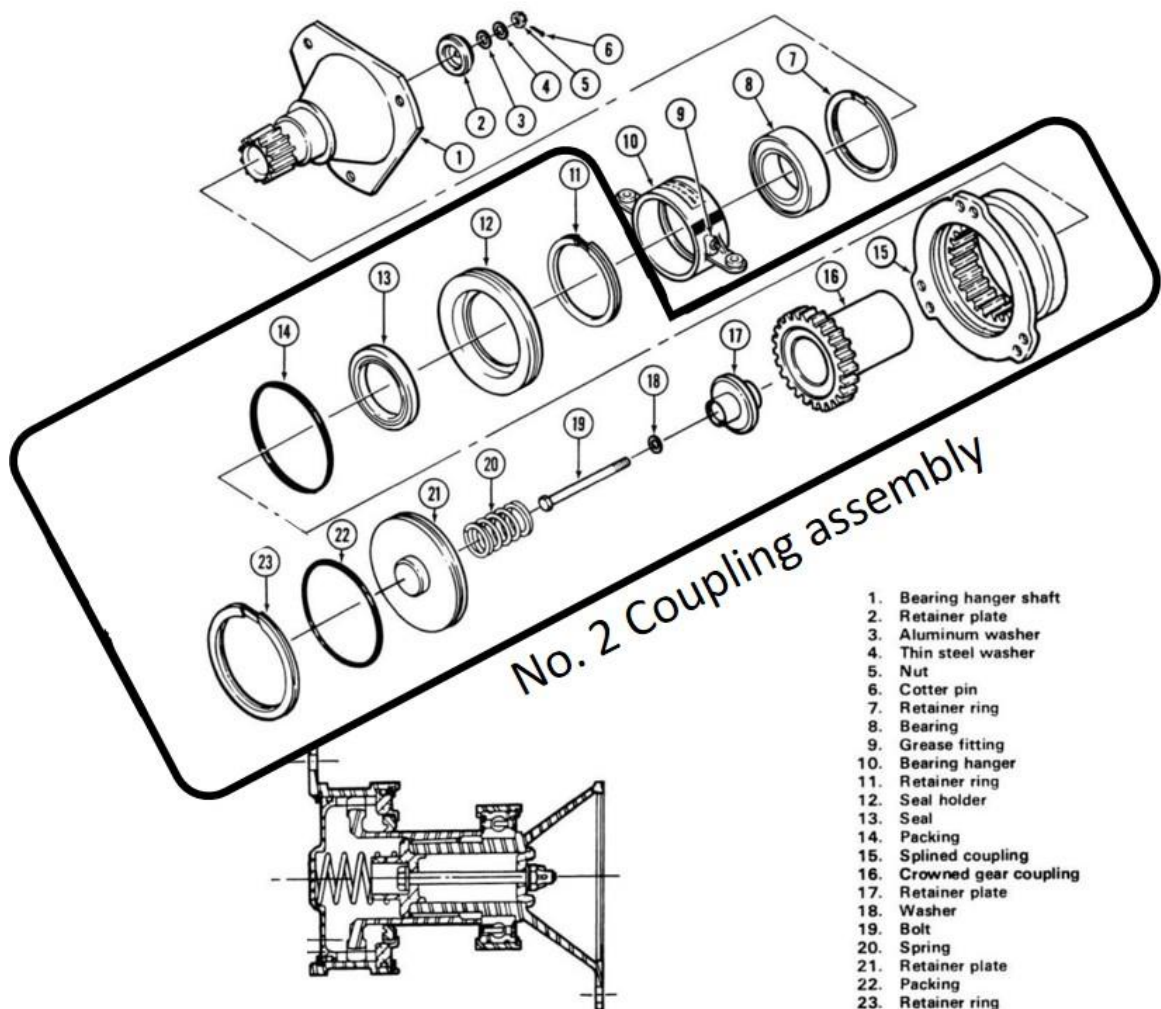
Figure 3. Exploded view of the engine-deck-mounted tail rotor driveshaft hanger (Source: Bell, with TSB annotations)

The splined coupling (Figure 3, item 15) on the aft end of the first driveshaft segment was found disconnected from the crowned gear coupling (Figure 3, item 16) of the engine-deck-mounted tail rotor driveshaft hanger. The first driveshaft segment exhibited rotational scoring as a result of flailing and consequent contact with components in the fuselage compartment.

A retainer ring (Figure 3, item 11), which should normally secure the seal holder (Figure 3, item 12) and crowned gear coupling within the splined coupling, was found lying loose in the fuselage compartment. The seal holder had exited the splined coupling and was loose on the shaft between the crowned gear coupling and the bearing hanger (Figure 3, item 10).

The retainer ring (Figure 3, item 11) is a spiral of approximately 690° made of flat spring steel that seats into a groove machined into the inner diameter of the splined coupling. The retainer ring secures the seal holder, and thus the crowned gear coupling, within the splined coupling.

The dimensions of the retainer ring groove were examined using a coordinate measuring machine, a digital comparator, and optical scanning at a manufacturer’s facility. According to specifications, the retainer ring groove in the splined coupling should be between 0.068 inch and 0.073 inch wide. The retainer ring was 0.062 inch thick. This would result in a free space from 0.006 inch to 0.011 inch between the retainer ring and the edge of the groove.

This suggests that a foreign object, or debris, thicker than 0.011 inch trapped between the spiral layers of the retainer ring could prevent the retainer ring from seating. However, an examination of the retainer ring could not determine whether a foreign object or debris had been trapped between the retainer ring layers.

For an undetermined reason, the retainer ring was dislodged from the splined coupling. Subsequent movement of the main rotor transmission resulted in axial movement of the driveshaft. The seal holder, and ultimately the crowned gear coupling, exited the splined coupling, at which point the tail rotor drivetrain separated. This resulted in the loss of tail rotor thrust, and consequently, yaw control was lost.

The investigation noted that, without the use of a visual inspection aid such as a mirror, or verification with a measuring device, inspection of the installed retainer ring (Figure 3, item 11) is hampered by the proximity of the bearing hanger (Figure 3, item 10).

The HTSC Bell 214ST daily inspection was amended to require the opening of an additional access panel to facilitate the inspection of the engine-deck-mounted tail rotor driveshaft hanger and the No. 2 coupling assembly.

As seen in this occurrence, the consequences of an incompletely seated retainer ring entering service can lead to a failure of the tail rotor drivetrain and consequent loss of tail rotor thrust. Therefore, since some components, such as a seated retainer ring, may be difficult to view, the use of visual inspection aids and measuring tools may be warranted during installation and subsequent DCC inspection.
