AIR TRANSPORTATION SAFETY INVESTIGATION REPORT A21O0085

LOSS OF CONTROL AND COLLISION WITH TERRAIN

Privately registered
Mooney M20J, C-FLJL
Sundridge/South River Airpark, Ontario
16 September 2021

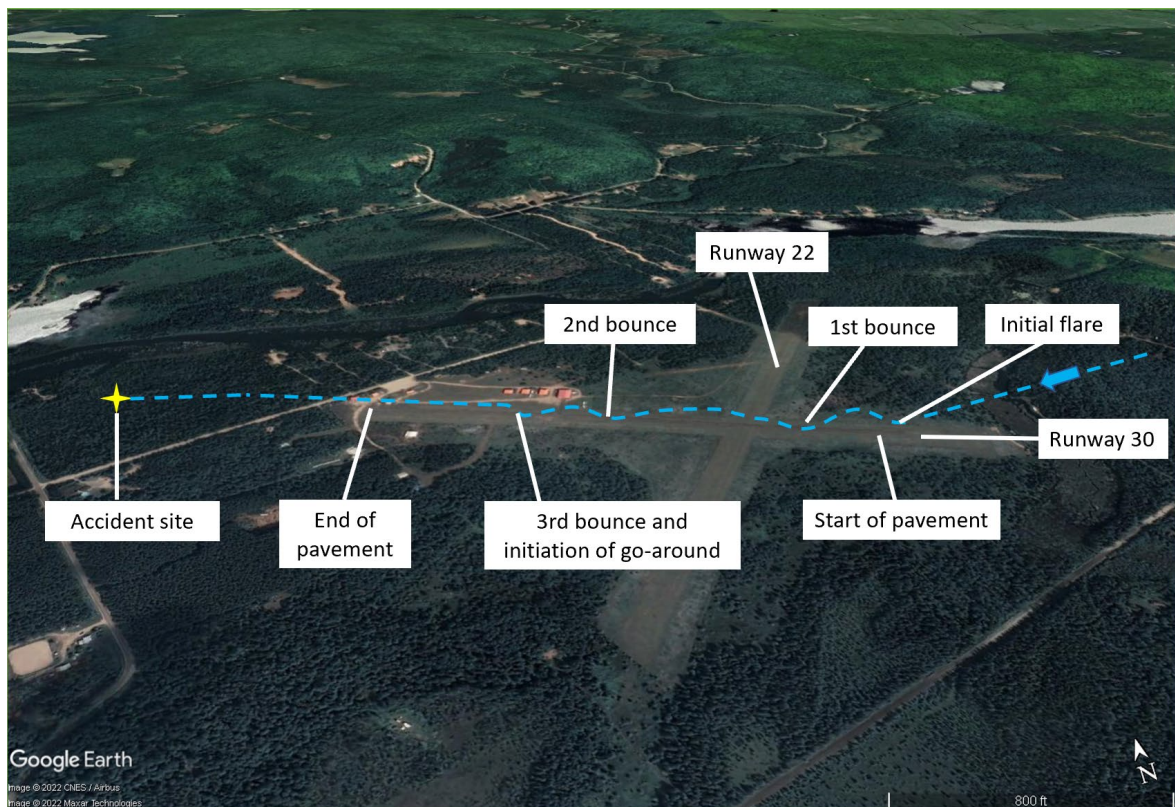
Observers who had aviation experience reported that during the latter stages of the final approach, the aircraft's nose-down pitch attitude increased, and its airspeed and rate of descent were faster than a normal approach for a Mooney M20J aircraft. During the initial flare, the aircraft ballooned into the air and then bounced 3 times on the runway surface (Figure 1).

During the 2nd bounce, the aircraft landed on its nose wheel and wheelbarrowed momentarily before becoming airborne. During the 3rd bounce, it was reported that the aircraft bounced approximately 15 feet into the air and appeared to have lost a significant amount of airspeed and momentum. At this point, approximately 700 feet of the runway remained.

The pilot initiated a go-around after the 3rd bounce and retracted the landing gear. As the aircraft slowly climbed and cleared some smaller trees located approximately 250 feet from the departure end of the runway, it was reported to be moving slowly and not accelerating. The aircraft then disappeared from view and, shortly afterwards, crashed into a wooded area located approximately 1300 feet from the end of Runway 30.

Figure 1. Map showing the accident sequence at Sundridge/South River Airpark, Ontario. All annotations related to the aircraft's operations are approximate. (Source: Google Earth, with TSB annotations)
