Air Transportation Safety Investigation Report A21P0001

LOSS OF CONTROL

Privately registered
Mooney M20F, C-GYGN
Vicinity of Upper Kananaskis Lake, Alberta
03 January 2021

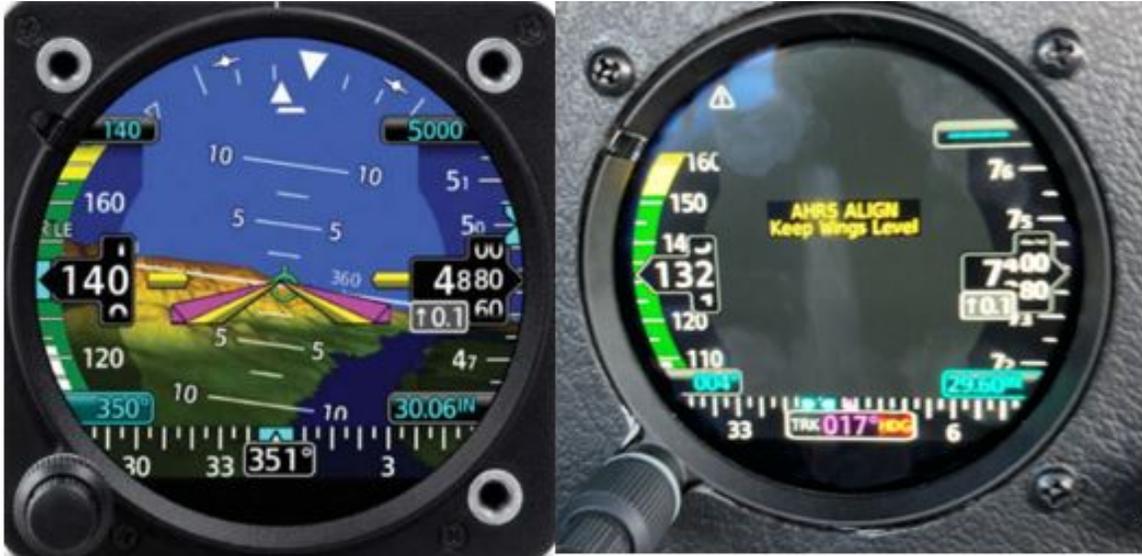
The pilot then requested a minor deviation from the route of flight to avoid entering clouds. However, during this deviation, the clouds could not be avoided, and the aircraft entered instrument meteorological conditions (IMC). Shortly thereafter, the aircraft's attitude direction indicator (ADI)³ displayed the "AHRS ALIGN" (attitude and heading reference system alignment) message, and indications of attitude (pitch and bank) were lost while indications of airspeed, altitude, and vertical speed were retained (Figure 1).

Figure 1. Garmin GI 275 multi-function instrument configured as an attitude direction indicator. Left image demonstrates a functioning attitude direction indicator (Source: Garmin, GI 275 Pilot's Guide, Revision C [2020], p. 175). Right image shows the occurrence aircraft's attitude direction indicator displaying the "AHRS ALIGN" message. (Source: aircraft owner)

the investigation by Garmin. Therefore, the exact source of the initial fault could not be determined. Nevertheless, based on the information that was available to the investigation, it was determined that the most likely cause of the AHRS ALIGN message on the primary ADI was either an uncommanded AHRS alignment that took place during the flight or a sensor fault within the AHRS that required the instrument to be realigned once the fault was resolved.

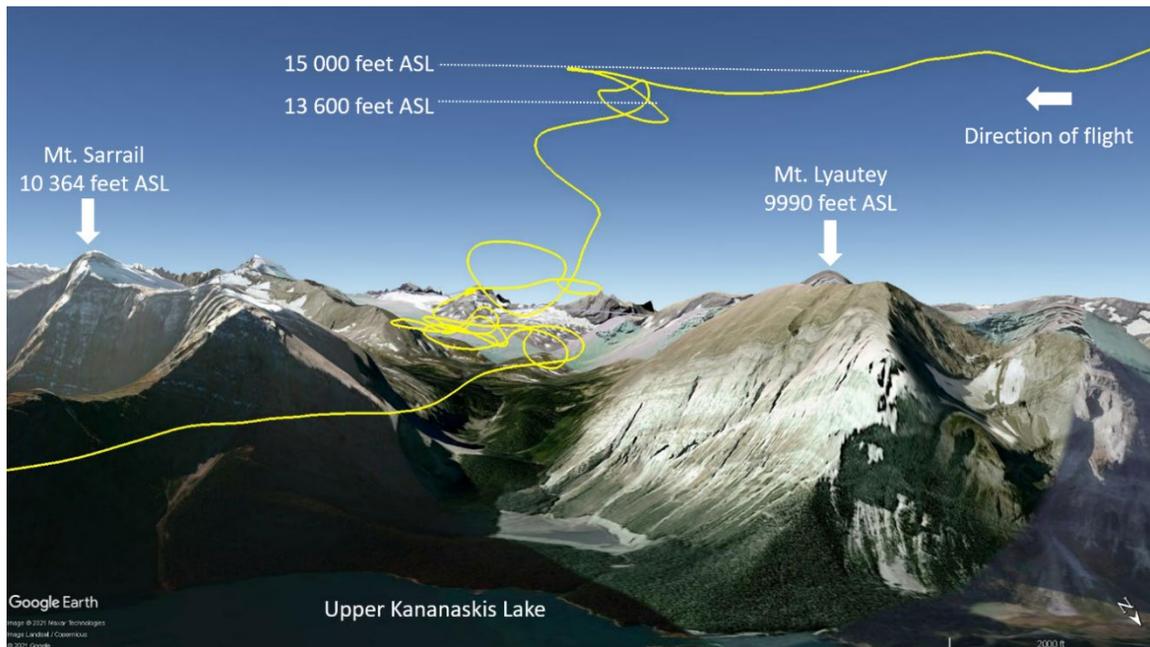
addition, the aircraft's airspeed varied from a low of 43 knots indicated airspeed (KIAS) to a high of 242 KIAS, exceeding the aircraft's never exceed speed by approximately 70 knots. The aircraft descended to as low as 8100 feet ASL (approximately 700 feet above ground level [AGL]) before abruptly climbing again.

The pilot was able to see the terrain below as the aircraft descended through approximately 8500 feet ASL and control of the aircraft was regained at approximately 8100 feet ASL. At the time, the aircraft was in the Kananaskis Valley, where nearby mountain peaks extended up to 10 364 feet ASL (Figure 2). Flight visibility at the time was approximately 1 statute mile (SM), and improved to 2–3 SM as the pilot descended to approximately 7500 feet ASL, while flying toward Upper Kananaskis Lake.

Figure 2. Aircraft's flight path during loss of control event derived from its global positioning system (Source: Google Earth, with TSB annotations)
