AIR TRANSPORTATION SAFETY INVESTIGATION REPORT A21W0001

COLLISION WITH TERRAIN

Privately registered
Robinson R44 Raven II (Helicopter), C-FBGT
Grande Prairie, Alberta, 39 NM NE
01 January 2021

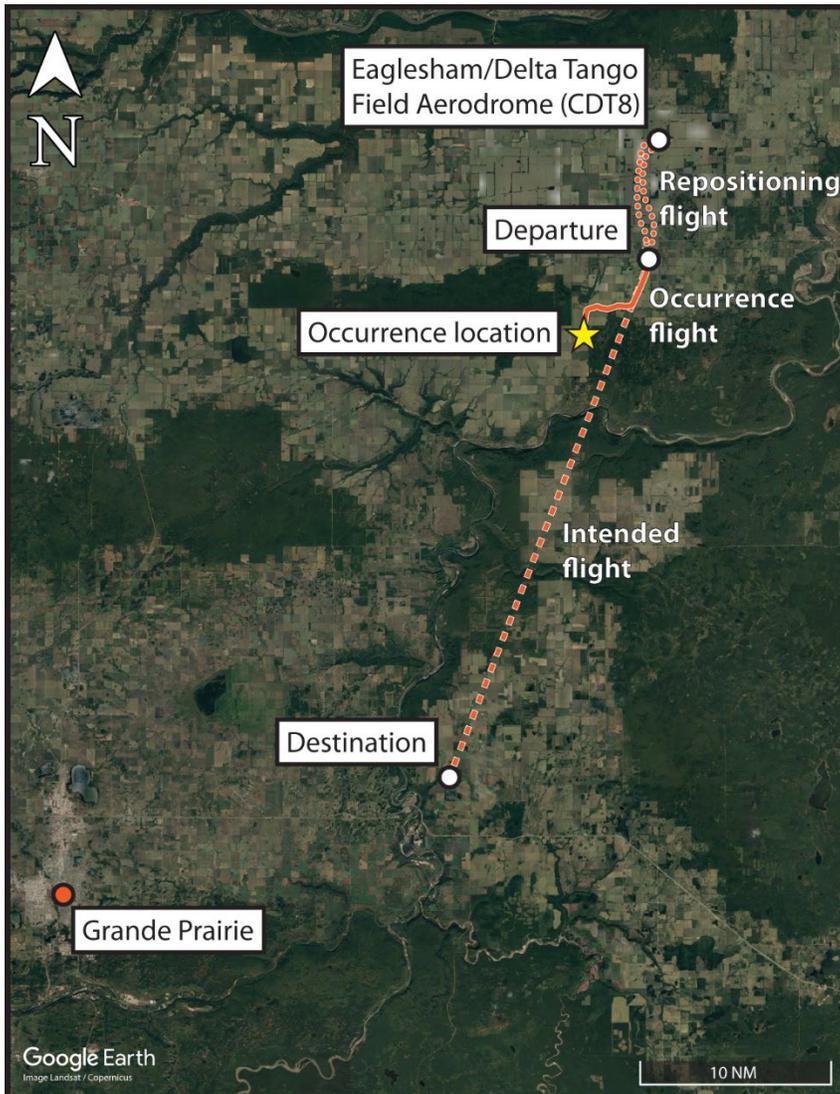
Figure 1. Map showing the repositioning flight (dotted line), the intended flight path (dashed line) and the actual flight path (solid line) (Source: Google Earth, with TSB annotations)

Upon departure, the helicopter initially flew on a direct track (approximately 204° magnetic [M]) to the destination for 2.45 NM. During this segment of the flight, the helicopter reached its highest altitude (2364 feet ASL). At 1943:43, the helicopter's track changed to the west, to approximately 270°M, for 2.3 NM. Between 1945:23 and 1945:52, the helicopter descended at a rate of up to 1049 fpm to an altitude of 2081 feet ASL. The ground elevation was 1970 feet ASL at this point. The helicopter then climbed back up to 2279 feet ASL. At 1946:40, the helicopter's track changed back to a south-southwest direction (approximately 188°M). At 1948:21, the helicopter began a 360° turn to the left. At this point, control of the helicopter was lost and, 8 seconds later, it collided with terrain.

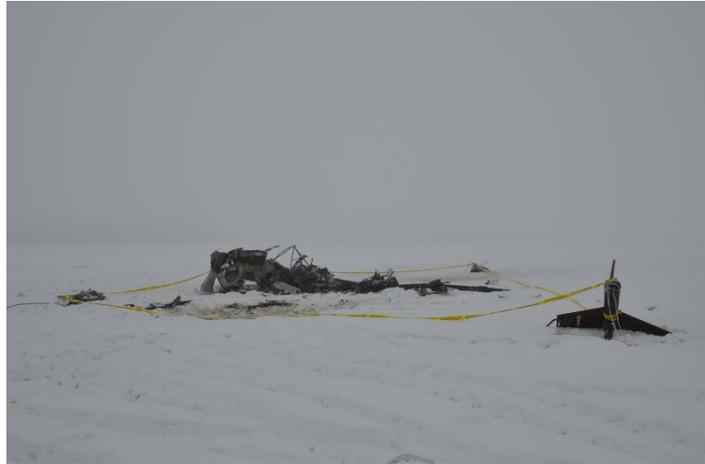
Figure 2. Photo of the occurrence site (Source: TSB)

The left side of the airframe sustained impact damage. The right fuel tank was consumed by the fire. The left fuel tank was located 25 feet from the main wreckage and contained approximately 10 U.S. gallons of fuel.

The engine had broken away from its mounts in the airframe, resulting in damage to the oil sump, accessory case, and associated components. Engine controls were severed during the impact sequence.

The main rotor severed the tail boom in front of the horizontal stabilizer during the impact sequence, which also severed the tail rotor drive shaft and tail rotor pitch control shaft. The main rotor transmission and mast had broken away from the airframe. The main rotor assembly was still mounted to the mast, and the mast to the transmission. The main rotor blades showed distortion from contact with the ground and the tail boom.

Ice was observed on the leading edge of one of the rotor blades. This ice was not consistent in shape and color with ice associated with in-flight icing. Water had been used by first responders to put out the post-impact fire.
