# AIR TRANSPORTATION SAFETY INVESTIGATION REPORT A21F0210

## **RUNWAY EXCURSION ON TAKEOFF AND IN-FLIGHT FUEL IMBALANCE RESULTING IN DIVERSION**

Mitsubishi Heavy Industries, Ltd. CL-600-2D24 (Regional Jet  
Series 900), C-GJZV

San Diego International Airport, California, United States

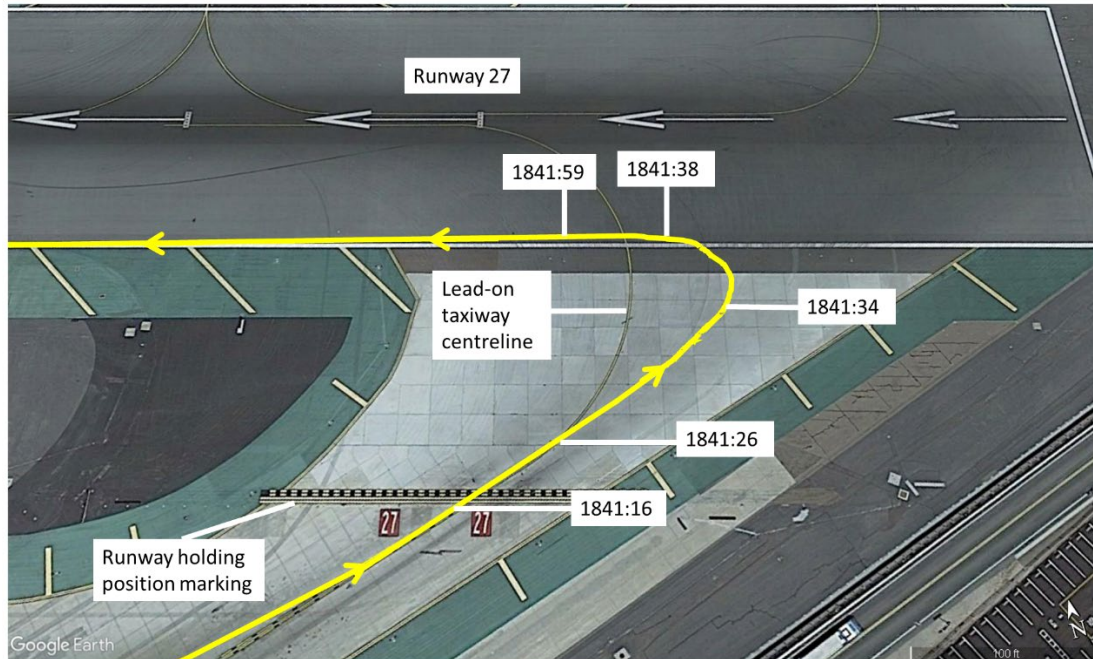
Figure 1. The occurrence aircraft's taxi route onto Runway 27, based on data from the flight data recorder (Source: Google Earth, with TSB annotations)

aircraft had turned onto the runway but was aligned with the left runway edge, unbeknownst to the flight crew. At 1841:53, the first officer read back the ATC take-off clearance and was then given control of the aircraft from the captain. The first officer assumed the role of pilot flying (PF), and the captain took on the role of pilot monitoring (PM). At 1841:59, the PF advanced the aircraft power levers and began the take-off roll approximately 1500 feet before the displaced threshold of Runway 27.

During the take-off roll, the wheels on the aircraft's left main landing gear struck and damaged 3 consecutive runway edge lights. The flight crew heard sounds and felt vibrations, but they thought they were rolling over embedded runway centreline lights and were thus unaware of the contact with the runway edge lights. Around this time, the PF visually identified the misalignment with the runway and began to correct toward the runway centreline. As the aircraft crossed the runway's displaced threshold, its lateral position on the runway had moved approximately 40 feet to the right (closer to the runway centreline). When the aircraft began to rotate, approximately 4650 feet from the point at which it had begun the take-off roll, it remained about 40 feet to the left of the runway centreline. At no point did the aircraft reach the centreline.
