Air Transportation Safety Investigation Report A21Q0007

LOSS OF CONTROL AND COLLISION WITH TERRAIN

Wag-A-Bond (amateur-built aircraft), C-GKGX
Barron Lake, Gore, Quebec
03 March 2021

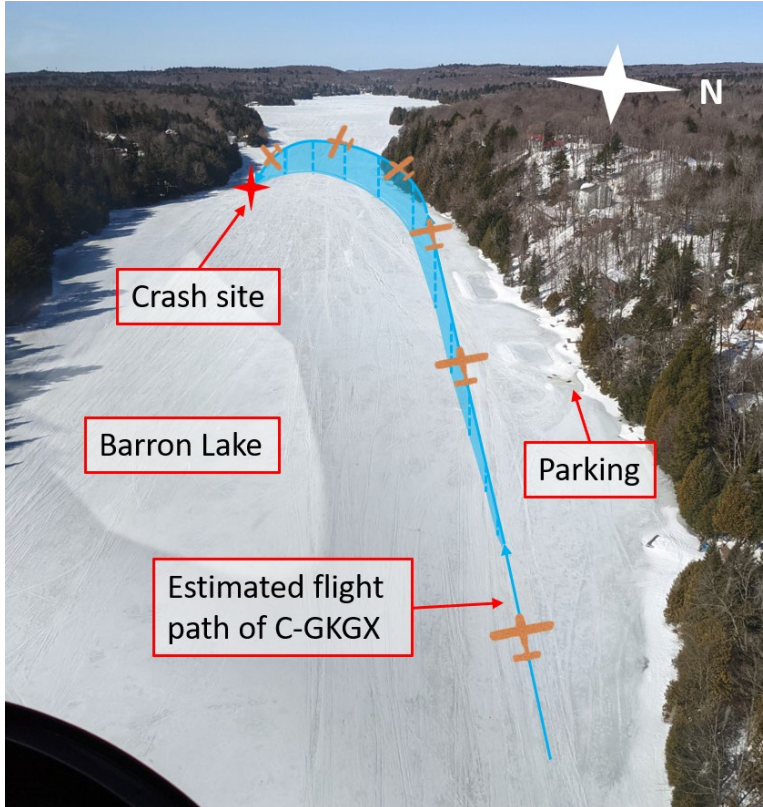
When the aircraft took off from the frozen surface of the lake, westbound, the flaps were set to 40°.² The aircraft climbed to nearly 50 feet above ground level (AGL), close to the north shore of the lake, and began turning left with the flaps still at 40°.³ The aircraft entered a spin to the left and struck the surface of the lake in a near-vertical attitude, with the left wing contacting the surface first (Figure 1).⁴

Figure 1. Estimated flight path of the occurrence aircraft (Source: TSB)

In the occurrence flight, the higher drag caused by the flaps being set to 40° limited the aircraft's speed during the climb. The engine torque at full power caused the aircraft to roll to the left; the slipstream on the stabilizer and rudder caused the aircraft to yaw to the left. When the pilot began a

low-speed left turn by applying the controls and left pedal, it is likely that the aircraft stalled, sending it into an incipient spin. With the aircraft at approximately 50 feet AGL when control was lost, it was not high enough for the pilot to avoid collision with the frozen surface of the lake.

In this occurrence, having the flaps at their maximum setting (40°) limited acceleration during the initial climb. When flying at a slow speed, especially during the initial climb after takeoff, pilots must watch for any warning signs that a stall is imminent and exercise caution in handling flight controls to avoid a stall and an incipient spin, and potentially impact with the ground.

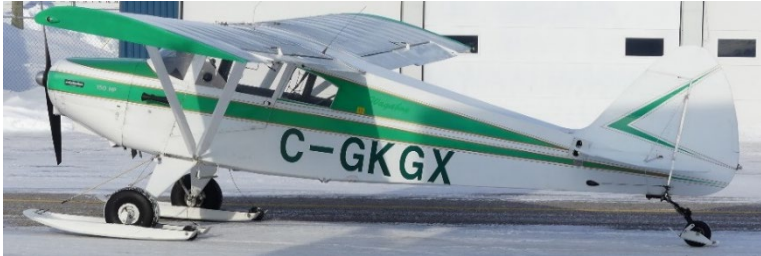
The Wag-A-Bond is an amateur-built aircraft. The occurrence aircraft was built in 2011. It received a special certificate of airworthiness⁵ on 15 November 2012. The aircraft was equipped with wheels and skis (Figure 2).

Figure 2. Photo of the occurrence aircraft (Source: Aircraft co-owner)

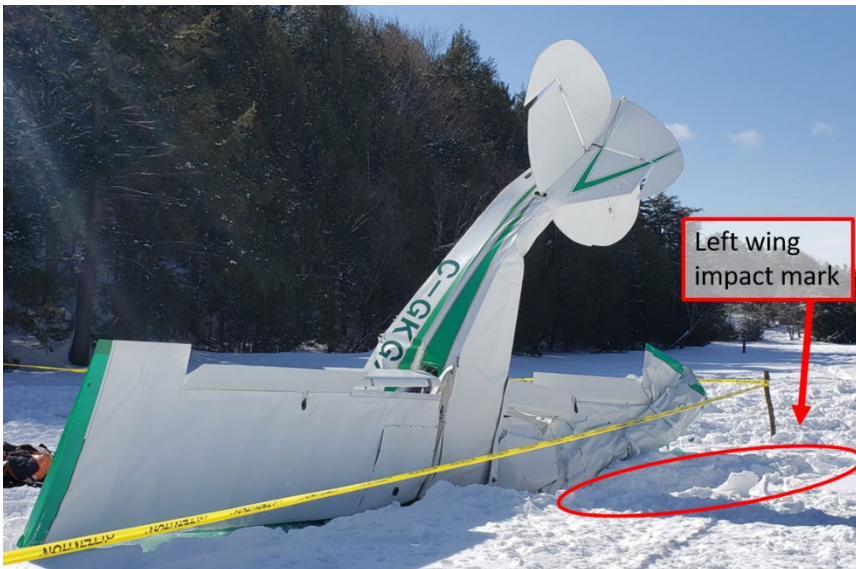
Figure 3. Photo of the wreckage (Source: TSB)

The aircraft struck the frozen surface of the lake at a near-vertical angle and came to rest in that position at the point of impact. Marks in the snow indicated that the left wing had contacted the surface first, followed by the nose of the aircraft (Figure 3). The fuel tanks, located in the wings, were damaged, causing a small fuel spill.

The wings had partially separated from the fuselage, but the cables controlling the ailerons were under tension and still attached to the cabin. The cable and pulley system that controls the elevators and rudder was checked to the extent possible: when the cables below the fuselage were pulled, the elevators and rudder moved freely. The control column and connecting cables were torn off by the impact forces. Damage to the wings and structure was the result of impact forces and the work of the first responders.

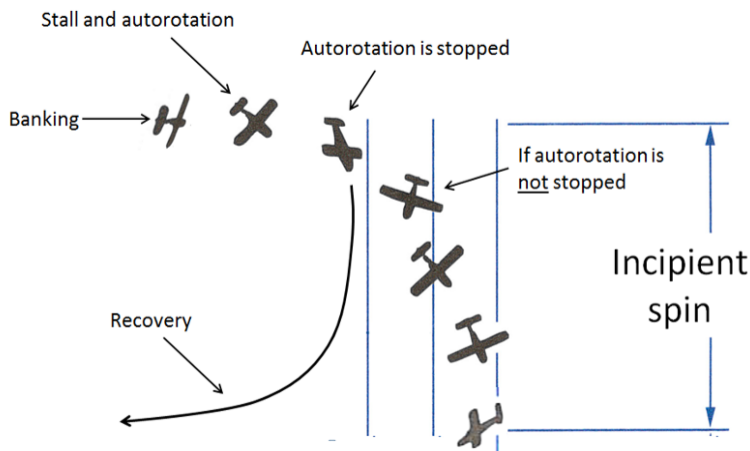
Stall speed varies depending on factors such as the aircraft's weight, power setting, flap position, and angle of bank. An incipient spin occurs when an aircraft stalls and one wing produces more lift than the other. Because the descending wing is at a greater angle of attack, it stalls even further and produces more drag, which triggers an autorotation. During this phase of the incipient spin, the flight path changes from horizontal to vertical.⁷

Generally, even if the pilot takes the necessary measures to stop the autorotation as soon as it begins, the aircraft is in a vertical position while accelerating rapidly, and a high altitude is necessary to regain a horizontal flight path. If the autorotation continues, the aircraft could stabilize in a spin and follow a spiral path downward (Figure 4).

Figure 4. Incipient spin (Source: TSB, based on Transport Canada, TP 1102, Flight Training Manual, 4th Edition [revised 2004], Figure 2-31)
