AIR TRANSPORTATION SAFETY INVESTIGATION REPORT A21Q0083

Loss of control and collision with terrain

Privately registered
Piper J3C-65 (floatplane), CF-SVT
La Tuque Aerodrome, Quebec, 25 NM ENE
12 September 2021

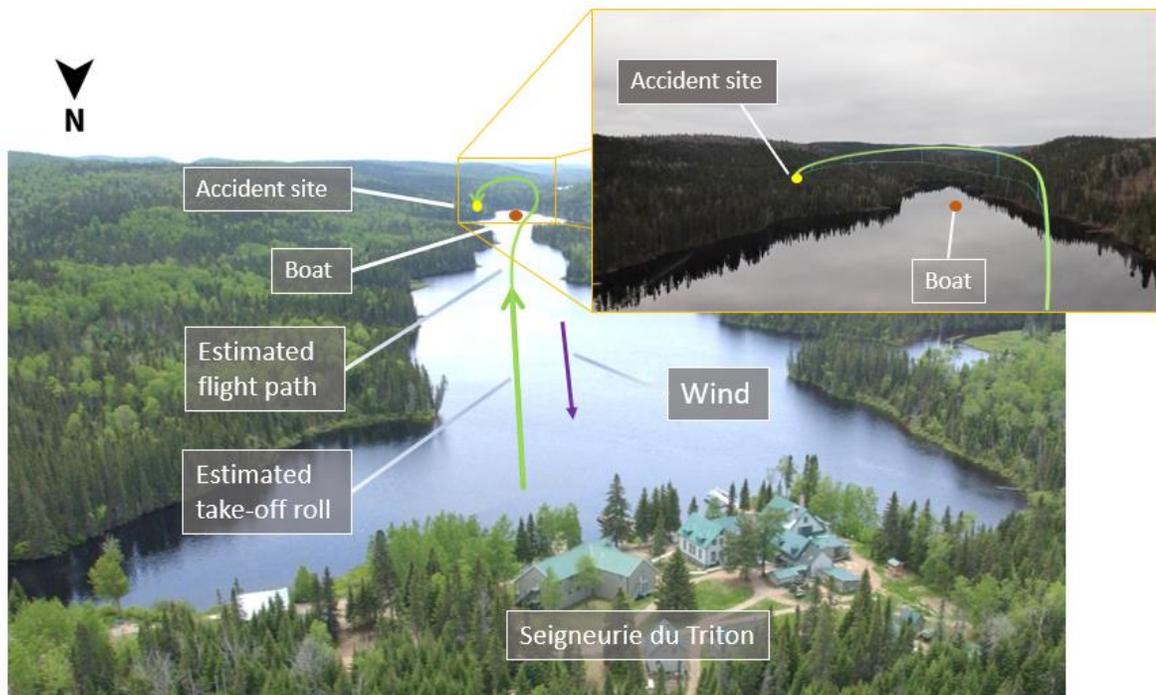
After a southbound takeoff, the floatplane flew near the surface of the water (in ground effect²) to reach the target climb speed of 70 mph more quickly. At approximately 4300 feet from the point of departure, the floatplane, still in ground effect, banked right to avoid flying over a boat. Approximately 2000 feet further (i.e. approximately 6300 feet from the point of departure), it climbed slightly to approximately 100 feet above the river and began a 180° left turn toward rising terrain (Figure 1). During the left turn, at a 45° bank angle,³ its speed and altitude decreased. The pilot lost control of the floatplane when it entered an aerodynamic stall, leading to an incipient spin. The floatplane struck trees, then terrain in a vertical attitude.

Figure 1. Aerial photos illustrating the occurrence aircraft's estimated flight path (Source of main image and inset image: TSB)

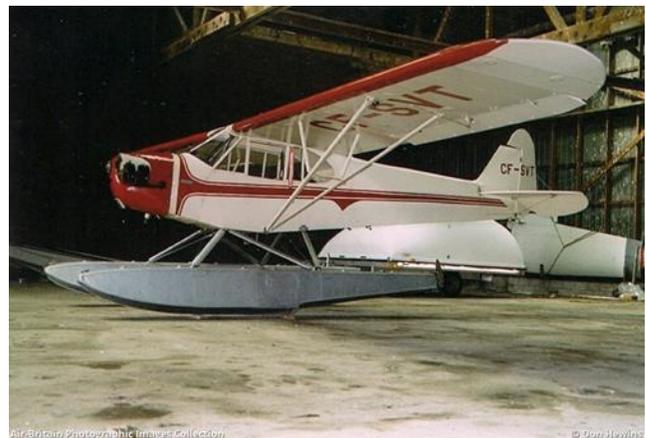
The occurrence Piper Cub J3C-65 was manufactured in 1945 (Figure 2). It had a valid certificate of airworthiness⁴ (A691 – Normal) and was equipped with a Teledyne Continental 90-hp C-90-12F engine. It had accumulated 3862.5 flight hours since it was manufactured and had no known deficiencies before the occurrence flight.

The aircraft was equipped with EDO 60-1320 floats and had a maximum allowable take-off weight of 1300 pounds. The weight and balance calculation performed as part of this investigation determined that the aircraft's take-off weight was 1367 pounds for the occurrence flight. Wing loading⁵ increases as the aircraft's weight increases, which in turn increases the stall speed and reduces aircraft performance during a climb.

Figure 2. Photo of the occurrence aircraft
(Source: Don Hewins)
