# AIR TRANSPORTATION SAFETY INVESTIGATION REPORT A22O0060

## **Loss of control and collision with terrain**

Diamond Aircraft Sales USA Inc.  
Diamond Aircraft Industries GmbH DA 42 NG, N591ER  
London Airport, Ontario  
25 May 2022

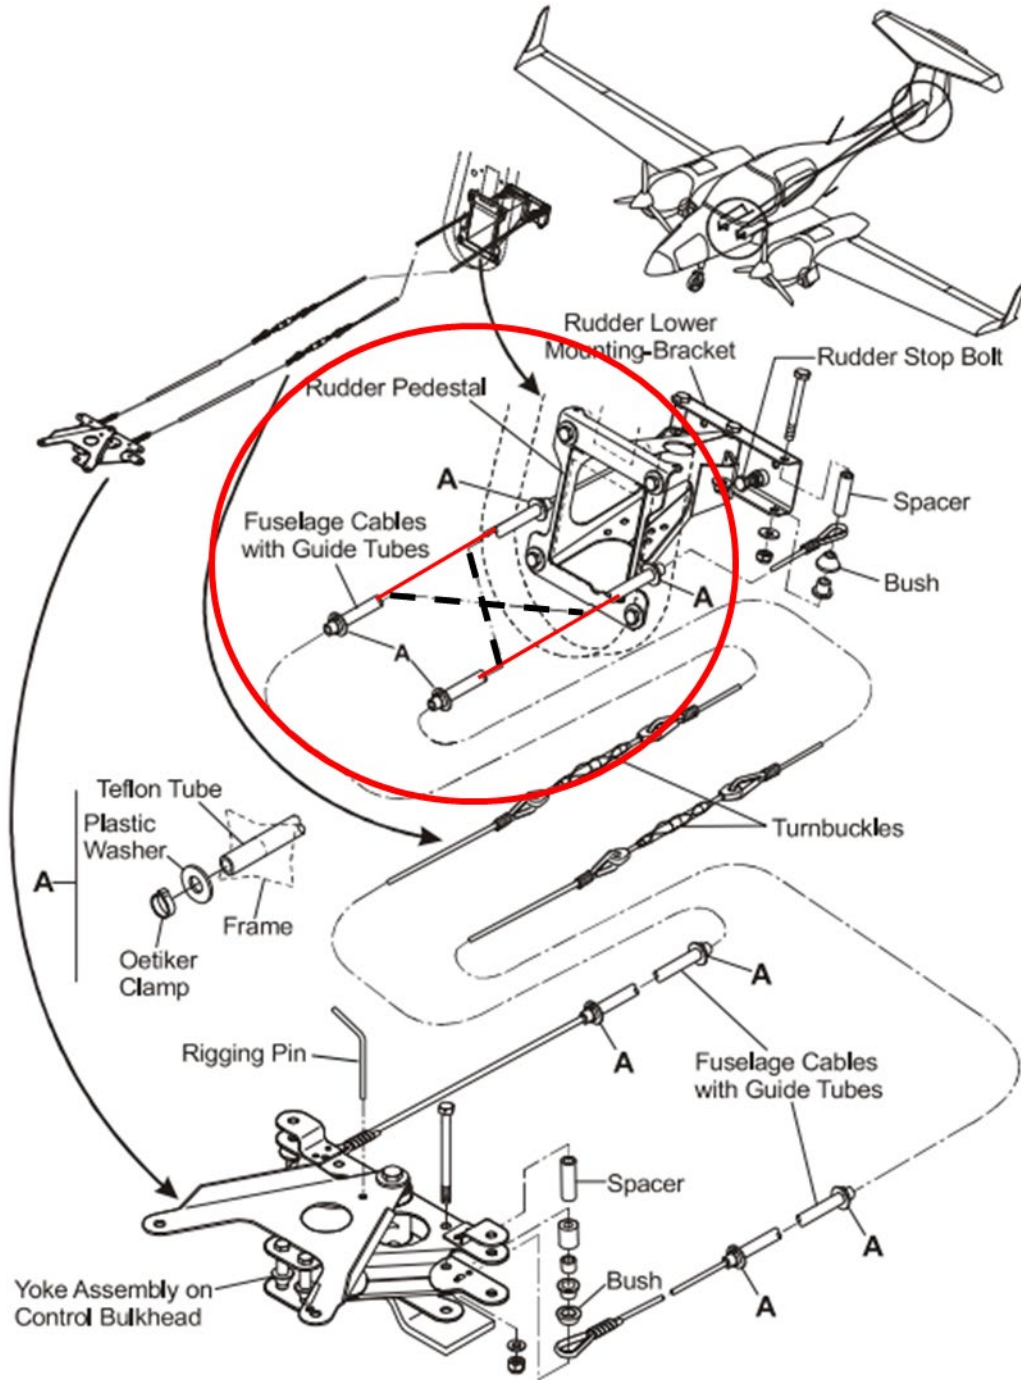
Following the occurrence, TSB investigators examined the aircraft at the Diamond Aircraft Industries Inc.'s facilities at CYXU and observed that the rudder cable guide tubes<sup>4</sup> had been installed incorrectly.

This configuration ensures the correct fuselage cable routing to the rudder so that the left rudder pedal controls the left rudder deflection, and the right rudder pedal controls the right rudder deflection. However, in this occurrence, the guide tubes were installed straight through, not crossed over. Consequently, pressing the right rudder resulted in a rudder deflection to the left, and vice versa. The improper cable routing did not affect the nose wheel steering system, which uses its own linkages attached to the rudder yoke assembly.

Figure 2. Rudder controls in the fuselage, with location of crossing guide tubes circled. The solid red lines in the circle indicate the actual installation (cables not crossed), while the dashed lines indicate the proper installation (cables crossing over). (Source: Diamond Aircraft Industries GmbH, DA 42 NG Airplane Maintenance Manual, Revision 5 [22 December 2021], Section 27-20: Flight Controls - Rudder, p. 9, with TSB annotations)

In this occurrence, the pilot experienced difficulties controlling the aircraft immediately after takeoff. Through the investigation, it was observed that the rudder cable guide tubes had been installed parallel to each other instead of crossing over each other and, as a result, the rudder cables moved the rudder in the opposite direction to pilot input.
