# AIR TRANSPORTATION SAFETY INVESTIGATION REPORT A22Q0116

## IN-FLIGHT SEPARATION OF LEFT WING

Privately registered  
Wag-Aero Sportsman 2+2 (amateur-built floatplane), C-FFDA  
Rivière Bonnard Aerodrome, Quebec, 13 NM WSW  
23 September 2022

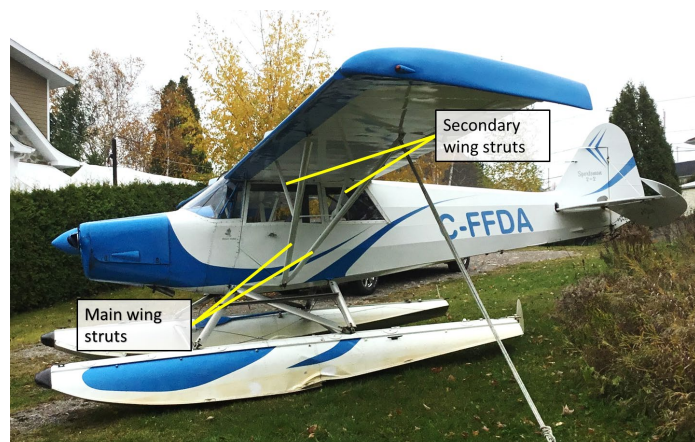
Figure 1. Occurrence aircraft (Source: aircraft owner, with TSB annotations)

The floatplane was equipped with a 200 hp Avco Lycoming IO-360-A1B6 engine (serial number L-59367A). Each wing was supported by 2 main wing struts and 2 secondary wing struts (Figure 1).

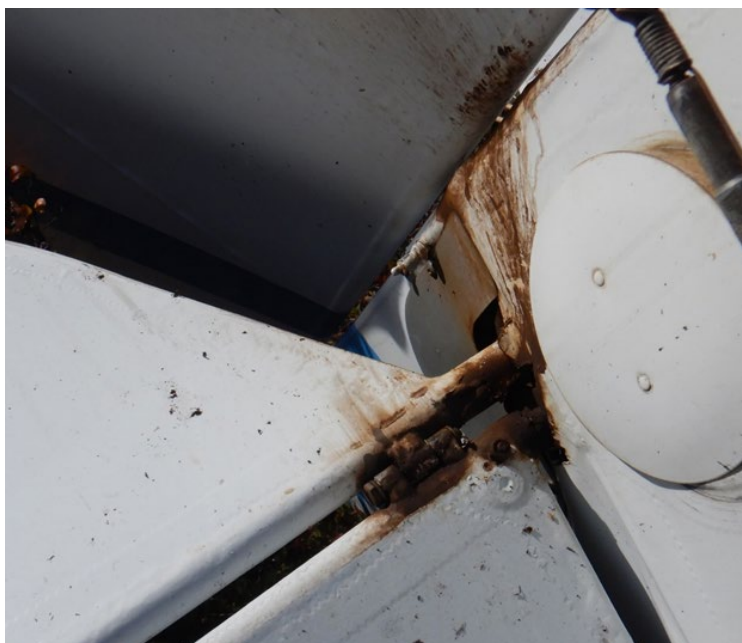
**Figure 2. Example of corrosion seen on the occurrence aircraft's tail**  
(Source: TSB)

The floatplane wreckage came to rest inverted. Damage to the floats and the engine was symmetrical, a sign that the aircraft was not rolling when it struck the ground. The right wing severed a small tree. The distance between this tree and the wreckage suggests a nose-down angle of approximately 60° when the aircraft struck the ground. As with the left wing, nearly all of the attachment points, hinges, and flight controls linkages on the right wing, as well as on the aircraft's tail, showed significant signs of corrosion (Figure 2).

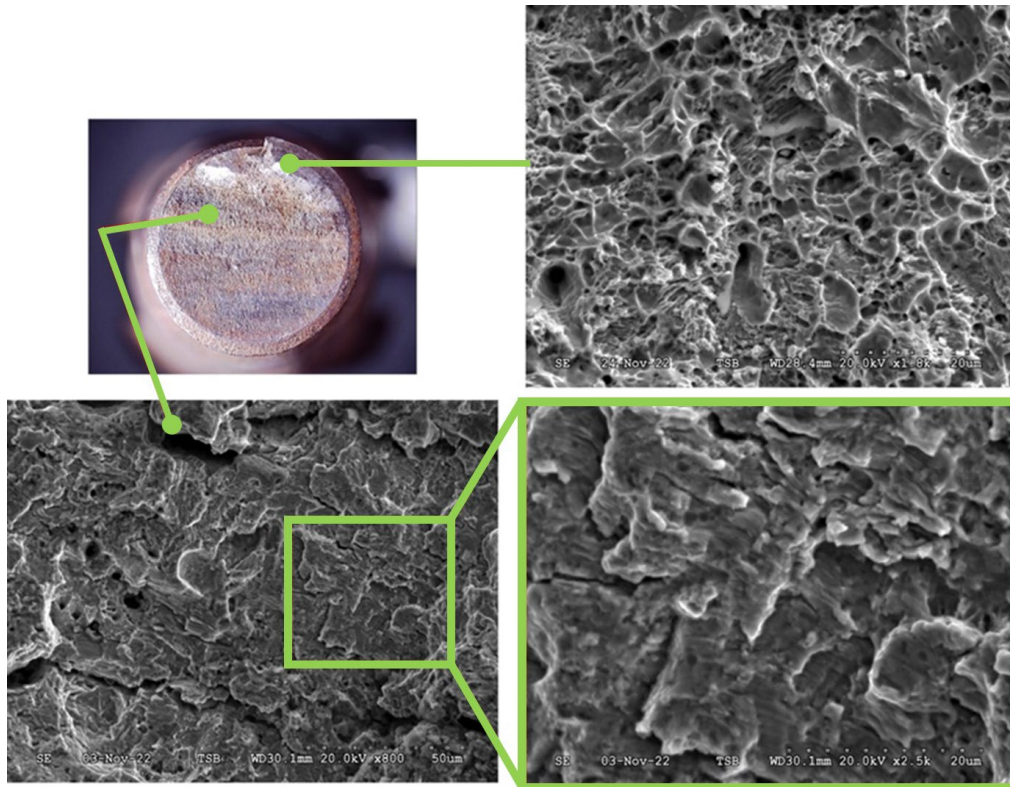
The forward left clevis was examined using a macroscope<sup>3</sup> and most of the fracture surface was found to be flat with beachmarks except for a small portion at the end, which was raised and textured (Figure 3, top left image). The clevis was then examined with a scanning electron microscope.<sup>4</sup> The flat portion of the fracture surface was found to be heavily obliterated, although

some striations and secondary cracking (indicative of fatigue) were observed (Figure 3, lower images). No crack initiation sites were found. The raised and textured area observed macroscopically consisted of ductile dimples (Figure 3, top right image), which is indicative of ductile overload.

Figure 3. Fracture surface of the forward left clevis (top left image), ductile dimples (top right) and micrographs showing striations and secondary cracks (lower images) (Source: TSB)

The failure of the forward left clevis likely caused the aft left clevis to fail in overload, which in turn caused the separation of the left wing. An irreversible loss of control then occurred, followed by the collision with the terrain.

It is important that owners of amateur-built or owner-maintained aircraft ensure that maintenance work is carried out in accordance with the manufacturer's recommendations or, in the absence of such recommendations, in accordance with equivalent maintenance practices, such as those described in FAA AC 43-13.
