Marine Transportation Safety Investigation Report M17C0205

LOSS OF POWER AND SUBSEQUENT GROUNDING

Chemical product carrier *Bro Anna*
Beauharnois, Quebec
29 August 2017

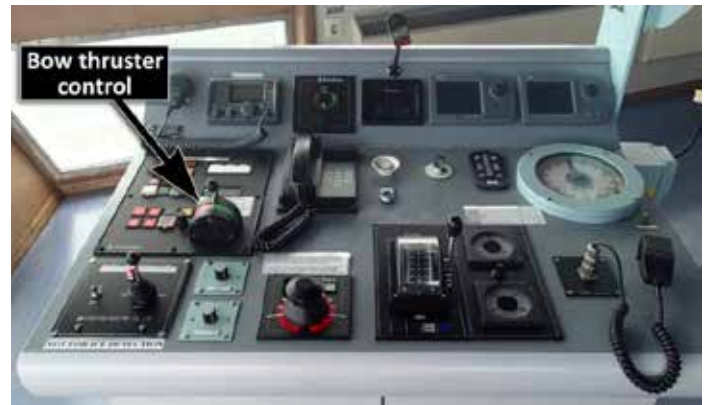
Figure 2. Port conning station showing location of bow thruster control

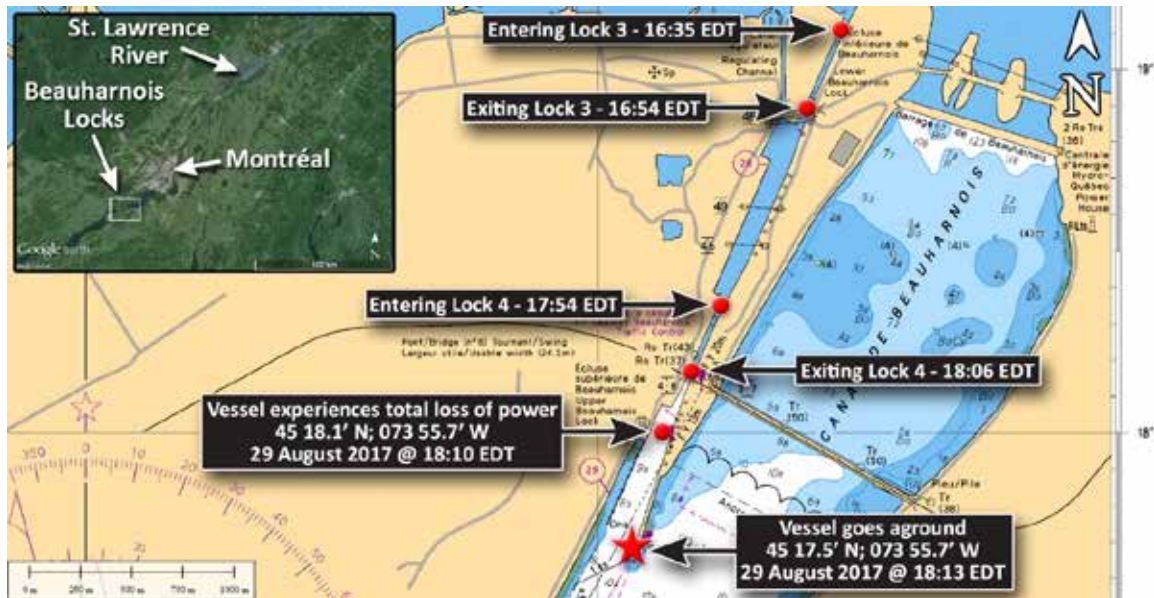
At 1813, the vessel made contact with the breakwater on the south side of the Beauharnois Canal and subsequently ran aground (Figure 3). The vessel's speed at the time of the grounding was estimated at 4.7 knots.

Figure 3. Vessel's progress through the locks until the time of the grounding (Source: Canadian Hydrographic Service and Google Earth, with TSB annotations)
