MARINE TRANSPORTATION SAFETY INVESTIGATION REPORT M18P0257

CREW FALL OVERBOARD FROM RESCUE BOAT

Roll-on/roll-off passenger ferry *Spirit of Vancouver Island*
Swartz Bay, North Saanich, British Columbia
31 August 2018

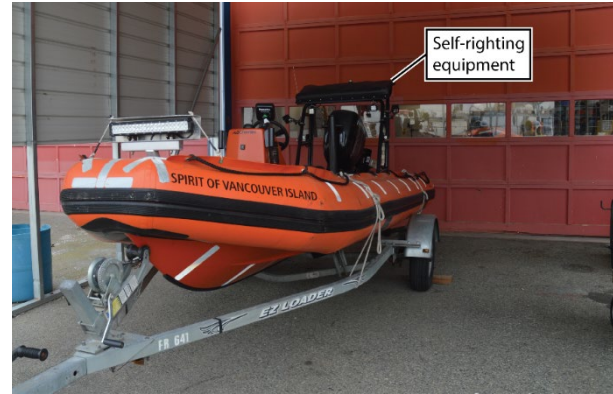
Figure 3. Rescue boat No. 1 with self-righting equipment at the stern (Source: TSB)

In 2016, the vessel’s original rescue boats No. 1 and No. 2 reached the end of their useful lives and were replaced with a new type of rescue boat. Their respective rescue station davits and cradles were not replaced. The original rescue boats were a flat-type rescue boat without self-righting equipment; the new rescue boats are of a different type, with a greater height due to the boats’ self-righting equipment located at the stern (Figure 3).

BC Ferries and the installer did not conduct a risk assessment to examine the impact of the new rescue boats on the stations’ original equipment and on the crews’ rescue boat operating procedures.

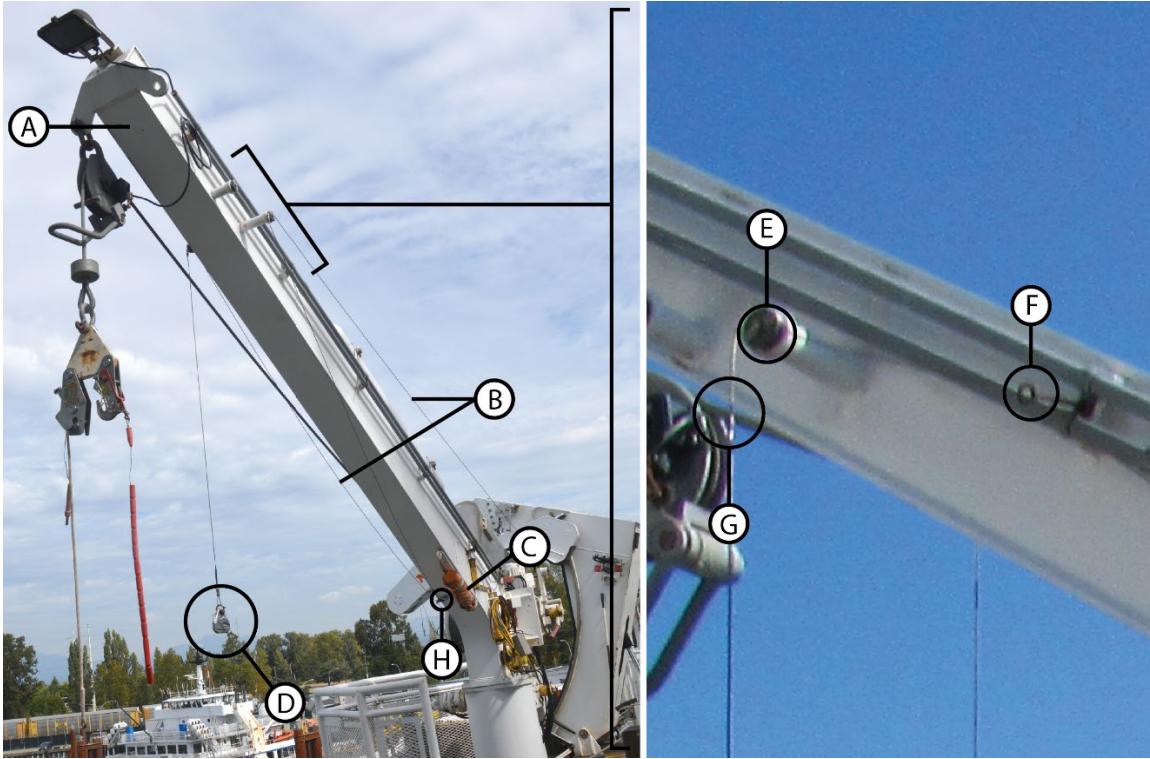
Figure 4. Davit for rescue boat No. 1 on the Spirit of Vancouver Island (Source: TSB)

On board the *Spirit of Vancouver Island*, when a davit operator uses a davit to lower a rescue boat, a crew member (usually a deckhand) coils and stores the brake release line in an orange brake release line bag. Before the rescue boats were replaced with the type used in this occurrence, crew stored each boat's brake release line and bag under its respective davit arm, as shown in Figure 4.

When the vessel's new rescue boats were installed, crew noticed that the brake release line on each davit was sagging along its davit arm. An eye bolt manufactured by a company other than the original equipment manufacturer was installed on each davit arm to run the brake release line through and reduce sag. There is no record that this modification was approved by the original equipment manufacturer.⁴ The brake release line stopper⁵ on davit No. 1 was not moved closer to the topmost sheave to accommodate the new rescue boat's greater height.

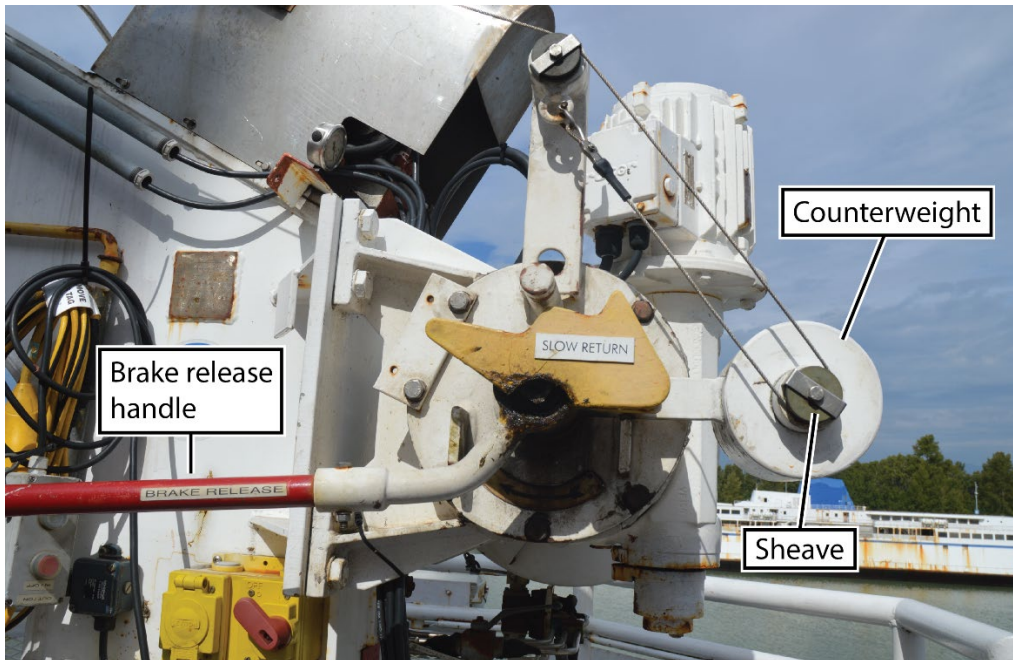
Figure 5. Photo of davit brake release mechanism, showing the counterweight, the sheave, and the brake release handle (Source: TSB)

When the rescue boat is launched with a davit operator, the davit operator is positioned at the davit and slews the davit using the davit's slewing control. The operator then releases the davit's brake by manually raising the counterweight, or by pulling down on the davit brake release handle, which in turn raises the counterweight and releases the brake (Figure 5).

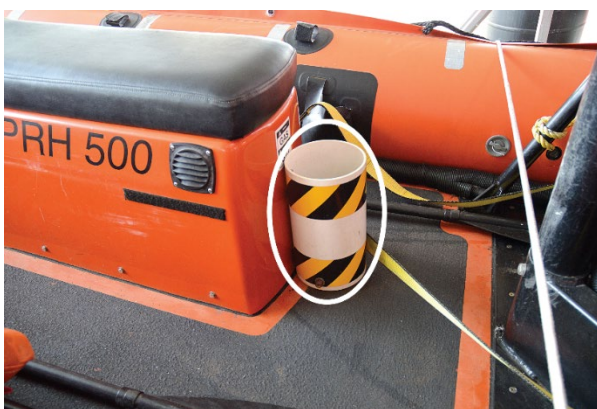
Figure 6. Cylindrical container for brake release line and bag stowage (Source: TSB)

During a drill conducted in May 2017, 15 months before the occurrence, rescue boat No. 2's brake release line was sagging from its davit arm and became tangled on one of the rescue boat's stern lights. Following this incident, BC Ferries conducted an internal review. On 12 June 2017, the *Spirit of Vancouver Island's* senior master issued a directive to crew stating that the brake release lines were to be deployed (i.e., dropped into the water and allowed to float freely beside the rescue boat) every time a rescue boat was lowered to water level, and that crew should not stow brake release lines and bags on davit arms. Crew then made cylindrical containers (Figure 6) to stow the brake release lines and bags on rescue boats No. 1 and No. 2 when the rescue boats were in their stowed position; these containers were fitted to the back of a bench where the coxswain usually sits in each boat. Crew moved the brake release lines and bags for davits No. 1 and No. 2 to those containers.

Several months after the brake release lines and bags were relocated to these cylindrical containers, another incident occurred during a drill where the brake release line for rescue boat station No. 1 was deployed to the water and became tangled with rescue boat No. 1's propeller. To prevent a recurrence of this incident, some members of the crew developed an informal and undocumented practice of not deploying rescue boat No. 1's brake release line to the water, and instead passing the line and the bag from the rescue boat to an officer on deck when a rescue boat was launched with a davit operator. When an officer was not at a

rescue boat station to receive the line and bag, crew left the line and bag on the vessel's deck. Crew did not inform vessel management of this practice or of the incident that led to the practice.

Similarly, neither BC Ferries nor the *Spirit of Vancouver Island's* senior management conducted an assessment to identify the potential hazards of moving the brake release line bags for rescue boat stations No. 1 and No. 2 from under the davit arms to the cylindrical containers in the rescue boats, which differs from the davit manufacturer's original stowage location under the davit arm. This move required crew to deploy the brake release line bag of rescue boat No. 1 and No. 2 every time the boats were lowered to the water, increasing the risk of the brake release line becoming entangled in one of the boat's propellers, as occurred with rescue boat No. 1 during a drill.

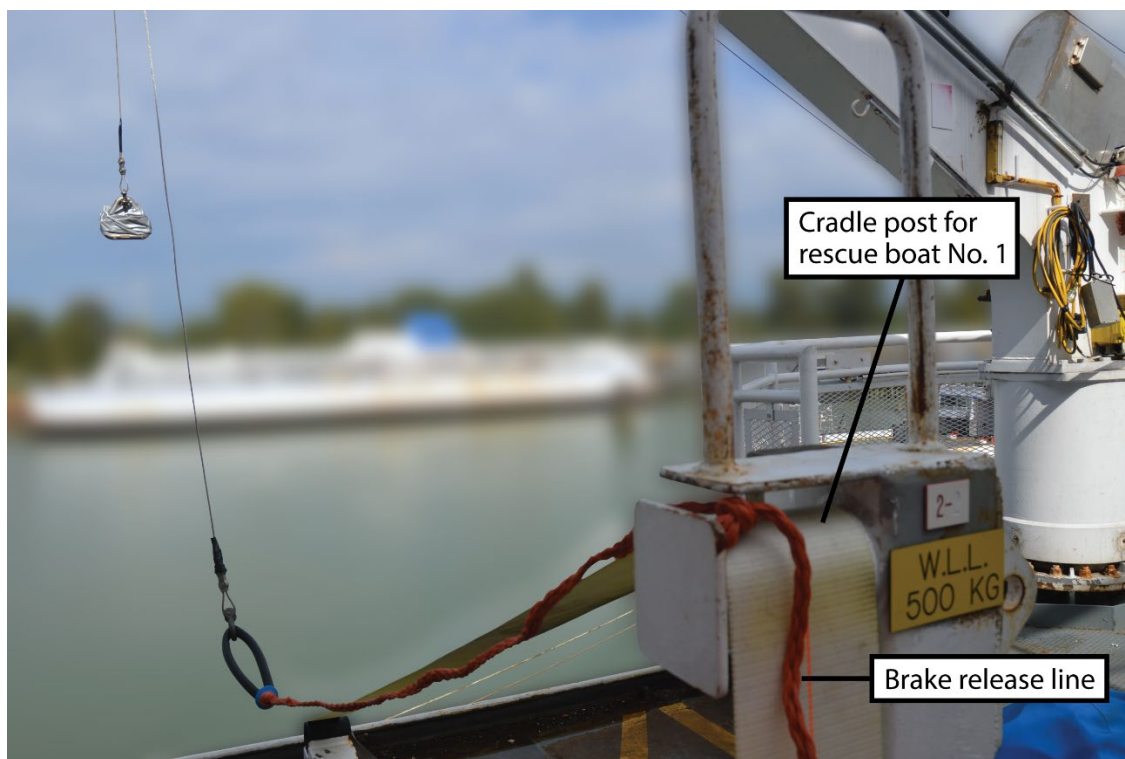
Figure 7. Brake release line snagged on the cradle post for rescue boat No. 1 (Source: TSB)

The coxswain and bowman each donned the required personal protective equipment, boarded rescue boat No. 1, and placed the brake release line bag on deck 6. The coxswain and bowman completed BC Ferries' In the Boat Checklist, and then signalled the davit operator to raise the boat. Using the davit's controls, the davit operator began raising the rescue boat from its cradle. At this time, the master arrived at rescue boat station and observed the rescue boat being raised. With sufficient clearance from the cradle, the coxswain pulled the self-slewing line⁷ hanging above the rescue boat to slew the davit arm outboard. While slewing, approximately 15 cm of brake release line uncoiled from the brake release line bag on deck. The brake release line snagged on a vertical section of the cradle post, creating tension on the brake release line (Figure 7).

As the davit arm slewed further outboard, the rescue boat suddenly dropped, and the bottom of its port side hull hit the raised edge of the vessel's outboard deck. The rescue boat tilted outboard to such a degree that the coxswain and bowman fell from the boat. The coxswain fell approximately 14 m into the water below, while the bowman grabbed hold of the rescue boat's painter line approximately 4 m above the water. The rescue boat continued its descent toward the water as the bowman held on to the painter. Eventually, the bowman let go of the painter and dropped approximately 2 m into the water. The rescue boat reached the water level soon after.

The rescue boat's bottom hull sustained minor damage around the port keel area due to the impact with the edge of the outboard deck.
