**RAILWAY INVESTIGATION REPORT
R10E0096**

NON MAIN-TRACK COLLISION

**CANADIAN NATIONAL
SWITCHING ASSIGNMENT NUMBER 602-23-17
AND A STATIONARY CUT OF CARS
TRACK VC-64, SCOTFORD YARD
VEGREVILLE SUBDIVISION
FORT SASKATCHEWAN, ALBERTA
18 AUGUST 2010**

Report Number R10E0096

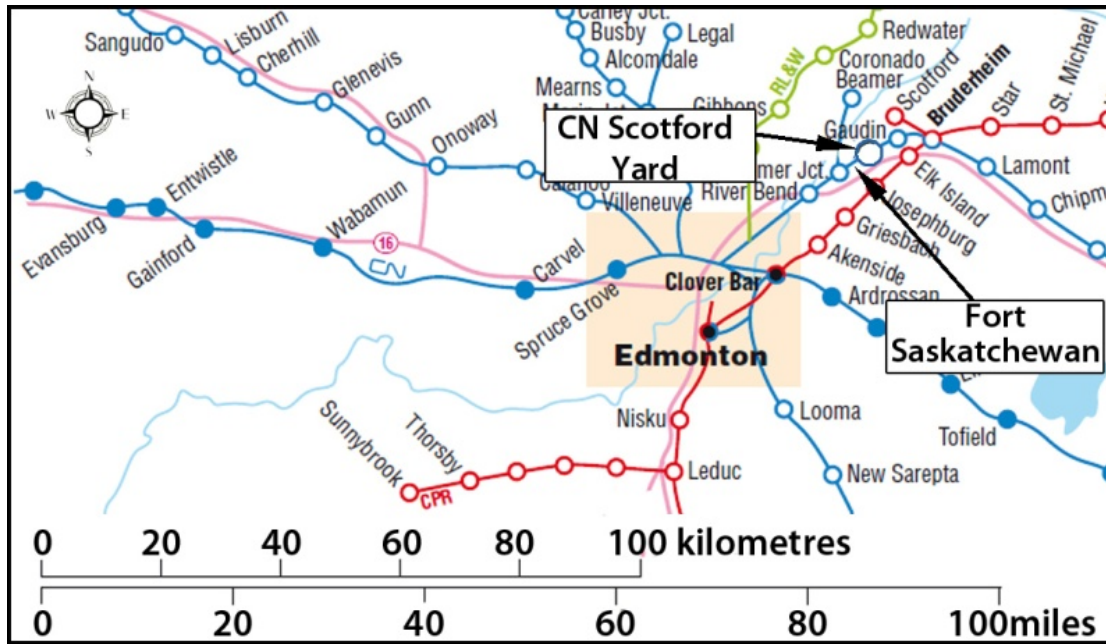
Figure 1. Scotford Yard east of Fort Saskatchewan, Alberta

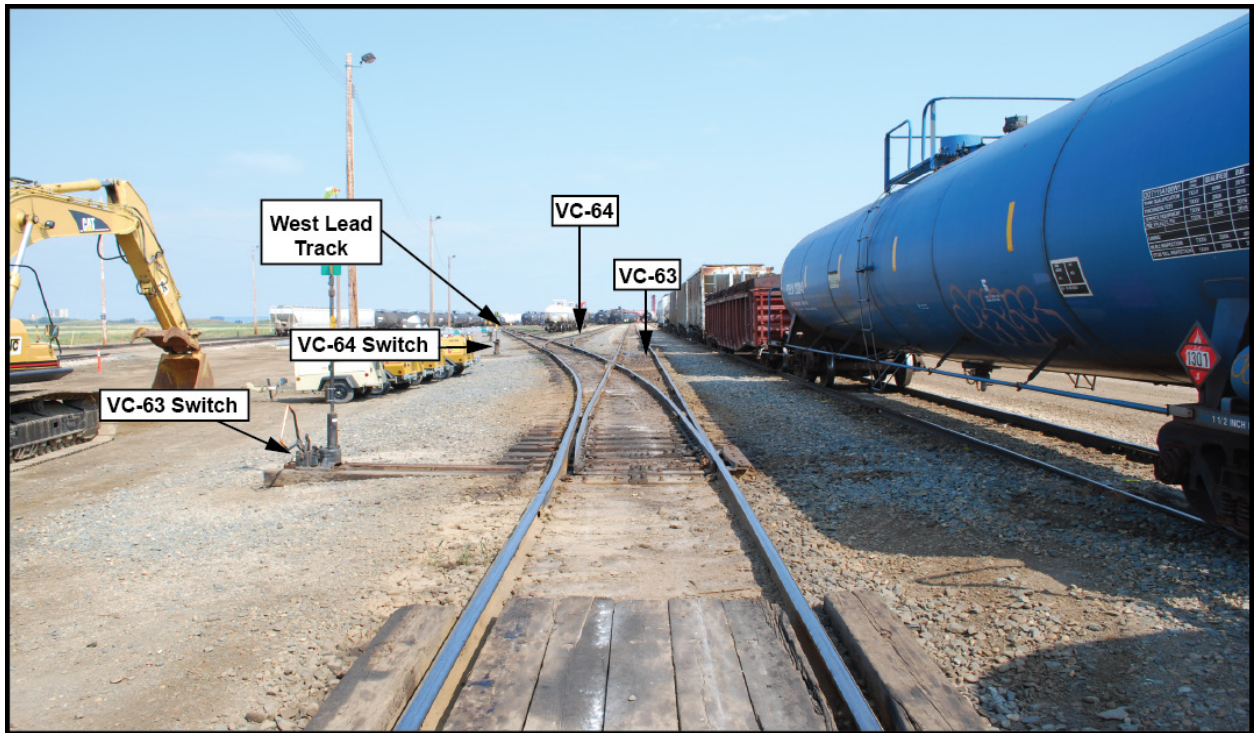
Photo 1. West yard lead looking east

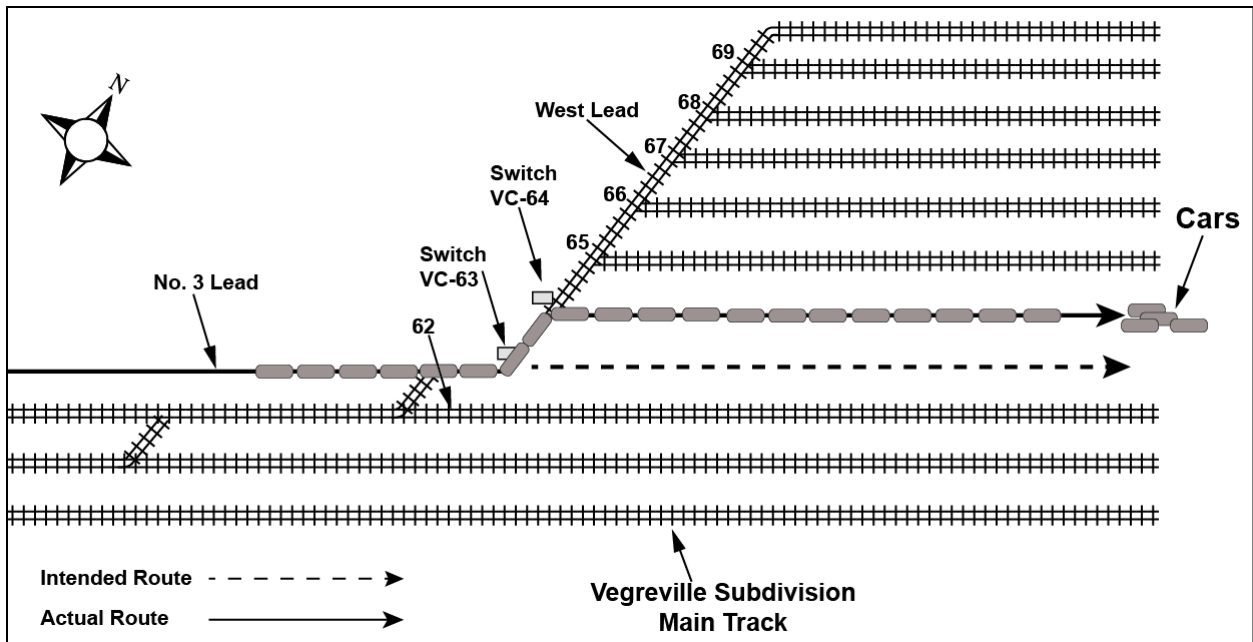
Figure 2. Movement's intended versus actual route

The intended move for assignment 602 was to shove 55 cars into track VC-63 which the crew knew was clear. However, the foreman mistakenly positioned himself at the VC-64 switch. Before instructing the assignment to shove eastward, he did not confirm his location by reading the number on the switch target. In addition, when looking eastward down track VC-64, had the track been clear he would have been able to see the east lead lighting. The absence of visible lighting at the far (east) end of the track was a visual cue that the track was occupied. However, the foreman either did not perceive this visual cue or did not interpret it correctly. The collision and derailment occurred when 55 cars were shoved, unprotected, into track VC-64 where they contacted a cut of stationary cars.

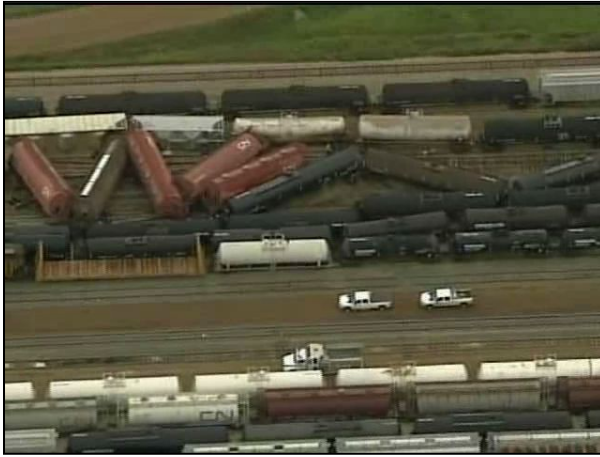
Assignment 602 travelled approximately 12 car lengths into track VC-64 and at a speed of 9 mph struck a stationary cut of 46 empty cars (with the air brakes applied) that had been placed in the track about 2 ½ hours earlier. As a result of the collision, a total of 43 cars, 17 loads and 26 empties, derailed. The derailed cars included 8 cars from assignment 602, 8 stationary cars on track VC-64, 8 stationary cars on track VC-62, 9 stationary cars on track VC-65, 5 stationary cars on track VC-66 and 5 stationary cars on track VC-67 (see Photos 2 and 3). Eleven cars were destroyed. The dangerous goods cars involved included:

Photo 2. Aerial view of the derailment

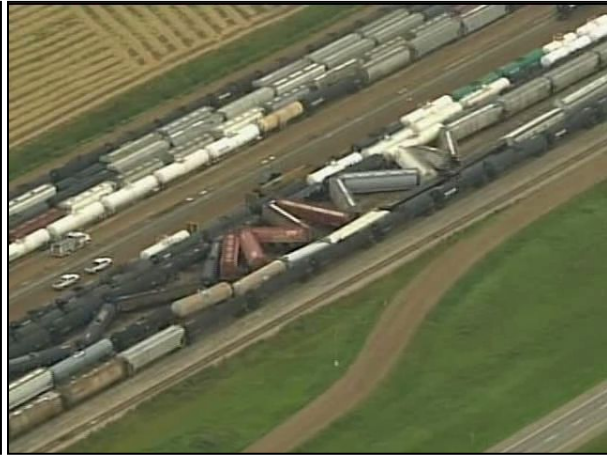
Photo 3. Other aerial view of the derailment
