**RAILWAY INVESTIGATION REPORT
R12Q0030**

**MISALIGNED SWITCH AND TRACK DIVERSION
VIA RAIL CANADA INC.
PASSENGER TRAIN NO. P600-21-09
MILE 78.11, CANADIAN NATIONAL
LAC ST-JEAN SUBDIVISION
HEGADORN, QUEBEC
09 AUGUST 2012**

Report Number R12Q0030

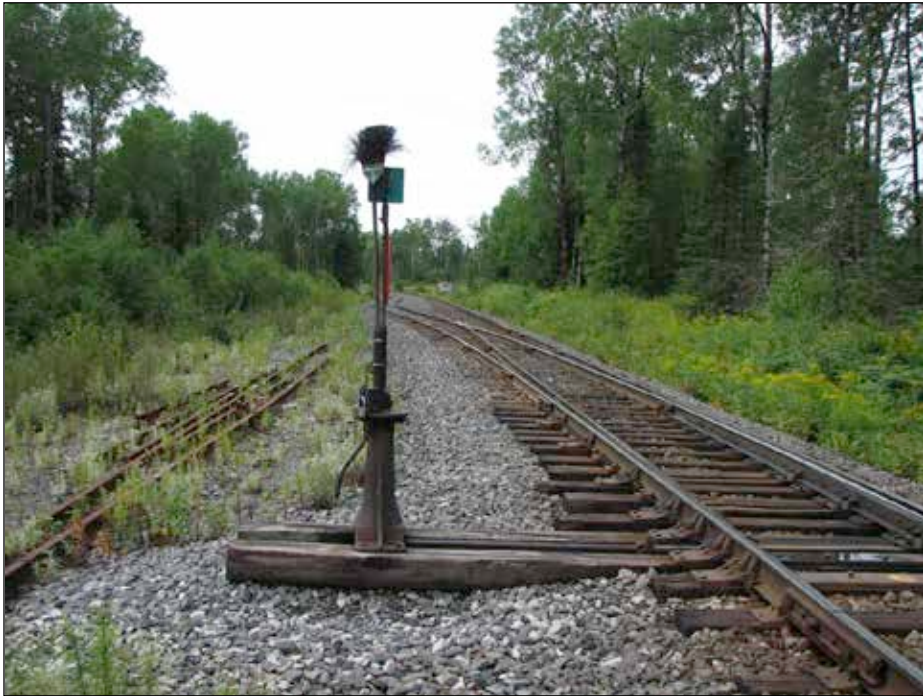
The turnout at the north end of the Hegadorn siding is a hand-operated No. 12 switch designed to switch trains travelling at a maximum speed of 15 mph. The switch stand mast measures 48 inches and is equipped with an oblong standard red target and a small red reflectorized target that faces north when the switch is in the reverse position. The switch stand is positioned on the east side of the track, on the same side as the diverging route. A switch broom is located on the switch stand (Photo 1). The switch components (Figure 2) were in good condition and properly adjusted and maintained.

Photo 1. JM33 turnout switch stand in normal position

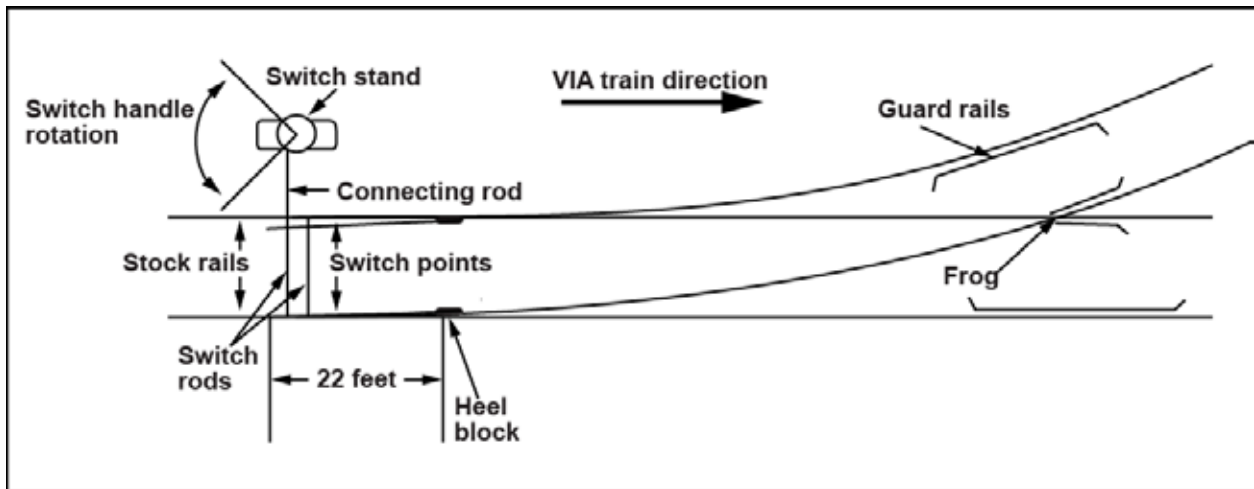
Figure 2. Turnout in reverse position at Hegadorn

The incident took place when the train arrived at a misaligned switch and was diverted into the siding. On the day of the incident, the track maintenance crew was to replace switch bolts at the Hegadorn siding. In order to replace the bolts, the switch stand was handled a few times to release the tension on the switch rods and adjust the alignment of the switch points. After completing the work, the crew members retrieved the lock key and left the site without going back over the switch, ⁸ thinking that they had left it in the normal position, as required. Employees can lock switches in either the normal or reverse position to retrieve their lock key.

1. The switch was inadvertently locked in the reverse position after the maintenance crew handled it and left the site.
2. The crew did not verify the exact position of the switch after it was last handled.
3. Given the track configuration, the target's sightline was reduced. There was not enough braking distance for a train travelling at the authorized speed to stop before reaching the switch.
4. The incident took place when the train arrived at a misaligned switch and was diverted into the siding.

On 10 August 2012, Canadian National (CN) issued Bulletin 2012-08-E-01 and introduced a supplement to Rule 104(q) to Engineering – Eastern Region employees:

Employees must write the following information on the back of their clearance when handling a main track switch in OCS:

- 1) Time of Day
- 2) Location of the switch
- 3) Initials of employees' that either handled or confirmed the position of switch
- 4) Position the switch was left

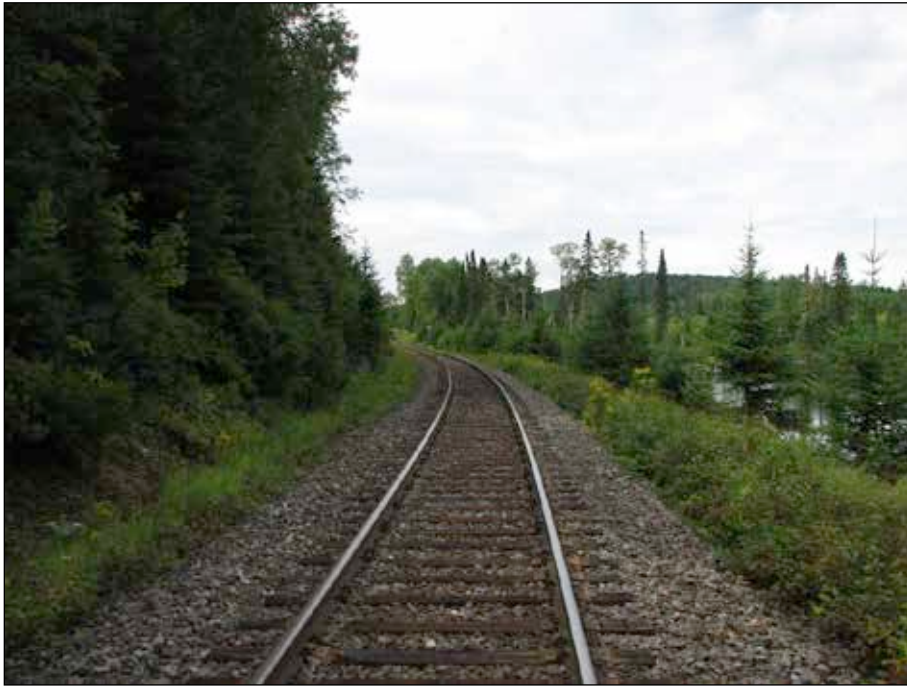
The area near Hegadorn is mountainous and wooded. In the vicinity of the turnout, the railway right-of-way is about 99 feet wide. It was overrun by dense vegetation, reducing the sightlines at and near the curves.

The turnout is situated on tangent track, about 400 feet south of a left curve, in the direction of the train movement. A rocky overhang runs several hundred feet on the east side of this 3.25° curve. That obstacle, which is about 15 feet from the centre of the track, obstructs the crew's field of vision when the train is travelling south and approaching the north siding switch at Hegadorn (Photo 2).

Photo 2. Railway right-of-way in the curve, at the north switch approach

The locomotive engineer detected the hazardous situation almost as soon as it was possible to do so and applied the emergency brakes. Given the topography of the surrounding area and the fact that there was a curve of more than 3°, the sightline for the target was about 650 feet. Given the track configuration, the target's sightline was reduced. There was not enough braking distance for a train travelling at the authorized speed to stop before reaching the switch.

Also, the target may be considered an effective defence provided it can be seen. However, in some situations, sightlines may be restricted by track configuration, weather conditions or vegetation. When sightlines are restricted, a train travelling at the authorized speed may not be able to stop before reaching a switch left in the reverse position, increasing the risk of derailment.

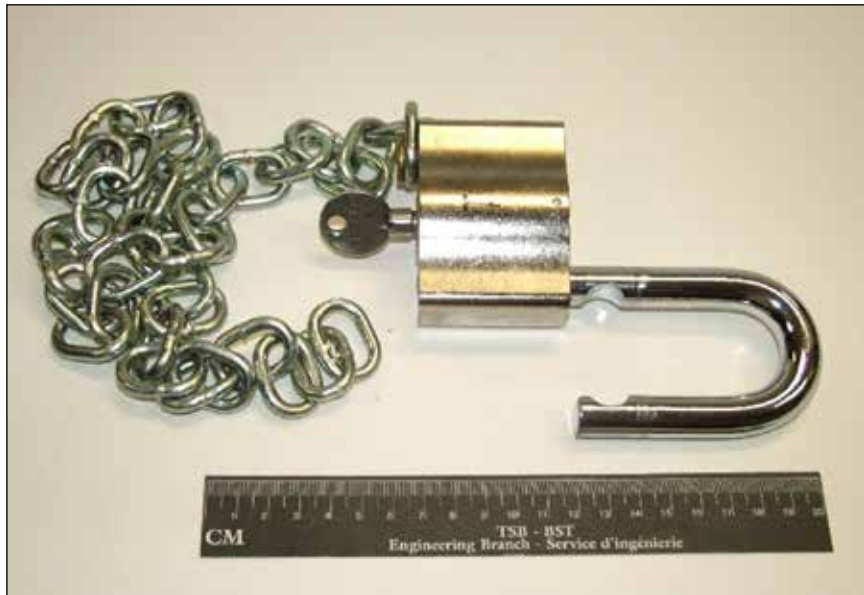
Four approved high-security devices (Photo 3) were sent to the TSB Laboratory to determine whether this type of lock could be opened with something other than a key without damaging the device.

Photo 3. High-security lock

1. Given the location, the time available, the fact that there was no evidence of lock tampering and the difficulty opening this type of lock, it is unlikely that someone else handled the lock.
2. Due to the vigilance of the operating locomotive engineer, the hazardous situation was detected almost as soon as it was possible to do so.
3. The previous similar occurrence was a missed opportunity for the railway to send an important message to improve the safety of main-track hand-operated switches in Occupancy Control System territory.

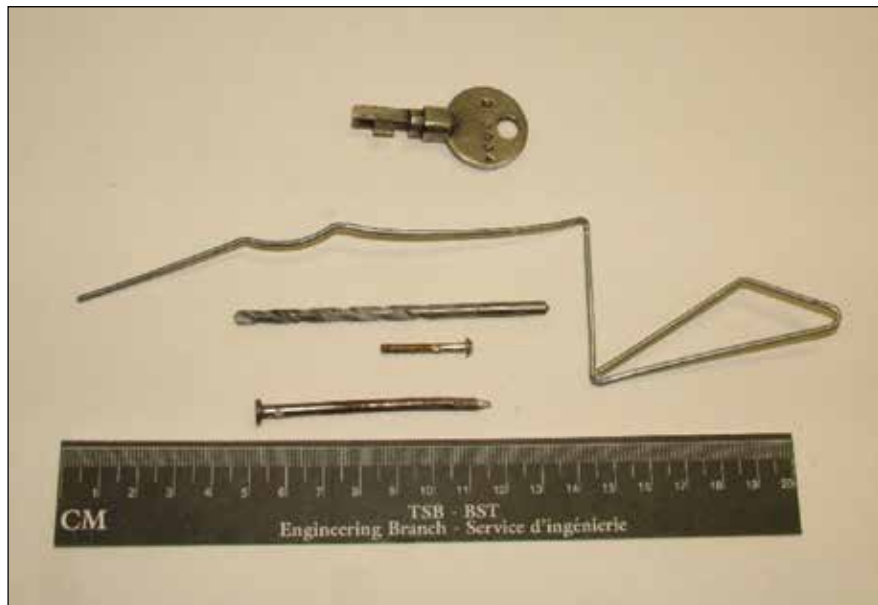
- Metal wire, drill bits, screws or nails were used to attempt to pry the lock open, with no success (Photo 4).
- An experienced person with in-depth knowledge of internal lock mechanisms and special tools could conceivably open the lock without damaging it.

Photo 4. Key and various tools
