Rail Transportation Safety Investigation Report R18W0168

MAIN-TRACK TRAIN DERAILMENT

VIA Rail Canada Inc.
Passenger train P69341-04
Mile 23.60, Turnberry Subdivision
Hudson Bay, Saskatchewan
05 July 2018

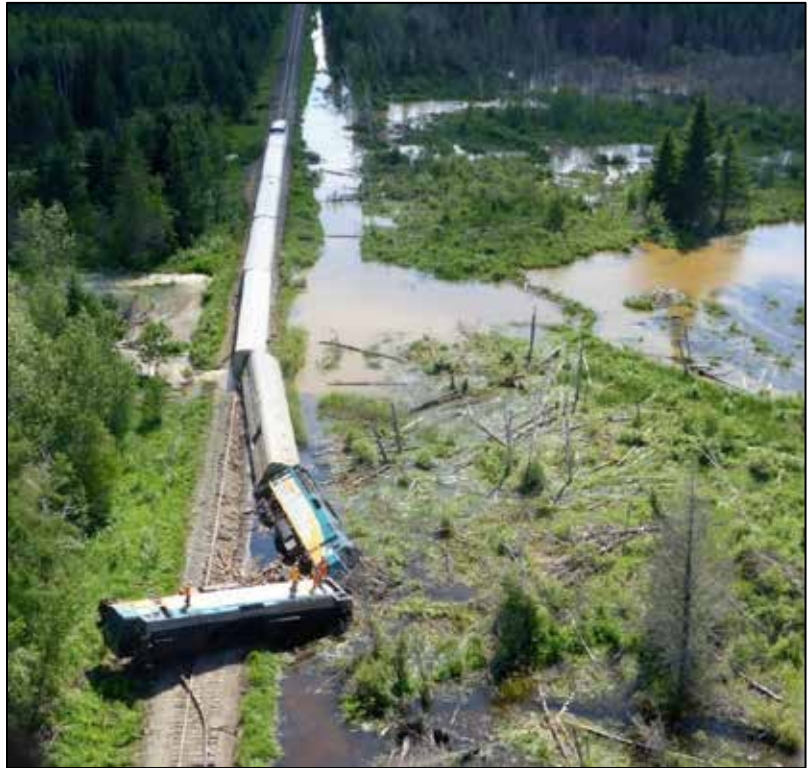
Aerial site examination revealed that the 2 locomotives and the first 2 cars had derailed and come to rest on the west side of the washed-out single main track (Figure 2). The locomotives had jackknifed, with the second locomotive partially submerged in water. The first derailed car was the baggage car, which had both trucks derailed and was leaning at approximately 40°.

The second derailed car was a passenger coach, which came to rest upright with the lead truck derailed. The trailing 3 passenger coaches and the observation car remained upright on the track. About 800 feet of track was damaged or destroyed.

Figure 2. Derailed locomotives, baggage car, and passenger coach

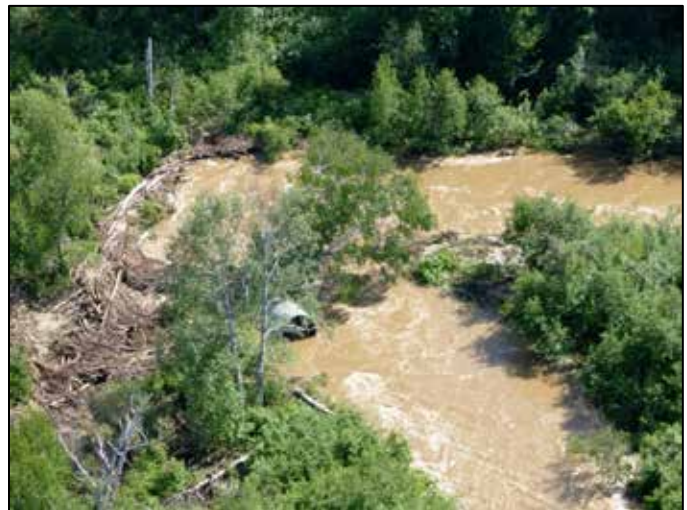
To provide drainage from the Pasquia Hills, 2 culverts, each measuring about 30 feet long by 8 feet in diameter, run from west to east under Highway 9 at roadway kilometre 37. Following heavy rains in the area in the week before the occurrence, the culverts under the highway began accumulating forest debris. This resulted in the accumulation of a significant amount of water along the west side of the highway. With the rising water levels and the associated rise in hydraulic pressure, the water flow eventually overwhelmed the culverts and washed out the highway, including the culverts. The culverts were displaced about 30 m east of the highway (Figure 3). In addition to this washout location, the highway and culverts were washed out at roadway kilometre 46 and roadway kilometre 78. A bridge at roadway kilometre 68 was also washed out.

On 04 July 2018, at about 0900, highway employees observed debris near the roadway culvert at kilometre 37, but water was still flowing freely through the culvert. At approximately 1600, highway employees observed that a partial washout had occurred at roadway kilometre 37 of Highway 9, but the roadway culverts were still in place. At this location, the rail line is not visible from the highway. There was no specific indication to the highway employees that the downstream railway infrastructure could be affected by the partial washout. Neither the Saskatchewan Ministry of Highways and Infrastructure nor the railways have any protocols in place to share information when nearby or adjacent infrastructure may be at risk during periods of heavy rainfall.

Figure 3. Washed-out highway culvert with related debris

In locations where railway and road authority infrastructure shares a common drainage basin, it is critical that the authorities have communication protocols in place for the sharing of information relating to the protection of the infrastructure.

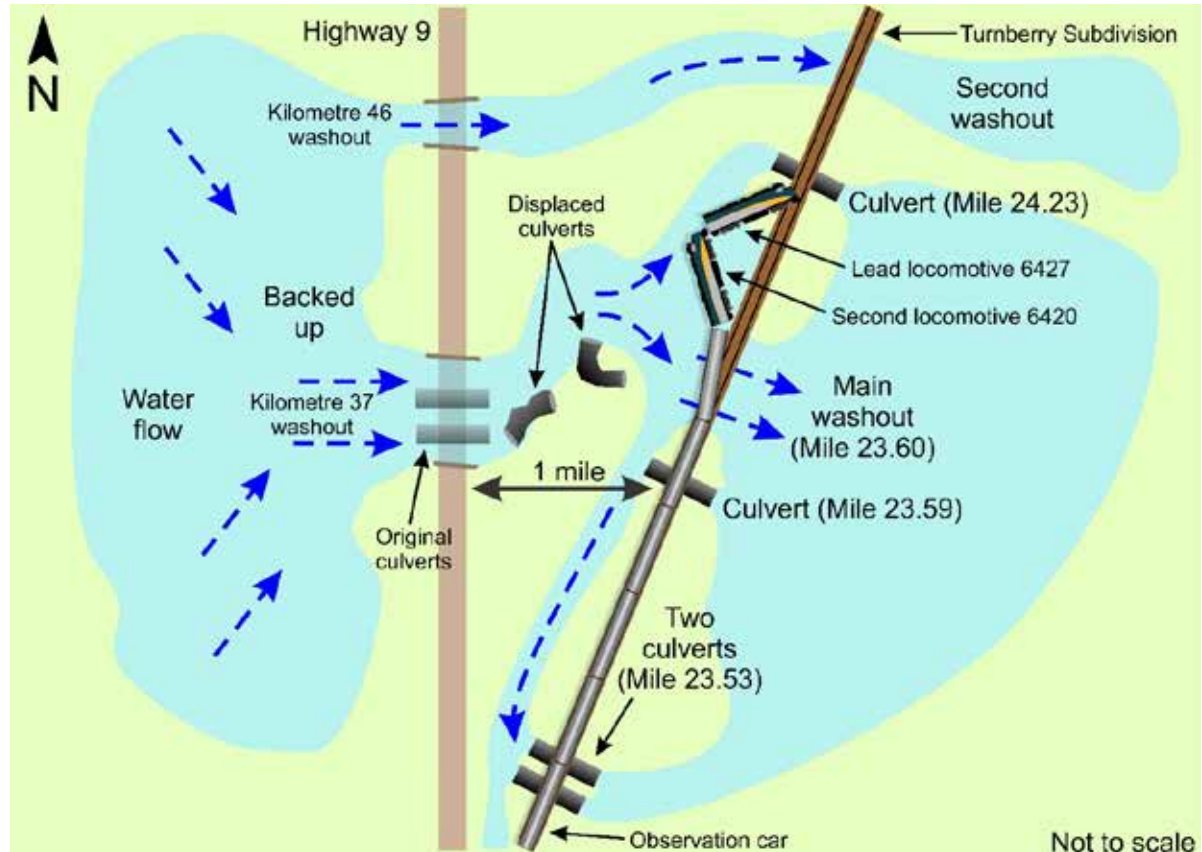
With the highway breached, the excess water flowed overland, flooding the railway right-of-way between 2 railway culvert locations (i.e., Mile 23.53 and Mile 24.23). The increased water volume

eventually overwhelmed the railway culverts (three of which measured 3-feet in diameter and one of which measured 2 1/2 feet in diameter) and started to flow through the track subgrade. Eventually, the trackbed washed out, leaving the track unsupported at the occurrence location (Figure 4).

Figure 4. Diagram of the occurrence site showing where the washouts occurred on Highway 9 and along the rail line

- CN's SkyGuard warning system was modified to identify weekly accumulation of precipitation and to communicate warnings when water capacity thresholds are reached for a specific area.
- When rainfall occurs over multiple days and sustained accumulation has been identified, the number of patrols in front of trains will be increased.
- When CN is informed by its weather information provider that a certain area is expected to exceed 40 mm of continuous rain or that a severe weather advisory is to be issued, CN will implement additional track patrols that will continue for 4 hours after the rain stops to monitor drainage along the railway right-of-way.
