## **RAIL TRANSPORTATION SAFETY INVESTIGATION REPORT R19E0147**

### **MAIN-TRACK TRAIN DERAILMENT**

Canadian Pacific Railway  
Train 201-27  
Mile 7.52, Leduc Subdivision  
Blackfalds, Alberta  
27 September 2019

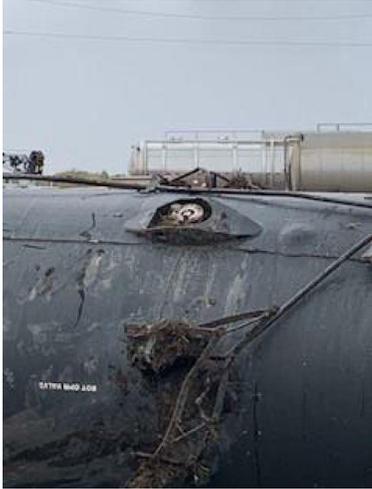
Three of the derailed cars had sustained damage that led to containment failure:

Figure 3. Damage to car CGTX 30182 (Source: Canadian Pacific Railway)

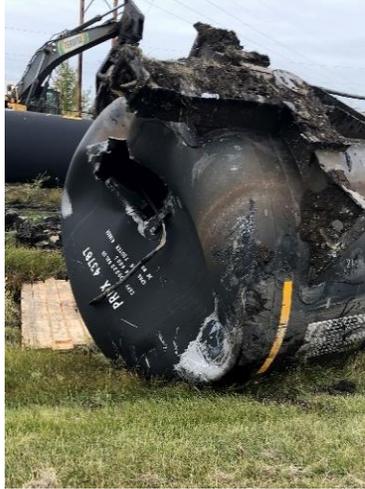
Figure 4. Damage to car PROX 43787 (Source: Canadian Pacific Railway)

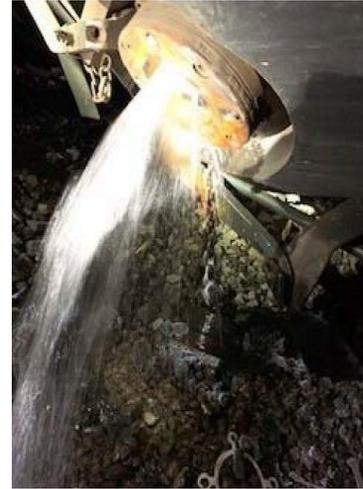
Figure 5. Damage to car PROX 43741 (Source: Canadian Pacific Railway)

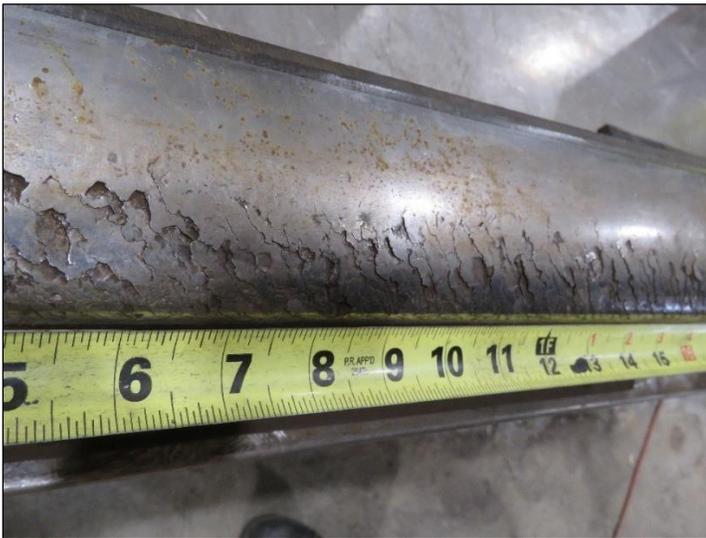
Examination of the recovered rail revealed that the rail head running surface displayed gauge corner shelling<sup>9</sup> and head checking<sup>10</sup> (Figure 6).

Figure 6. Condition of running surface of the rail head recovered at the occurrence site (Source: Canadian Pacific Railway)

The extent and depth of head checking and shelling on the rail surface indicate that the rail grinding conducted on 15 June 2019 was insufficient to remove the rail surface contamination and defects before UT on 28 August 2019.

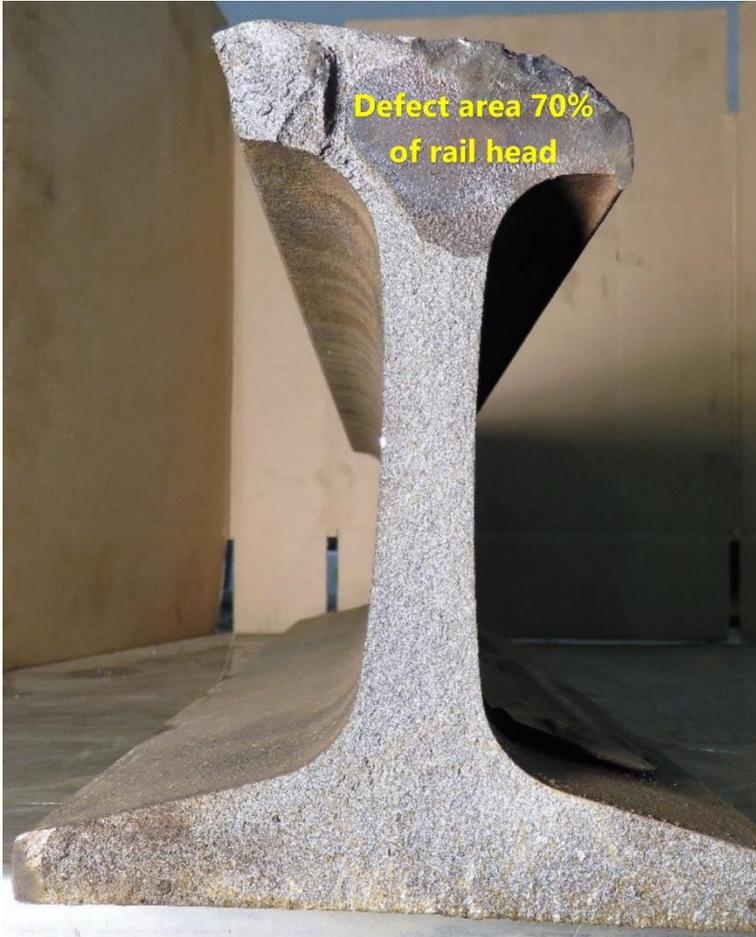
The size of a TDD is commonly recorded as a percentage of the head area of the rail. The analysis determined that the TDD observed on the primary fractured rail accounted for approximately 70% of the rail head cross-section (Figure 7). This TDD was observed at the primary fracture and originated from the root of a spall.<sup>11</sup> A second pre-existing detail fracture that accounted for approximately 25% of the rail head cross-section was observed at the second break.

Figure 7. Transverse detail defect on the occurrence rail accounting for 70% of the rail head (Source: Canadian Pacific Railway, with TSB annotations)

The photo of the rail fracture face in Figure 7 shows a well-defined defect that closely resembles a defect with normal and sudden growth patterns.<sup>12</sup>

A TDD at the point of derailment had originated from head check cracks at the upper gauge corner of the rail head. Over time, the crack had progressed in normal and sudden growth pattern to cover approximately 70% of the cross-sectional area of the rail head. The remaining rail section then failed in overstress once it could no longer support service loads.
