AIR TRANSPORTATION SAFETY INVESTIGATION REPORT A21Q0131

LATERAL RUNWAY EXCURSION

Keewatin Air LP
Beechcraft King Air B200, C-FSKO
Sanikiluaq Airport, Nunavut
17 December 2021

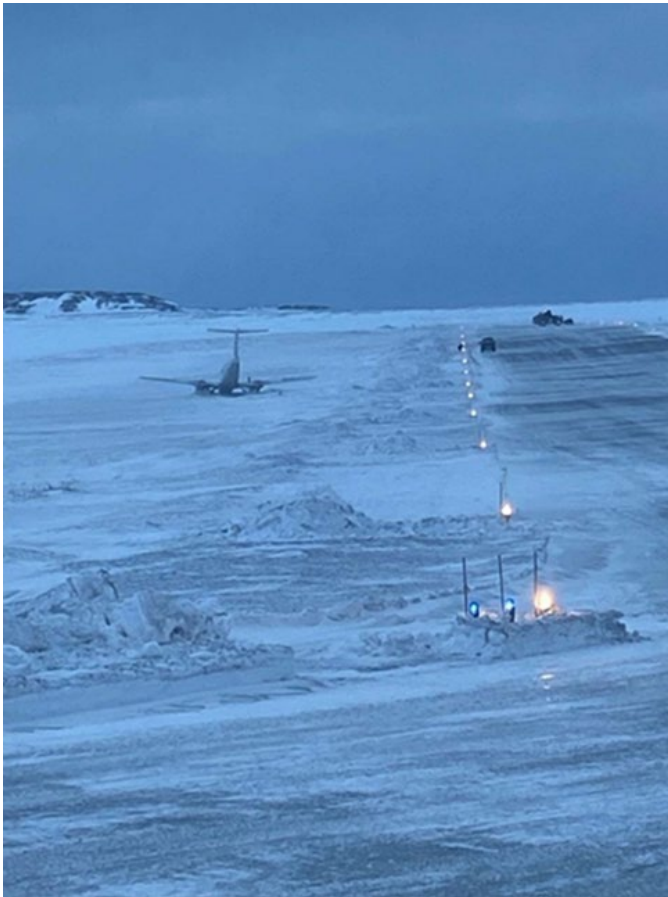
Figure 1. Occurrence aircraft where it came to rest in the snow following the runway excursion at the Sanikiluaq Airport, a few hours after the occurrence (Source: Sanikiluaq Airport universal communications facility)

The aircraft was substantially damaged during the runway excursion, and there was no post-impact fire.

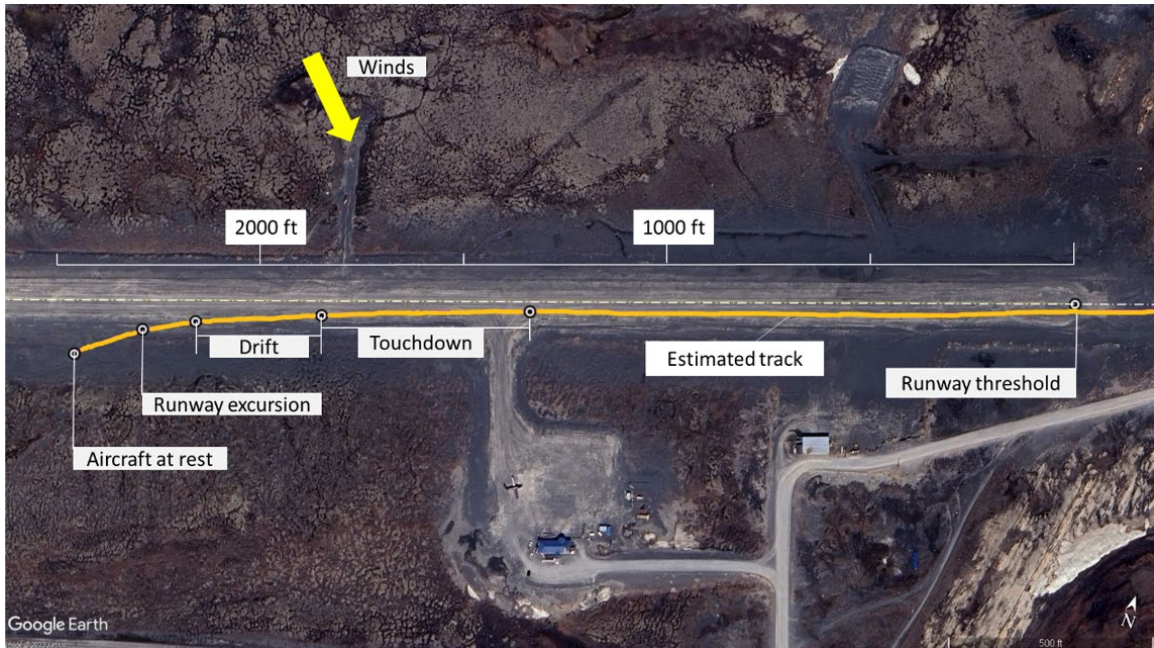
Figure 2. Estimated track of the occurrence aircraft over Runway 27 at Sanikiluaq Airport, along with points where the aircraft touched down, drifted to the left, exited the runway, and came to rest (Source: Google Earth, with TSB annotations)

The combination of the strength of the crosswind and the degree of tire traction on the runway surface caused the aircraft to drift to the left. When the PIC realized that he was unable to control the drift after about 3 seconds, he conducted a go-around as planned, but the aircraft exited the runway surface immediately thereafter.

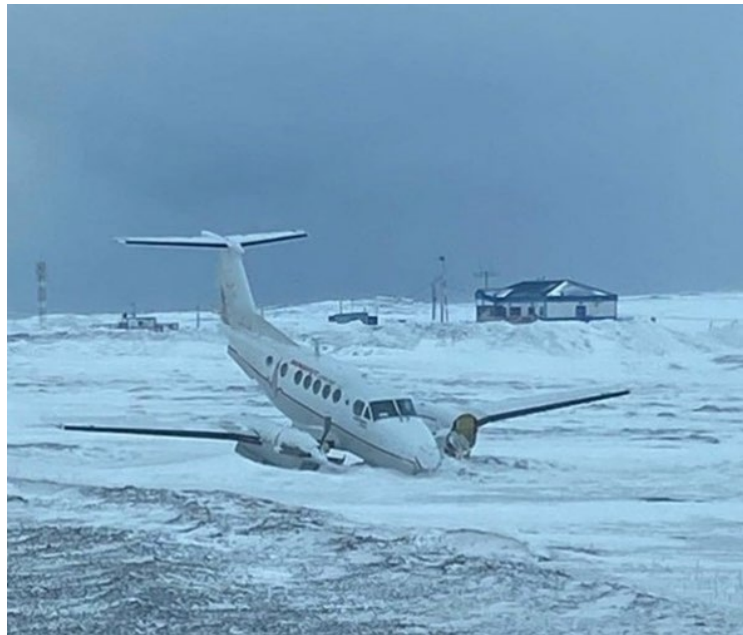
The aircraft came to rest, nose down (Figure 3). The left engine was torn from the firewall and folded completely under the wing between the nacelle and the fuselage. The propeller blades on the right engine were damaged and the nose landing gear strut failed. The nose of the aircraft sustained significant structural damage.

Figure 3. The occurrence aircraft after the runway excursion, stopped with the nose down (Source: Keewatin)
