MARINE TRANSPORTATION SAFETY INVESTIGATION REPORT M21P0297

LOSS OF CONTAINERS OVERBOARD AND SUBSEQUENT FIRE

Container vessel *ZIM Kingston*
La Perouse Bank, British Columbia
21 October 2021

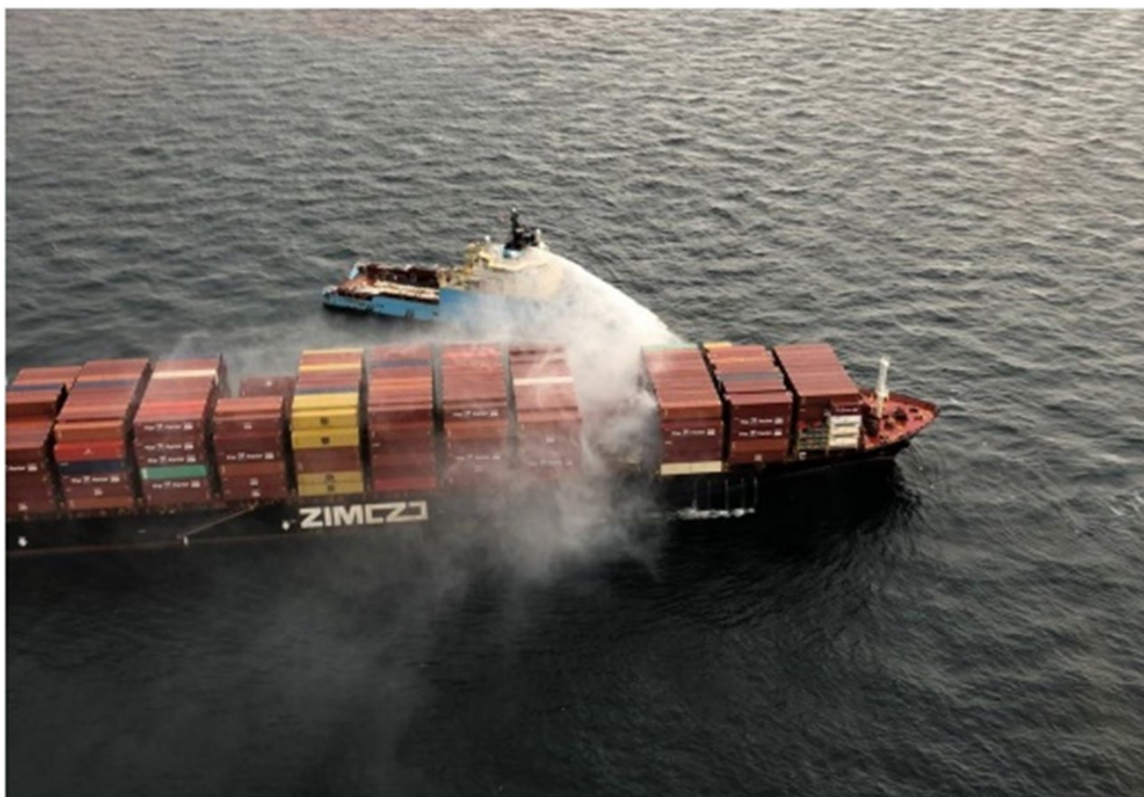
Figure 3. *Maersk Trader* performing boundary cooling (Source: Resolve Marine)

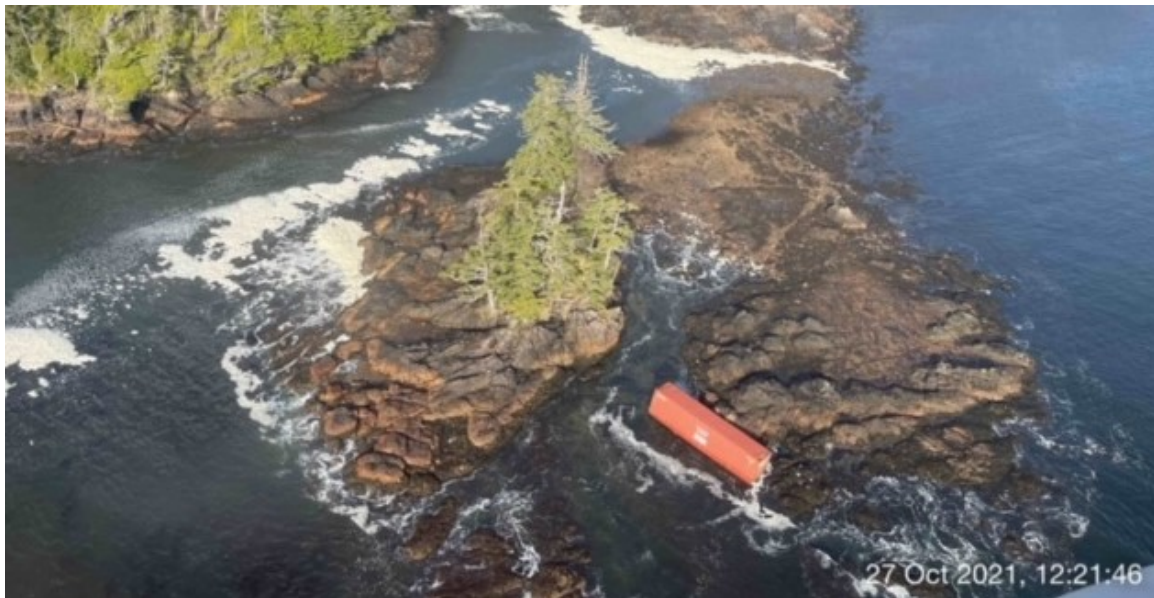
Figure 5. Aerial photo of a container from the *ZIM Kingston* washed up on land (Source: Transport Canada)

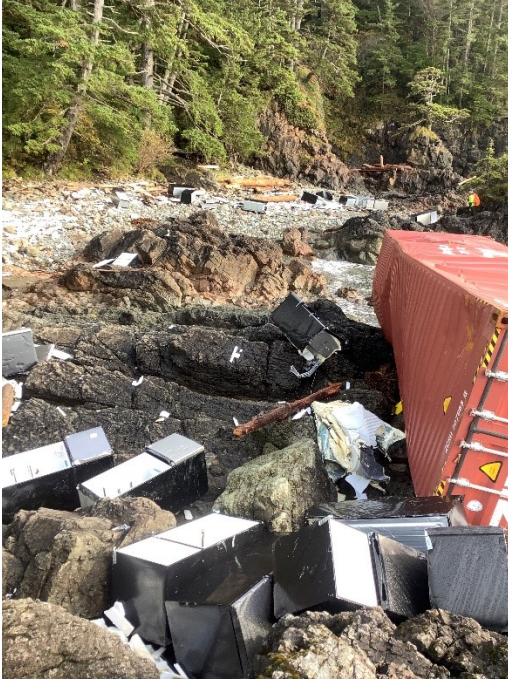
Figure 6. Photo of a container from the *ZIM Kingston* and refrigerators on the beach at Cape Palmerston, BC (Source: Pacificus Biological Services Ltd.)

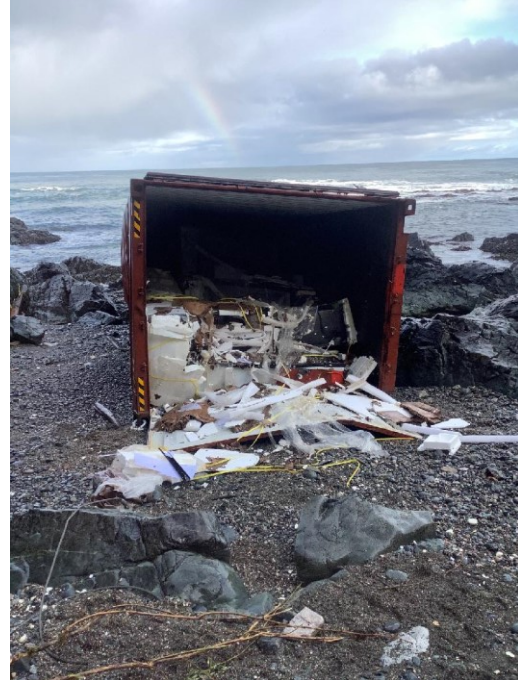
Figure 7. Photo of an open container from the *ZIM Kingston* with plastic debris inside at Shuttleworth Bight, BC (Source: Pacificus Biological Services Ltd.)

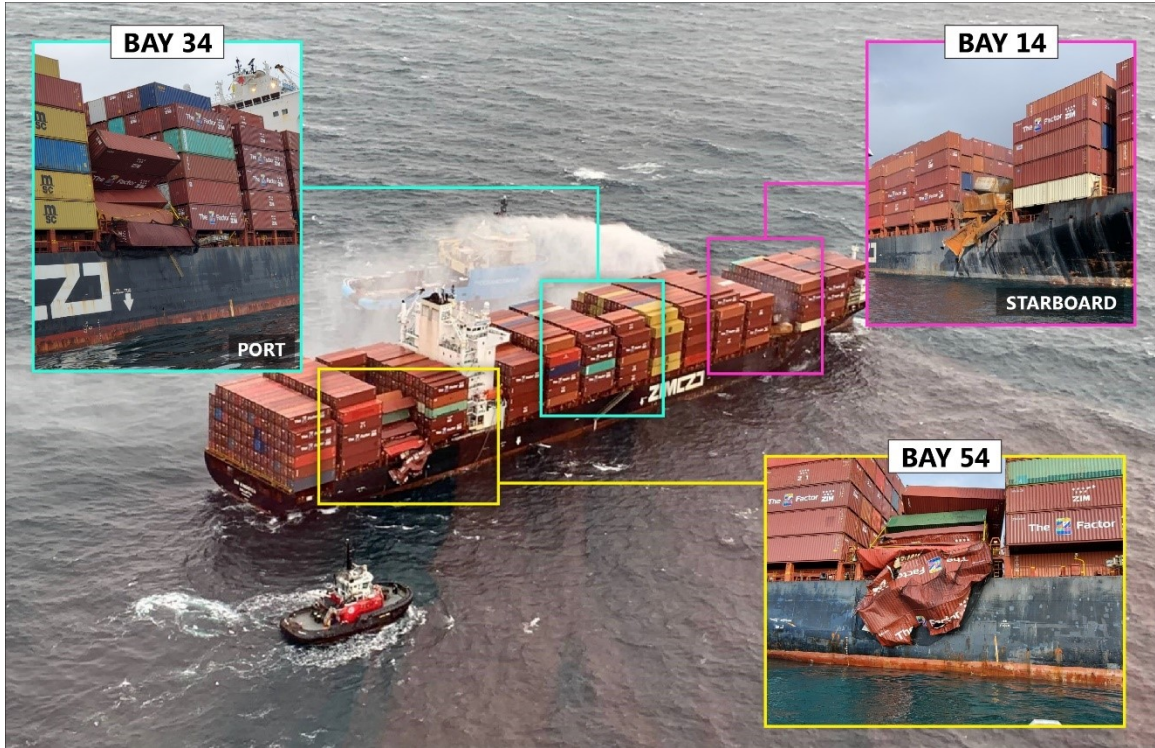
Figure 8. Bays in which containers were damaged or lost overboard (Main image source: Transport Canada; inset images source: TSB)

As a result of the occurrence, a total of 109 containers went overboard from 3 bays (bays 14, 34, and 54) and 53 containers on deck were damaged (figures 9 and 10). Post-occurrence examination of the containers showed that there had been fires inside 6 of the containers in bay 14: of these, 3 had held xanthates and 3 had held tires and general consumer goods. One of the hatch covers in bay 14 was bent, and the port-side accommodation ladder was also damaged.

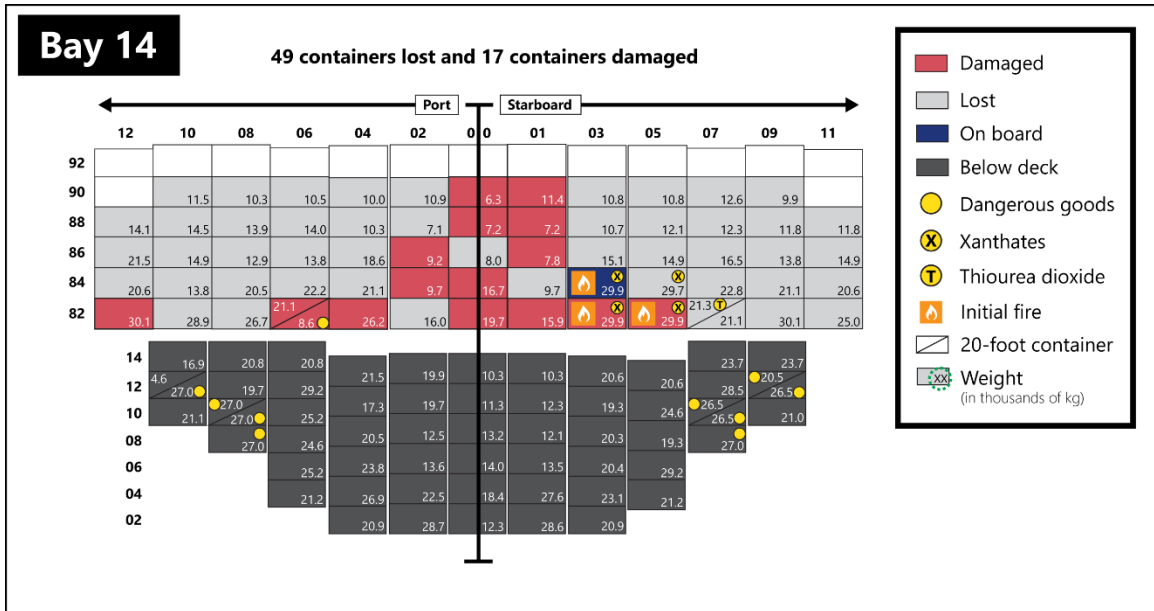
Figure 10. Cross-section of bay 14 showing lost and damaged containers (view from aft looking forward) (Source: TSB)

Bay 14 held a combination of 40-foot containers and 20-foot containers on deck. The 20-foot containers were stowed in pairs end-to-end, forming the equivalent length of the 40-foot containers. Forty-nine containers were lost overboard from bay 14, and 17 were damaged (Figure 10).

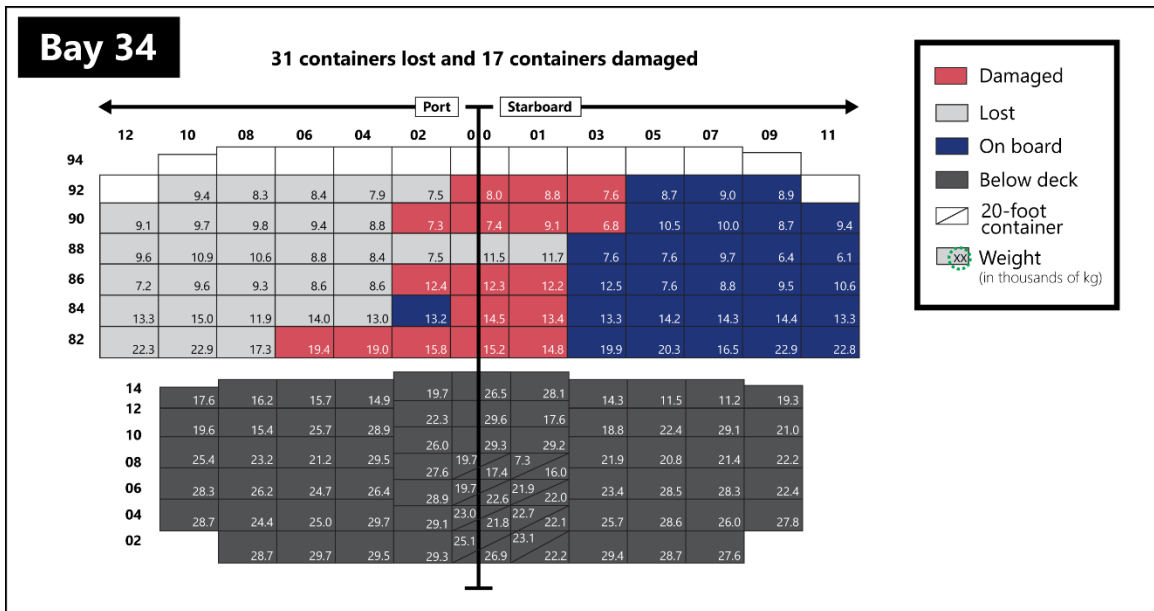
Figure 11. Cross-section of bay 34 showing lost and damaged containers (view from aft looking forward) (Source: TSB)

Bay 34 held only 40-foot containers on deck. Thirty-one containers were lost overboard from bay 34, and 17 were damaged (Figure 11).

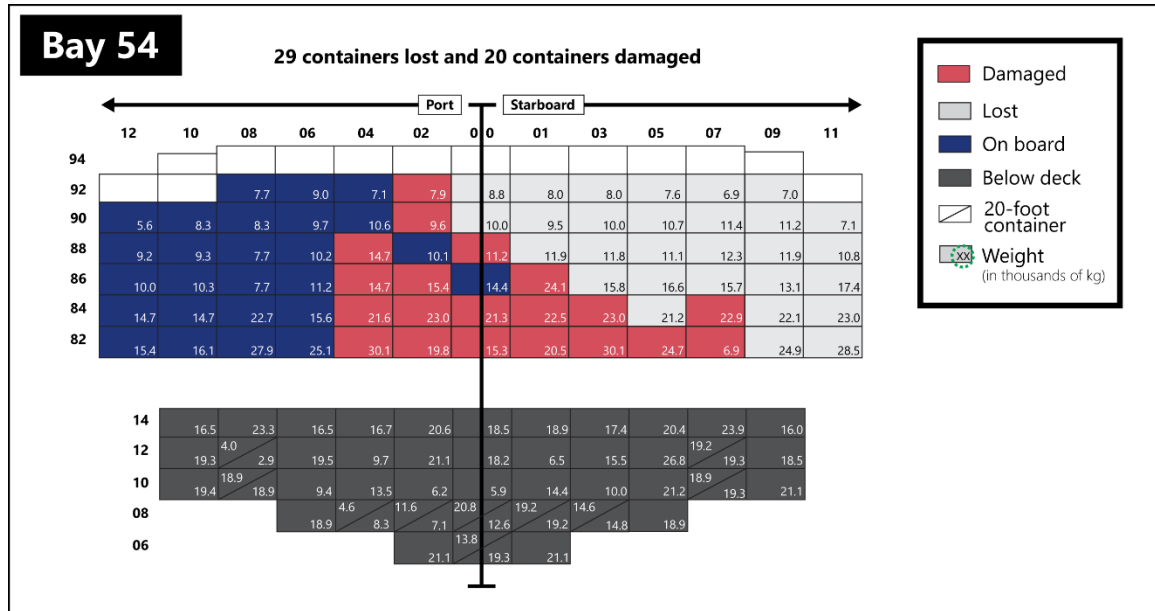
Figure 12. Cross-section of bay 54 showing lost and damaged containers (view from aft looking forward)
(Source: TSB)

Bay 54 held only 40-foot containers on deck. Twenty-nine containers were lost overboard from bay 54, and 20 were damaged (Figure 12).

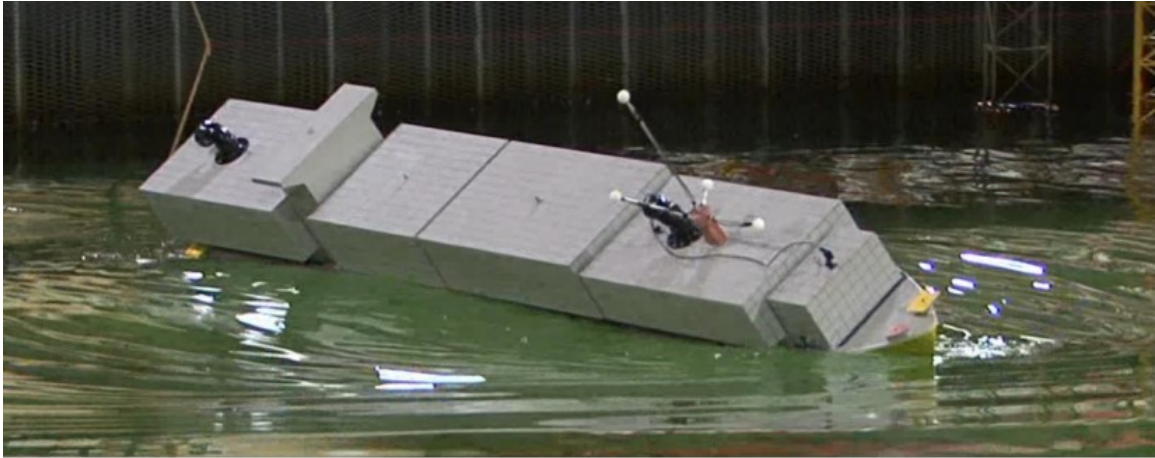
Figure 18. Still photo of the *ZIM Kingston* model rolling to large angles during tests. Note that the level of water is reaching the containers on the deck; at full scale, this would be considered a green water event (Source: National Research Council Canada)

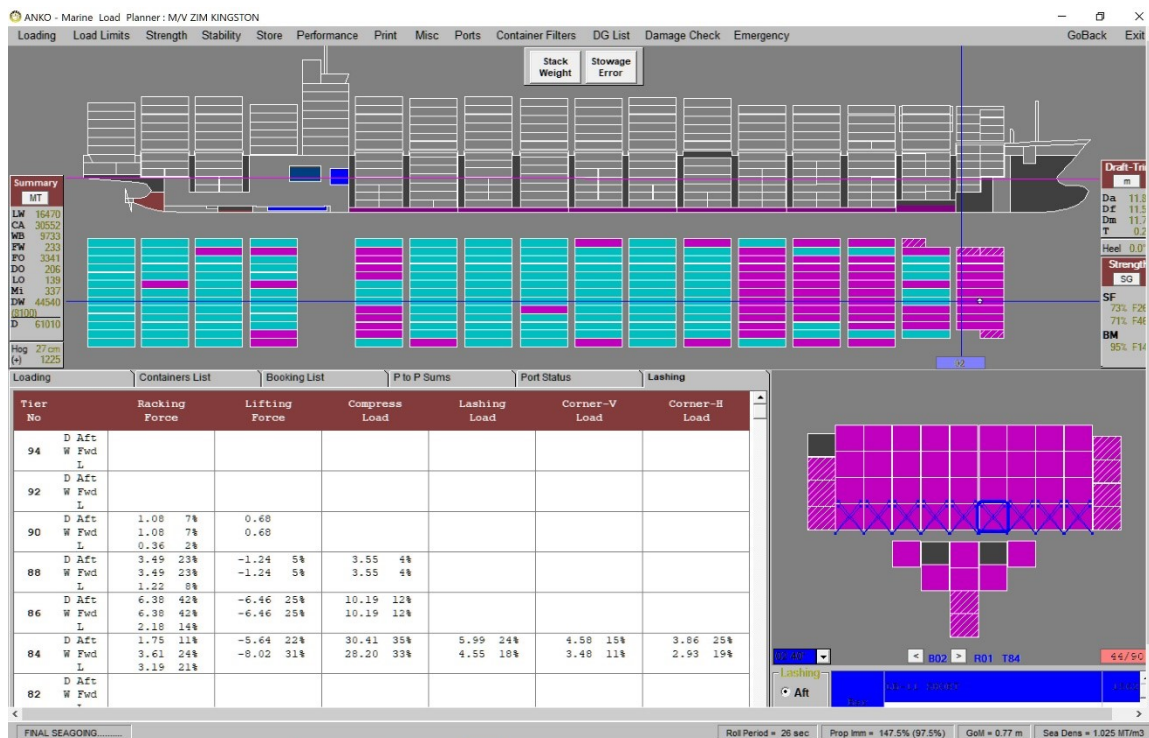
Figure 24. Screenshot of the ZIM Kingston load planning software showing containers with excessive lashing forces for the nominal roll angle (indicated in aquamarine) (Source: TSB)

If a loading plan proposed by a ZIM ship planner included containers with excessive lashing forces for the nominal roll angle, the master was to notify the ship planner, and they were to work together to rectify the issue. The SMS stated generally that the “vessel must not proceed to sea unless all lashing has been completed to the [m]aster’s satisfaction.”⁷⁰

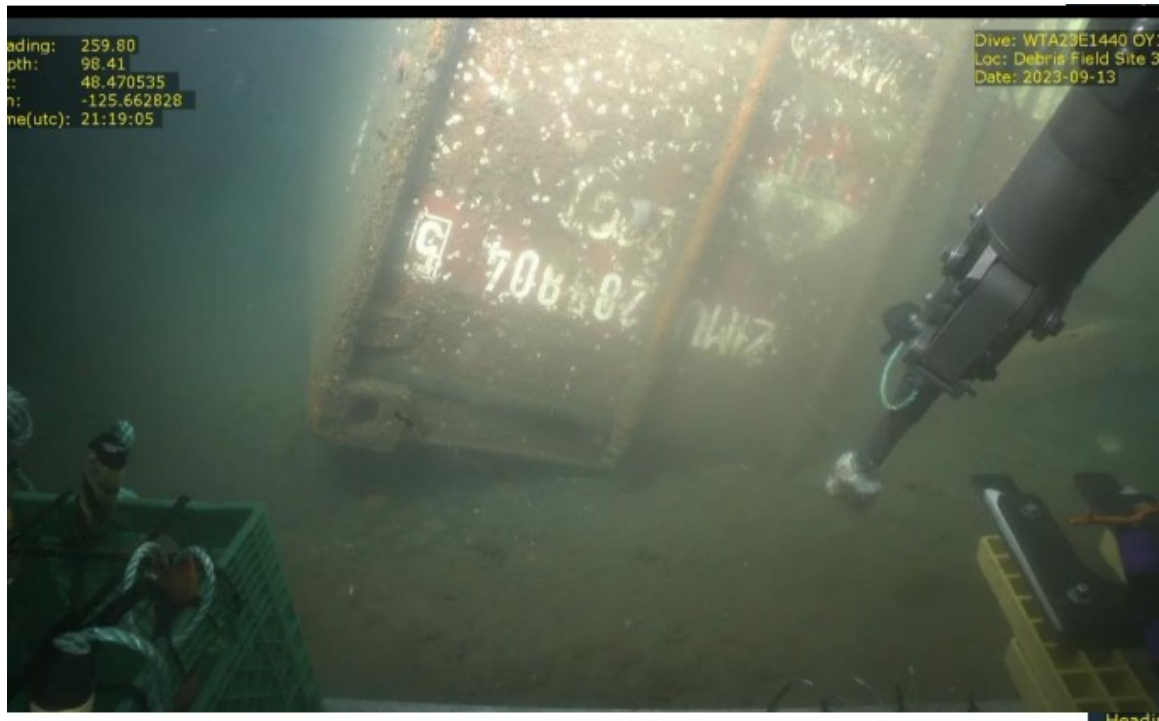
Figure 25. A ZIM container on the ocean floor (Source: DFO)

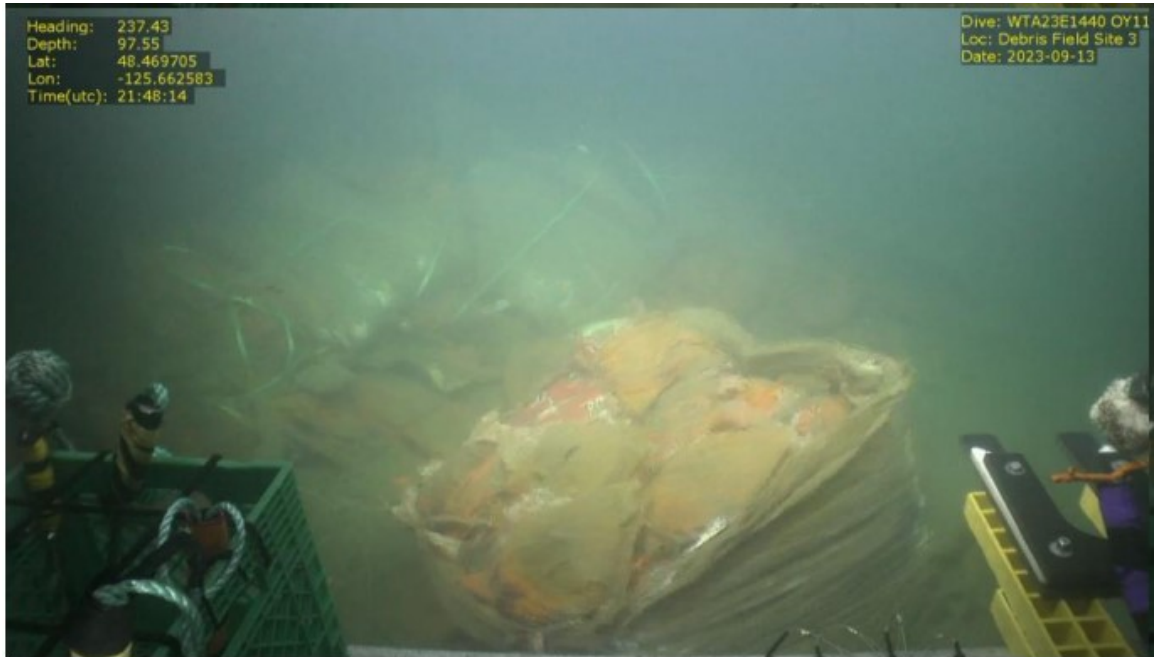
Figure 26. Plastic debris on the ocean floor (Source: DFO)

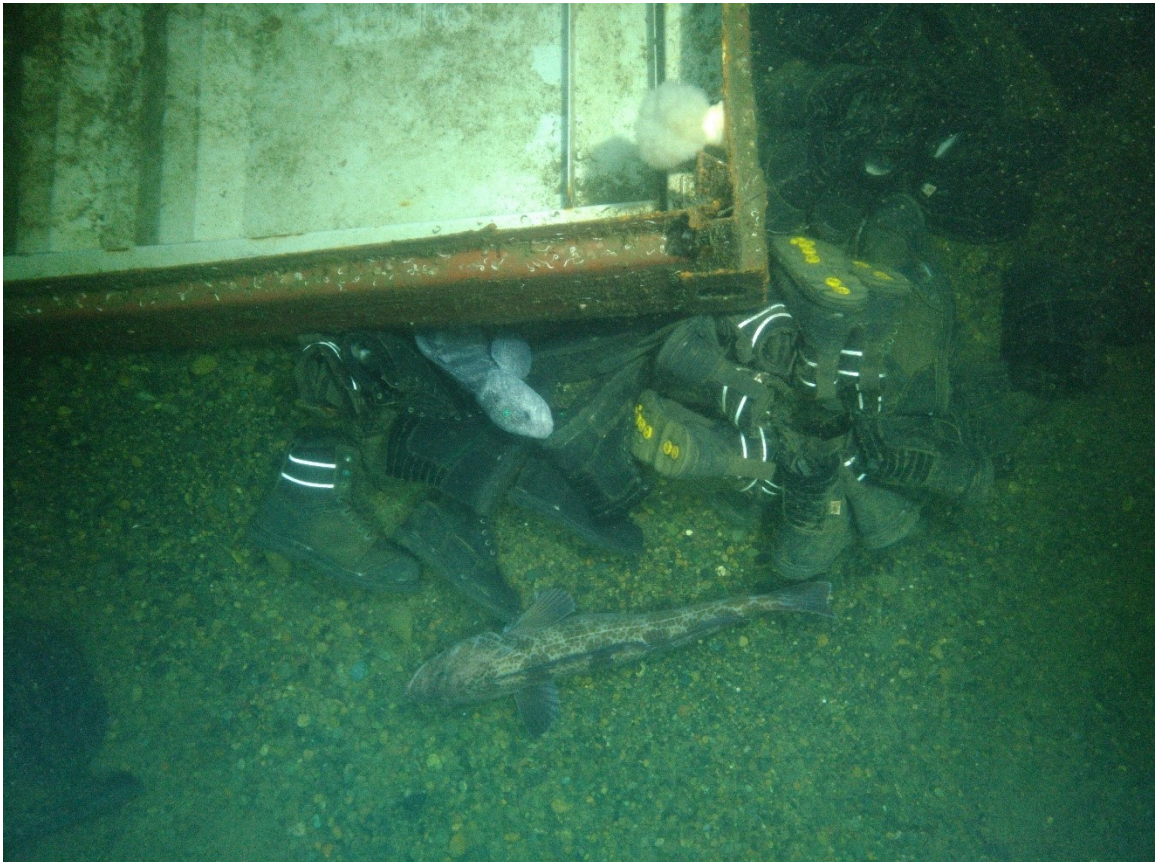
Figure 27. Boots on the ocean floor (Source: DFO)
