MARINE TRANSPORTATION SAFETY INVESTIGATION REPORT M22C0231

STRIKING OF BERTH

Passenger ferry *Sam McBride*
Toronto, Ontario
20 August 2022

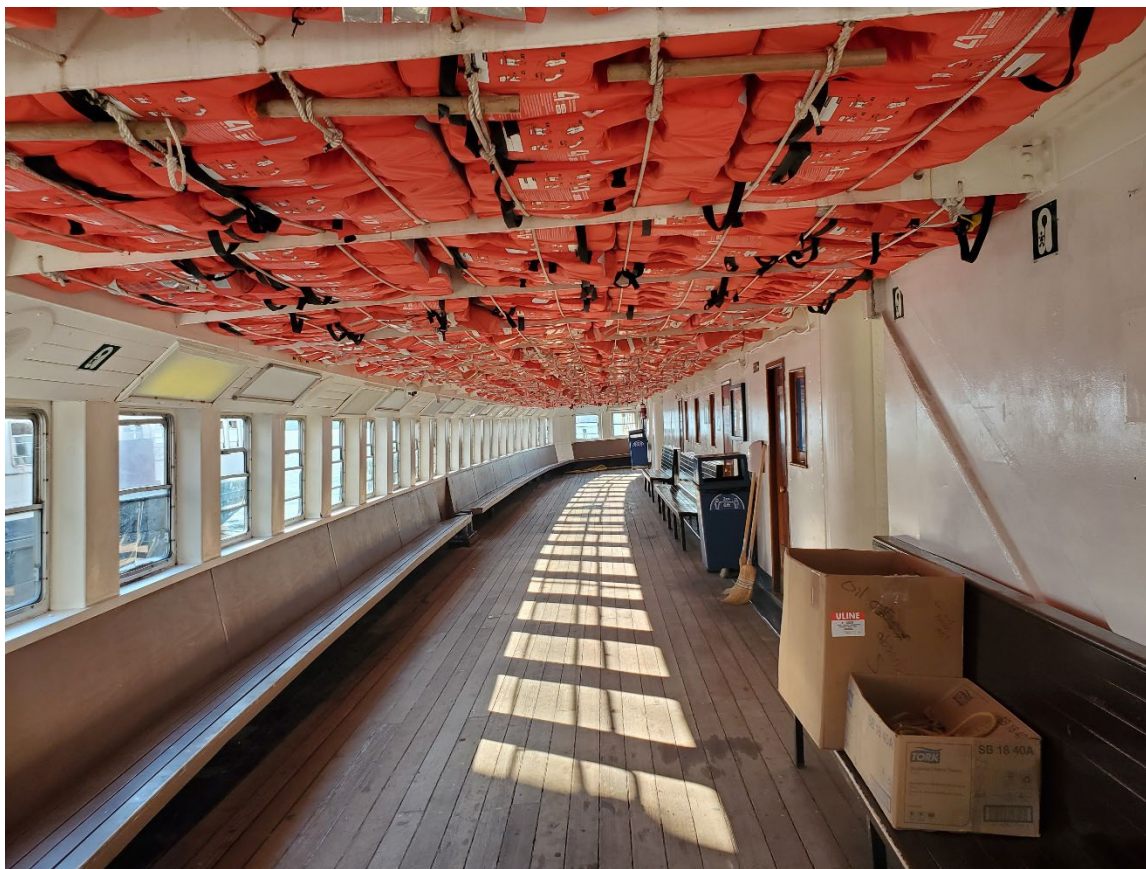
Figure 8. Lifejacket stowage above the main deck (Source: TSB)

Some of the lifejackets were stored in a way that obscured the information about sizing, which could impede the ability of passengers to select an appropriate lifejacket. Although there was 1 sign posted per deck (Figure 9), containing information in English and French on how to don adult lifejackets, the information was not specific to either of the 2 types on board.
