MARINE TRANSPORTATION SAFETY INVESTIGATION REPORT M22P0298

RISK OF COLLISION AND CAPSIZE

General cargo vessel *Saga Beija-Flor* and pleasure craft BC4010135
Vancouver Harbour, British Columbia
15 October 2022

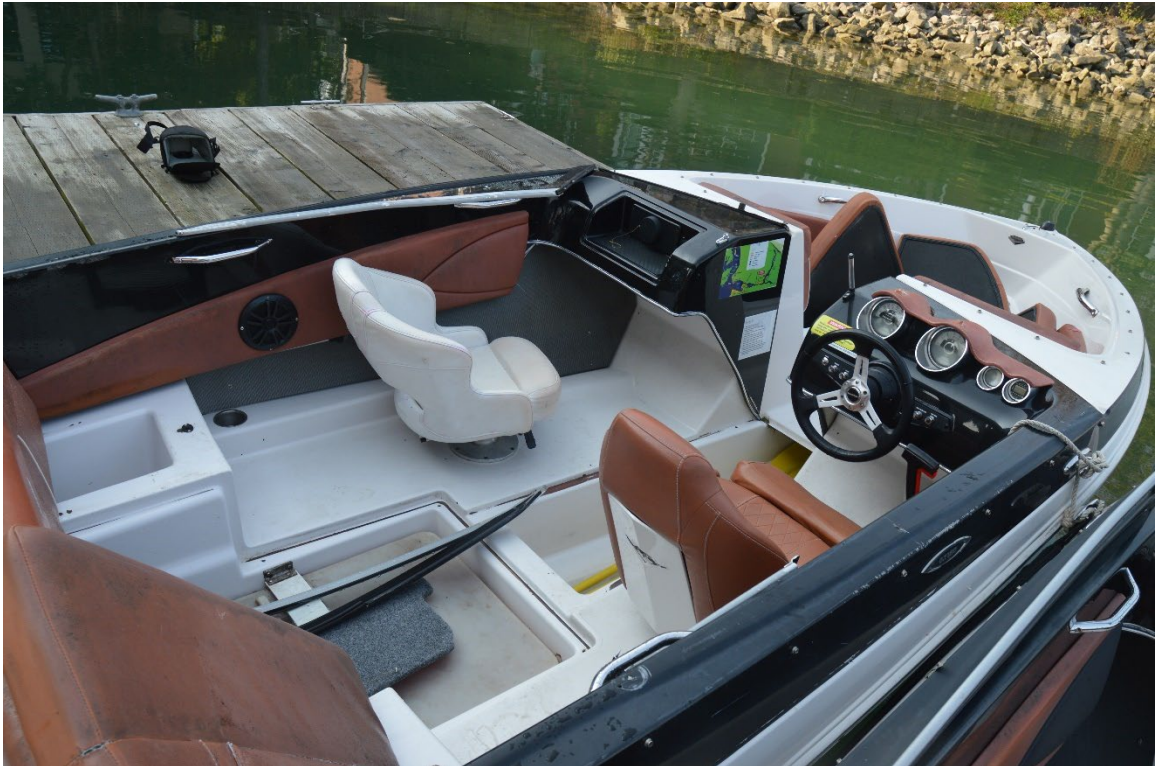
Figure 2. Pleasure craft BC4010135, docked at False Creek, Vancouver, British Columbia (Source: TSB)

The TSB conducted a post-occurrence examination of the pleasure craft after it was recovered and re-floated at Granville Island. The pleasure craft was observed to have sustained damage to its controls, electrical components, and steering. The front windshield was broken, and numerous seat cushions were scattered. All loose equipment was missing, likely as a result of the capsize. Numerous scrapes were observed on the topside of the

vessel's hull. The condition of the outboard engine and underside of the hull could not be assessed.

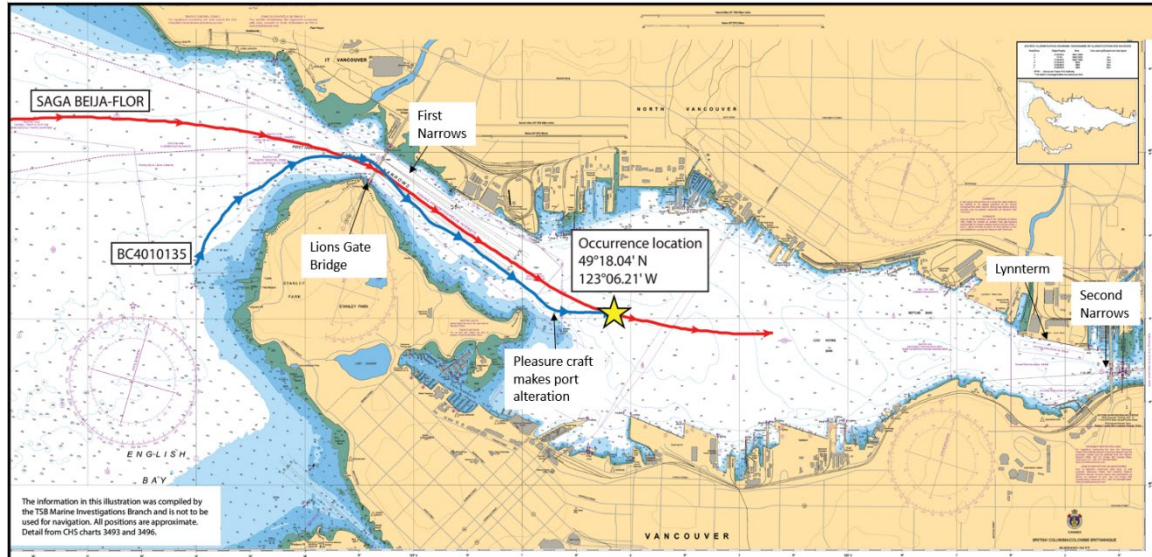
The pilot observed a tug responding to the incident and the vessel continued its voyage to the Lynnterm Terminal. The tugs for berthing were made fast alongside the *Saga Beija-Flor* at 1100, and the vessel was all fast at the terminal by 1330 (see Figure 3 for vessel track and occurrence location).

Figure 3. Vessel tracks for the *Saga Beija-Flor* and pleasure craft BC4010135, with occurrence location (Sources: Canadian Hydrographic Service charts 3493 and 3496, with TSB modifications)

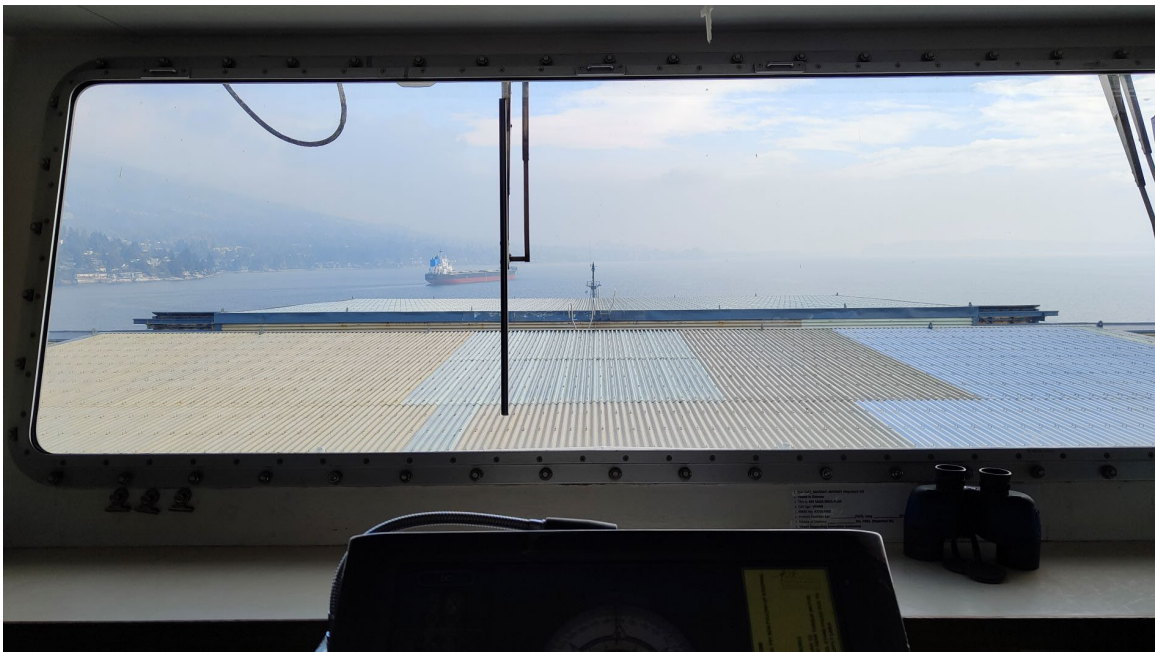
Figure 6. View of the sea surface from *Saga Beija-Flor*'s conning position with gantry cranes in stowed position aft (Source: TSB)

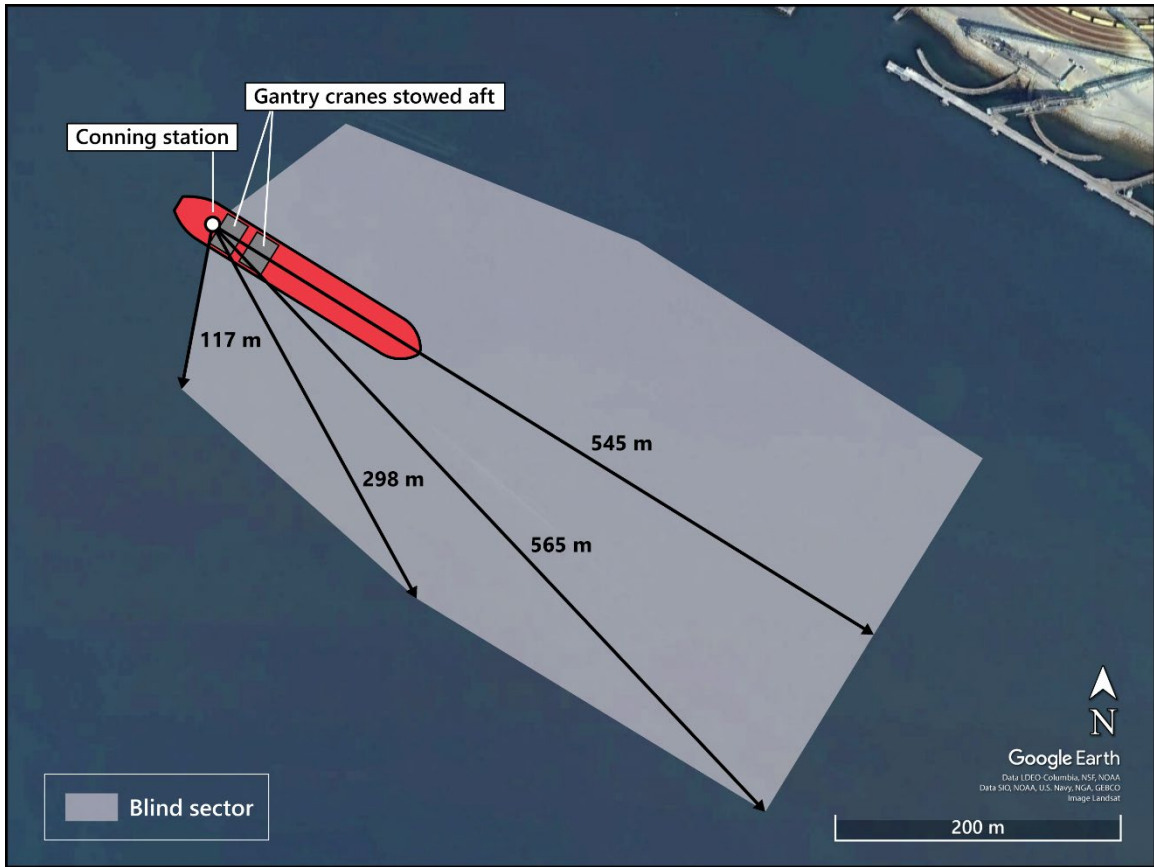
The TSB used vessel plans to calculate the line of sight from the conning position to the sea surface at the operating drafts. On the day of the occurrence, the calculated line of sight from the conning position was approximately 545 m along the centreline, and approximately 565 m at an angle of 14.9°. The vessel complied with SOLAS with regard to navigation bridge visibility, but operated with a blind sector (Figure 7).

Figure 7. Illustration of the calculated blind sector from the *Saga Beija-Flor's* conning station with gantry cranes in stowed position aft (Source: Google Earth, with TSB annotations)

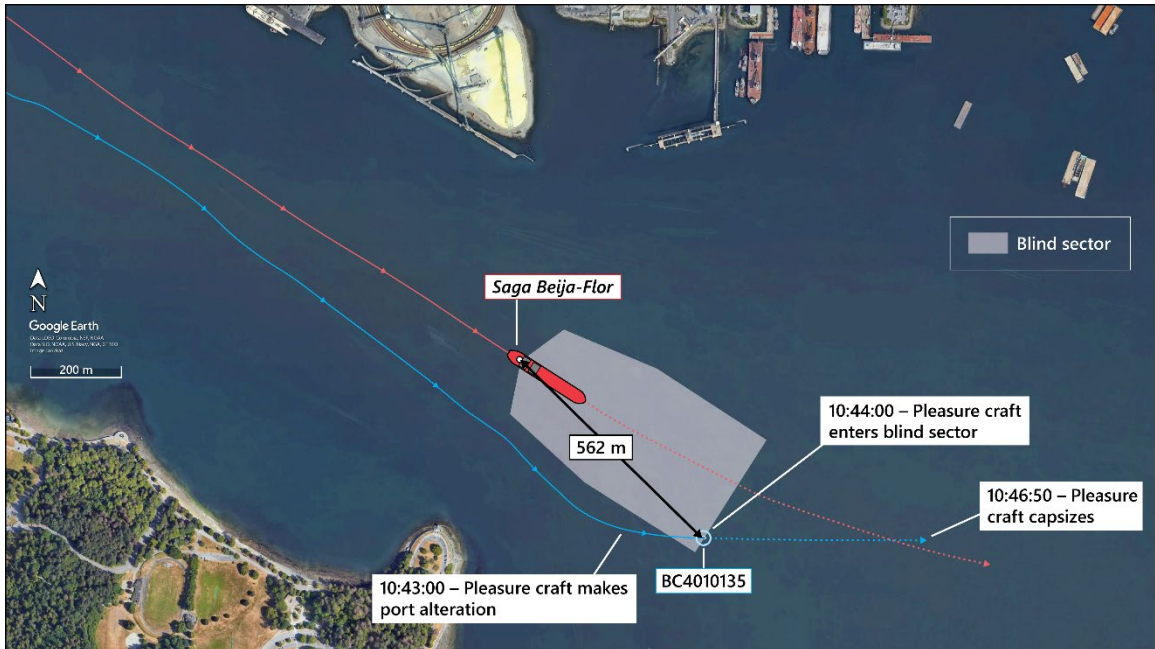
Additionally, visibility from the cargo vessel's bridge was obstructed by the stowed gantry cranes. Using measurements from the vessel's navigation bridge visibility plan, the TSB determined that the pleasure craft entered the *Saga Beija-Flor*'s blind sector at 1044:00, when it was 562 m forward of the bridge. Without a dedicated lookout from the bridge or at the bow, the crew had a narrow window of opportunity (approximately 1 minute) to recognize that the pleasure craft presented a hazard to navigation after it altered course to port (Figure 8).

Figure 8. Pleasure craft BC4010135 entering *Saga Beija-Flor*'s blind sector (Source: Google Earth, with TSB annotations)

The *Saga Beija-Flor*'s bridge team did not see the pleasure craft crossing the cargo vessel's path because the craft was obscured by the vessel's gantry cranes, which were in the stowed position.

There were no effective defences implemented to adequately mitigate the hazards associated with the blind sector caused by the gantry cranes, such as posting a lookout at the bow.
